# The Significance of Primary Volcanic Fabrics and Clay Distribution in Landslides in Hong Kong

P. A. Kirk, S. D. G. Campbell & C. J. N. Fletcher

*Geotechnical Engineering Office, Civil Engineering Department, Hong Kong*

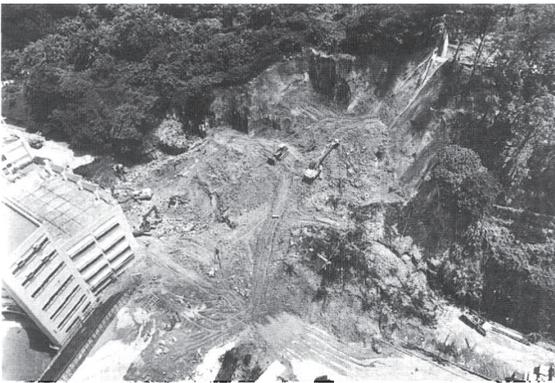
Figure 2. Oblique aerial photograph (17/8/95) showing the Fei Tsui Road landslide site

The failure occurred at the highest part of the cut-slope (c. 30 m) along a section about 50-60 m long. The main scarp was 15 m behind the original cut-slope crest and the depth of the failure averaged 15 m. Debris travelled up to 70 m, and spread out to a maximum width of 90 m (Figure 2 and GEO 1996a). Subsequent remedial work has extensively modified the site.

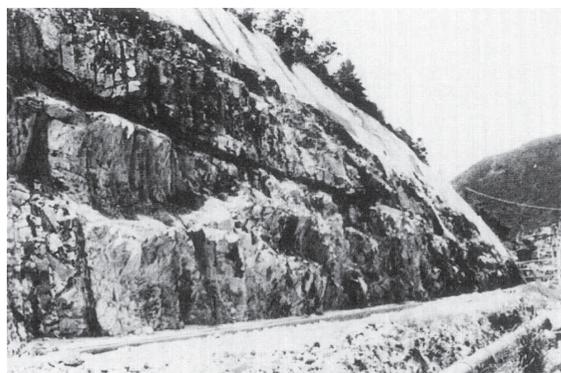
Figure 4. View NW towards the cut-slope at Fei Tsui Road during site formation (1977): dark band in middle of face is the kaolin-rich layer; chunam on slope covers soil.

In the central and eastern parts of the failure, the layer, now largely removed during remedial works, occurred within moderately to highly decomposed volcanic rock (PW50/90), was thin (0.5 m), highly kaolinized with very abundant kaolin veins, and was intimately associated with the surface of rupture. Landslide debris generally lay directly above the (partially eroded) layer. A photograph taken during site formation shows the same layer daylighting about 8 m above road level (Figure 4).

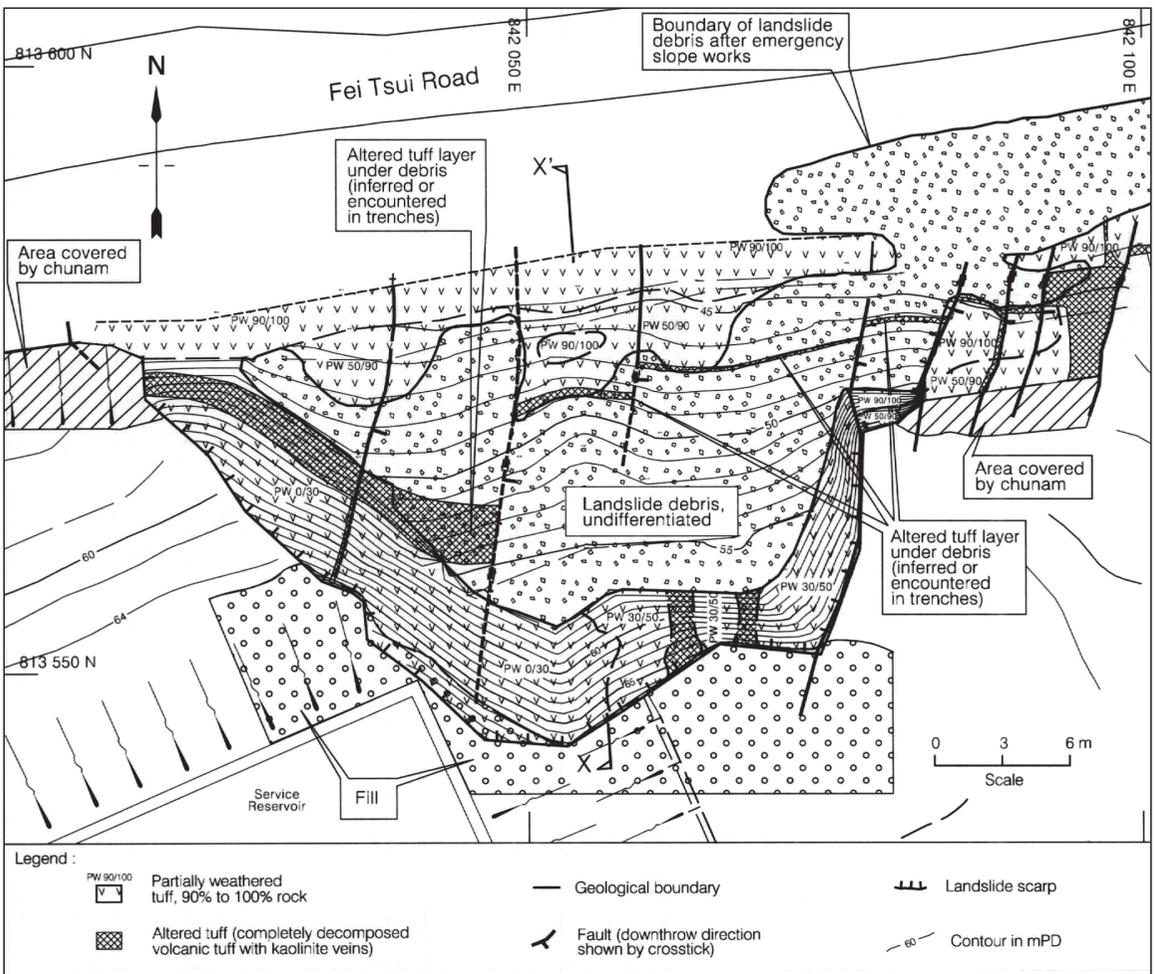
West of the failure, the layer occurs within completely decomposed volcanic rock, is more ‘diffuse’, relatively thick (3 m), less intensely kaolinized, and though predominantly of highly to completely decomposed, includes some moderately decomposed rock. Clay lenses and veins are less abundant, and most occur near the top of the layer. In the west, the failure truncated the layer near the base of the western release surface. The surface of rupture formed here at the abrupt interface between completely (PW 0/30) and slightly decomposed or fresh tuff (PW 90/100), which was virtually co-planar with the kaolin-rich layer to the east. The geometry and distribution of materials and features are shown in Figures 5-7.

Figure 5. Geological map of the Fei Tsui Road landslide site (modified from GEO 1996a)

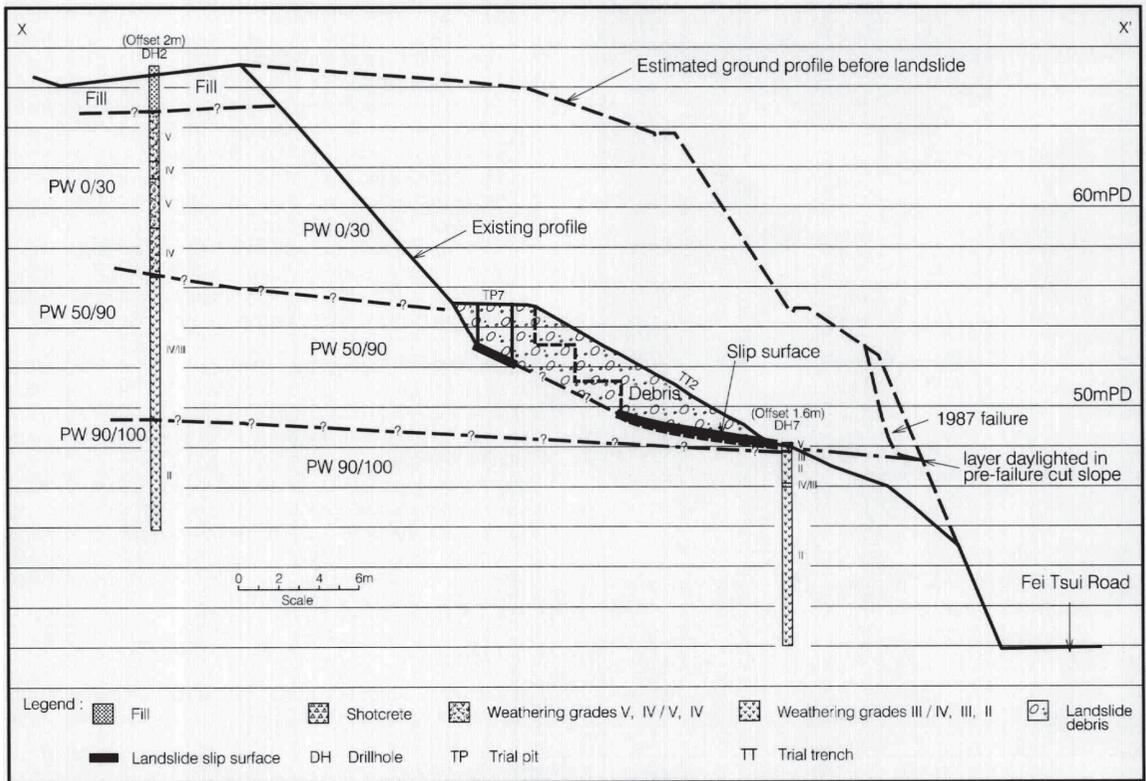
Figure 6. Geological cross-section of the Fei Tsui Road landslide. See Figure 5 for location (modified from GEO 1996a)

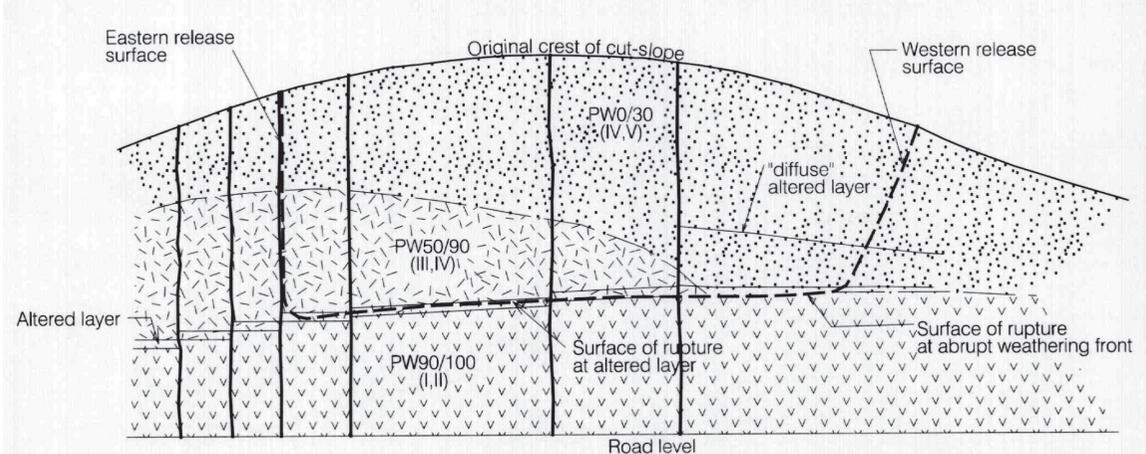
The GEO (1996a) concluded that the principal factors that caused the landslide were: the presence of the laterally extensive kaolinite-rich altered tuff layer which formed a weak and impermeable layer, and enabled development of a deep translational failure mechanism; and an increase in groundwater pressure, after prolonged heavy rainfall caused a perched water table to form above the altered tuff layer. Several small failures predated the major failure in 1995. Photographs and notes of landslides in 1987 and 1993 (GEO 1996a) show small-volume failures with surfaces of rupture coincident with the kaolin-rich layer.

Figure 7. Sketch transverse section with inferred pre-failure geology of the cut-slope at Fei Tsui Road, showing the weathering (by rock mass), the kaolin-rich layer, and the surface of rupture of the landslide

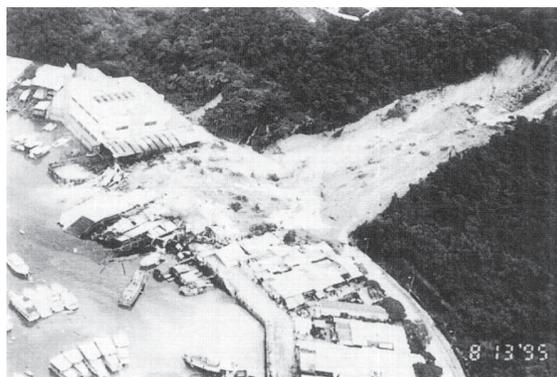
Figure 8. Aerial view of the Shum Wan Road landslide on the day (13/8/95) it occurred

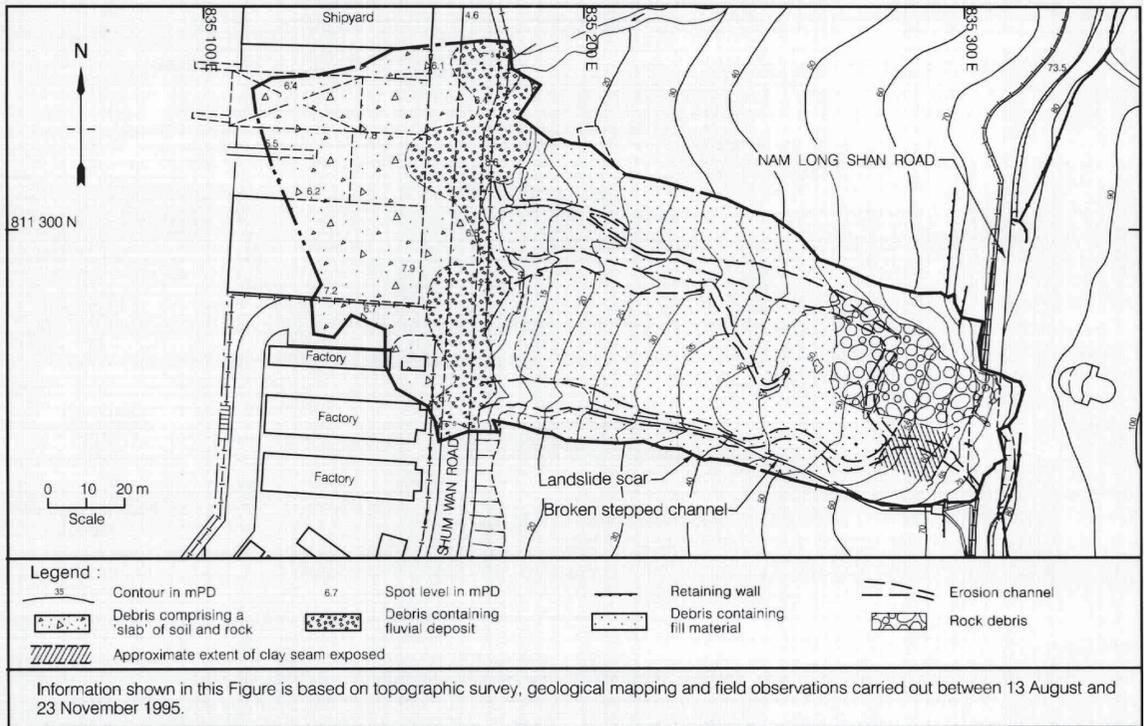
Figure 9. Geological plan of the Shum Wan Road landslide (modified from GEO 1996b)

Slabs of debris, tens of metres or more across and 2-3 m thick, were deposited west of Shum Wan Road (Figure 9). They largely preserved the stratigraphy of the upper soil profile of the slope. Vegetation, topsoil and fill were probably bulldozed in front of the slabs during emplacement and continually overridden by them. Detachment of the slabs may have been selective along kaolin-rich horizons seen in the soil profile.

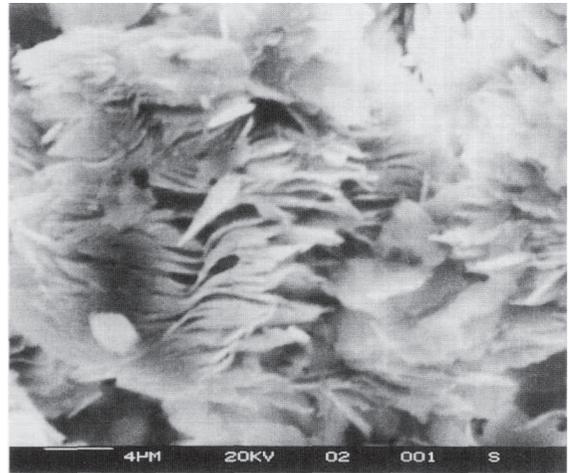
Figure 14a. Fei Tsui Road: backscattered secondary electron photomicrograph of crenulated books of kaolinitic crystals in white clay vein below surface of rupture

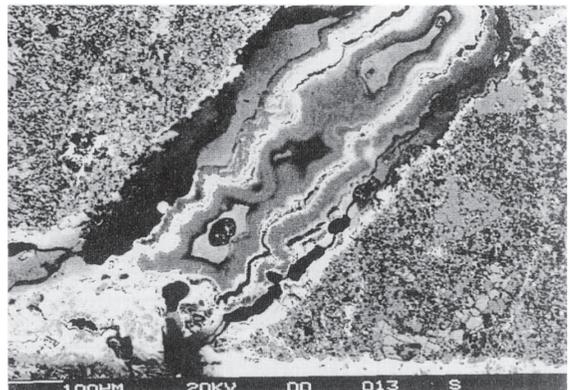
Close below the surface of rupture, joints are generally coated with todorokite (Mn-Ca-Ba-oxide) and commonly, but variably infilled with white and buff kaolin up to 20 mm thick. Sporadic, fissure-like joint infillings of soft, moist, buff, sandy kaolin, are up to 230 mm thick, but taper sharply downwards. These deposits also occur in shallowly inclined joints. In places, tabular fragments of white kaolin, detached from adjacent joint walls, occur within buff kaolin which resembles that along and above the surface of rupture. The complexity of joint infillings implies protracted minor movements, possibly related to near-surface creep prior to the main failure. These caused repeated openings of joints which were then infilled, physically with, or by precipitation of kaolin, and by Mn-oxide (see Figure 14b).

Figure 14b. Shum Wan Road: backscattered secondary electron photomicrograph image of undeformed kaolinite (dark grey) and Fe-Mn-oxide (bright grey) vein-fillings

as tensional fissures (Figure 14b) associated with shearing. The surface of rupture at Fei Tsui Road, and associated discontinuities, acted as conduits for mineralizing fluids.
