Engineering Geological Aspects of Landslides

S. Hencher

Halcrow China Limited, Hong Kong

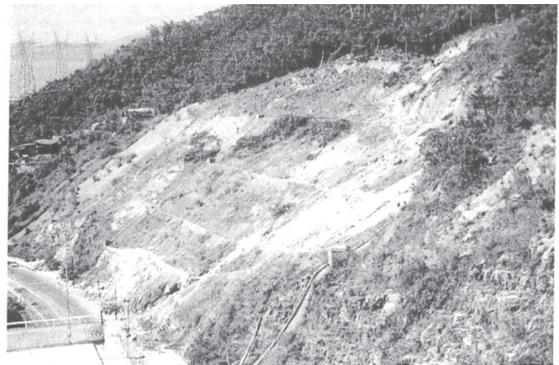
In Hong Kong the failure at Tin Wan Hill Road in 1983 was judged by the investigators to be a generalised failure through the closely fractured rock mass, mainly because of the lack of a clear kinematic mechanism (few obviously adverse discontinuities were identified). Furthermore the mass movement was unusual with essentially a "bulging", of the rock mass (Figure 3a). Figure 3b shows some of the initial signs of distress. Whilst a clear tension scarp was formed at the rear of the distressed zone, at the toe there were discrete rock falls and movements rather than overall detachment. To the right of the slope (facing) there was no apparent movement. To back-analyse the failure, the newly developed (then) Hoek-Brown criterion was used to provide mass strength parameters (see Hoek et al, 1995). The case is reported by Irfan et al. (1987).

Figure 3a. General distress in slope, Tin Wan Hill Road, 1983

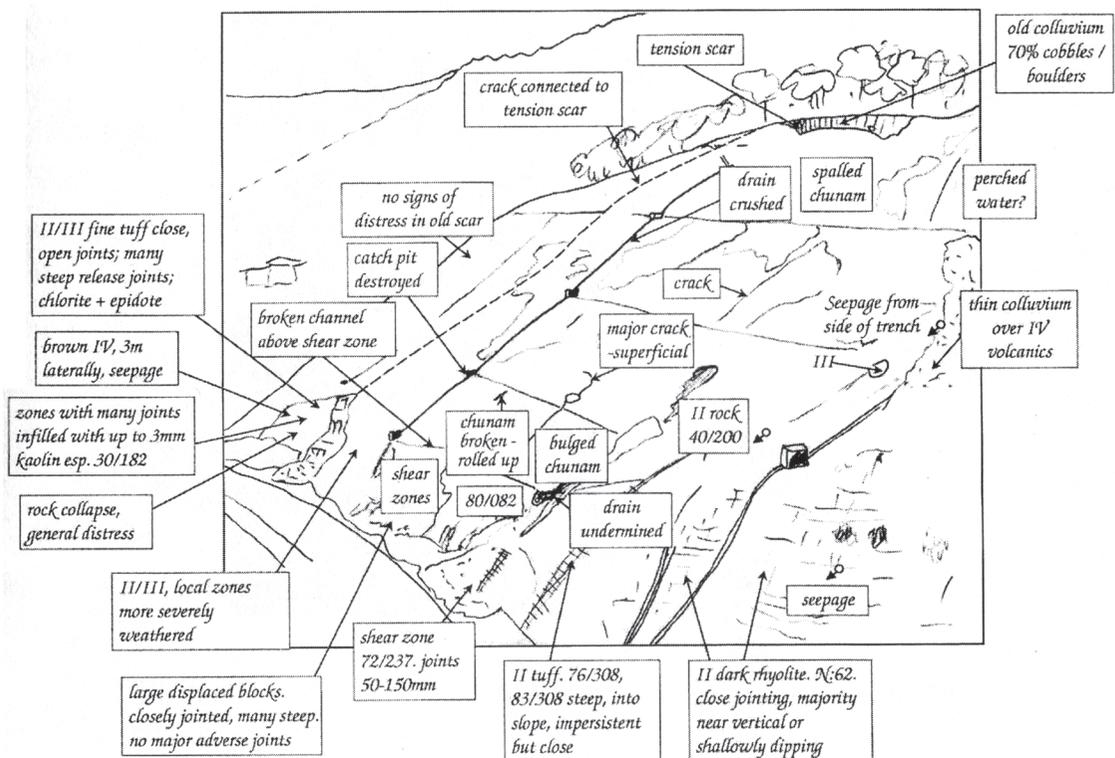
Figure 3b. Field observations, November 1983

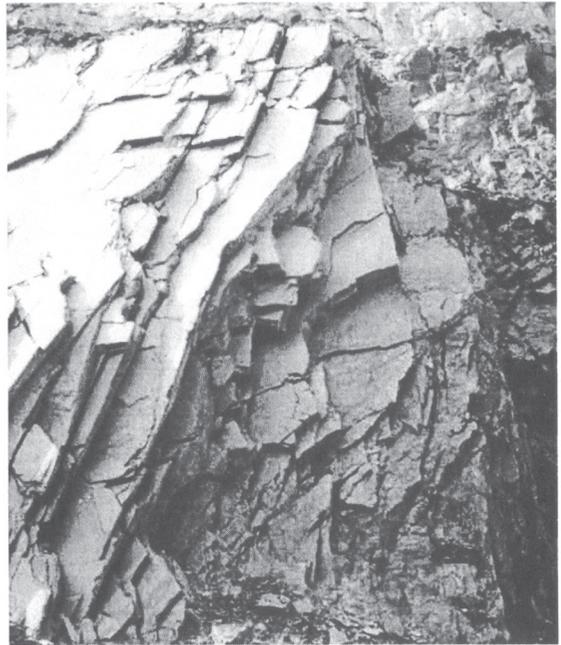
Another example of this type of failure is that at Aznalcollar open pit mine in Spain (Hencher et al, 1995) (Figures 4 & 5). One section of the slope was continually on the move (several mm per day), speeding up following heavy rainfall, whilst another, apparently similar section remained apparently stable. The latter slope was of most concern because it was feared that a sudden, brittle type of failure might occur and careful monitoring had to be set up to try to get some advanced warning of imminent failure. The rock mass is predominantly fairly closely fractured slate with steeply dipping cleavage (much steeper than the failing slope which has an overall angle of only about 33 degrees).

Figure 4. Typical cleaved rocks at Aznalcollar open pit mine

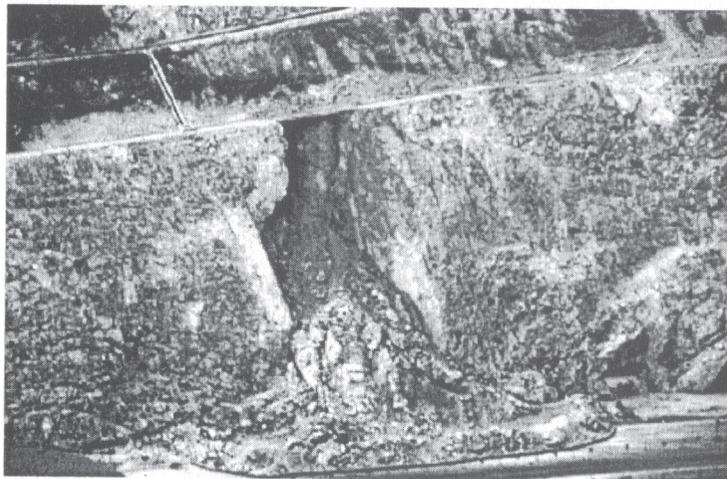
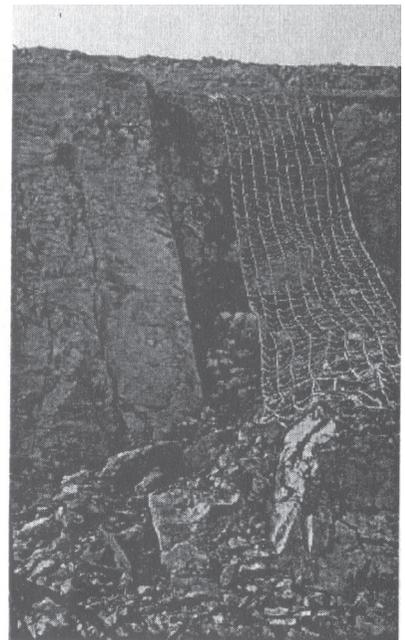
Figure 7. Failure through intact weak rock at the toe with sliding and release on joints a contributing factor, Tsing Yi, 1982

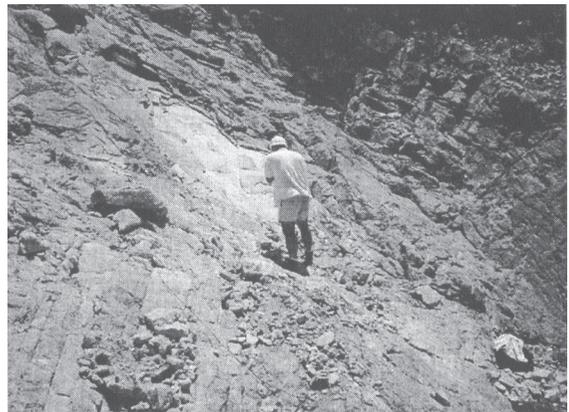
Examples of close, adverse fractures which have no doubt developed due to surface unloading and which had a controlling influence on a natural terrain landslide are shown in Figure 8. In this example, the near surface joints (above the detachment plane) are all infilled with clay, which probably reflects long term slope deterioration and movement.

Figure 8. Natural terrain landslide scar. Note probable stress relief fractures parallel to terrain surface. Also note apparent change in structure above and below the light coloured grade II surface (central)

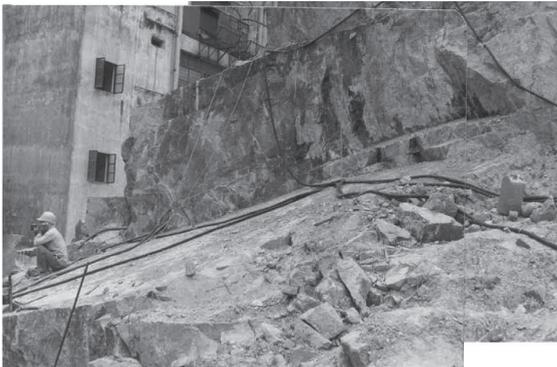
Figure 15. Almost planar failure surface at Yip Kan Street dipping at only 20 degrees (GCO, 1983d)

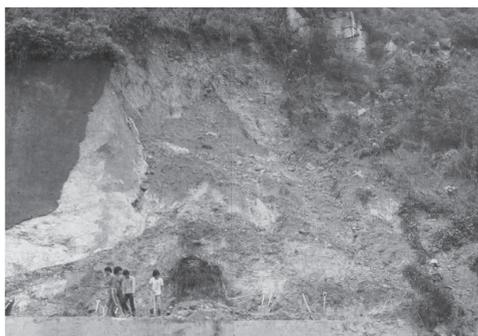
Figure 16a. Landslide at Tuen Mun Highway, 1982

& Hencher (1984) give examples. Au (1986) reviewed several cases. Figure 16 shows a failure that occurred on Tuen Mun Highway in 1982 together with a block model interpretation of geological conditions that, it was believed, led to the development of perched water.

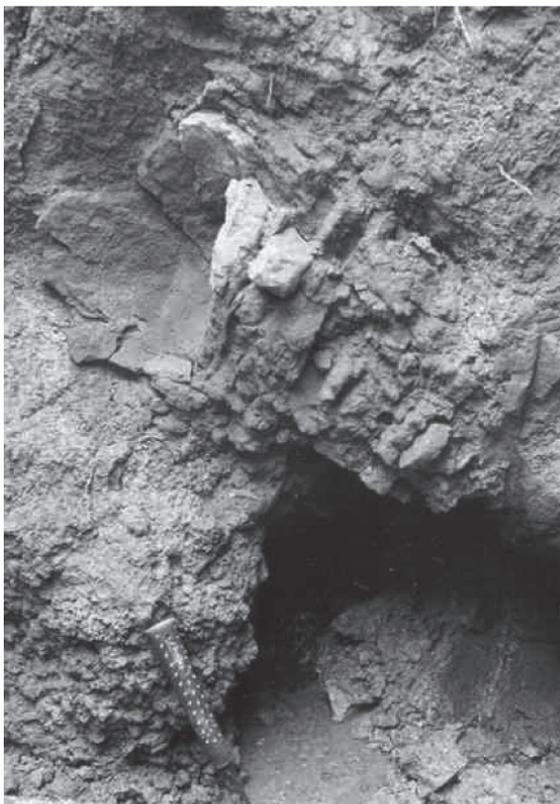
Figure 18. Large pipe with underground stream through weathered granodiorite, Stanley

Pipes can be large (of the order of metres) and associated with the development of a full underground stream network, which meanders through the rock mass, sometimes eroding and sometimes depositing sediments. An example of an active, underground stream (through weathered granodiorite behind a failed retaining wall) is shown in Figure 18.

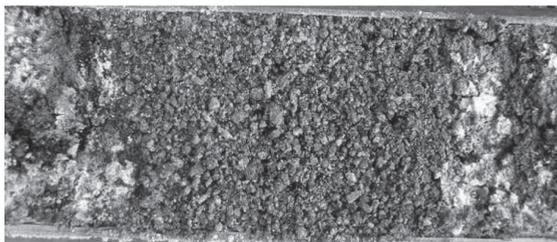
Figure 19. Coarse sand infill to pipe through weathered granite

An example of a sorted single sized sand layer, within granite at depth, and interpreted as a choked pipe is given in Figure 19.
