Two Landslides in Hong Kong

A. J. Vail

Binnie & Partners (Hong Kong)

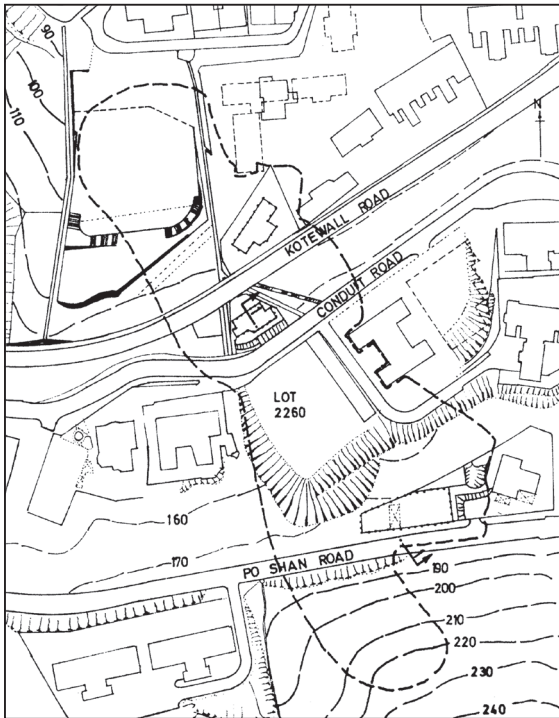
Figure 1. Po Shan Road Landslide. The shaded area shows the extent of the landslide and the limits of the debris (Commission of Inquiry 1972)

At about 5 pm, a mass of earth, rock and vegetation broke away from the south-west corner of the site flowed across Conduit Road to the north and half buried a four storey house between it and Kotewall Road.

At about 9 pm the major landslide took place in the hillside above Po Shan Road taking with it the slope behind the site together with the road. It engulfed and obliterated the four storey building struck by the previous slide, crossed the lower road and struck a

The slide, some 120 m long and 67 m across, with an average depth of 10 m was estimated to contain about 80,000 tons of material. It took from 7 to 10 seconds to complete its travel (Vail & Attewill, 1976).

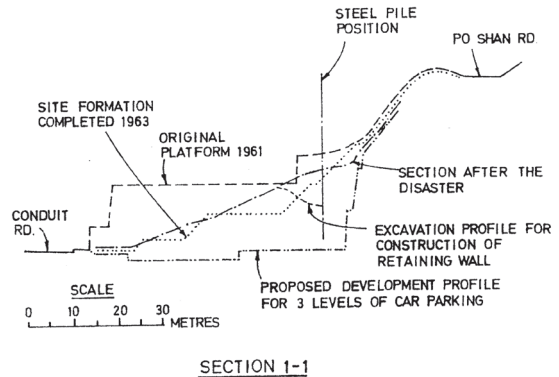
Figure 2. Section through Lot 2260

ground level. These new site formation works involved the formation of an unsupported cut slope of 80° some 13 m below an existing slope which supported Po Shan Road running above and behind the site (Figure 2).

The excavation of lot 2260, which began in 1965, was increased in May 1971 and again in May 1972, must have progressively reduced the stability of the hillside above and below Po Shan Road.

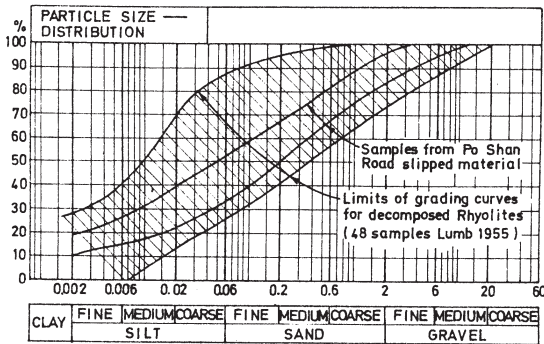
The hillside above Po Shan Road is of rhyolite covered by a mantle of colluvium between 20 m and 30 m thick. The hillside forms a distinct ridge and is among the steepest in the area with an overall slope of 36° down to the centre of lot 2260 where it meets the shallower 18° coastal slope. The material in the hillside consists of about 2 m of sandy silty clay overlying sandy clayey silt containing subrounded boulders. A number of boulders on the surface of the hillside appear to have migrated from the summit. Samples taken from the slipped material show 10% of clay and 30% of silt (Figure 3).

Figure 3. Grading band of samples recovered from Po Shan Road (Vail 1972)

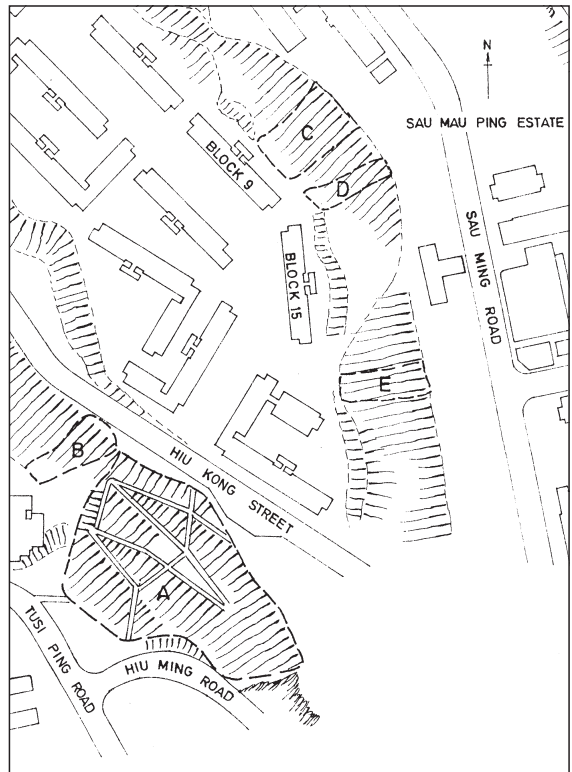
Figure 4. Part of the Sau Mau Ping Estate

Figure 4 shows part of the estate at Sau Mau Ping. In 1972, on the same day as the failure at Po Shan Road but some 8 hours earlier following a period of maximum intensity reaching 67 mm/hour, the fill slope marked A on Figure 5 failed. In failing the material liquefied and inundated a squatter village at the toe of the slope burying 71 people. The failure was described by an eye witness as “sliding like a carpet”.

At about 9 am on 25th August 1976, following 24 hours of heavy rain deposited by Tropical Storm Ellen, a section of the embankment behind Block 9 of the Estate 42 m wide, failed over the total slope height of 35 m and to an average depth of about 2 m. The disturbed material liquefied on failure, poured down the slope, across a courtyard and slammed into the back of Block 9, a six storey shop house and residential block entirely filling the rear ground floor rooms to ceiling height and engulfing 18 people (Morgenstern, 1978, 1980). This slope was described by a witness as “sliding like a sheet”. Within 15 minutes of the failure behind Block 9, marked C on Figure 4, slopes also failed at points B, D and E.

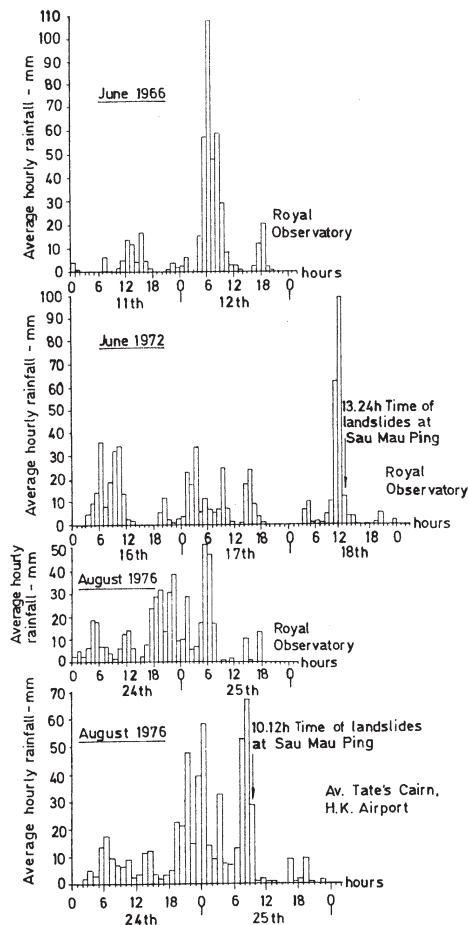
Figure 5, shows the maximum twenty-four hour cumulative rainfall for this rainstorm together with those for the only two comparable rainstorms in the period of record, in August 1966 and June 1972.

It can be seen that the 1966 rainstorm produced the highest intensity of 108.2 mm per hour followed by the 1972 rainstorm with 98.7 mm per hour. In the 1976 rainstorm there were two periods of high intensity, the first, after some 14 hours of rain, was recorded as a maximum of 57.5 mm per hour at Kai Tak and the second, after 22 hours, was recorded as a maximum of 51.5 mm per hour at the Royal Observatory. It was after the second of these periods of high intensity that the 1976 Sau Mau Ping landslide occurred.

Figure 5. Average hourly rainfall at The Royal Observatory and Tate’s Cairn - Kai Tak

rainstorm was less than that in the 1966 and 1972 rainstorms, the total maximum twenty four hour rainfall was greater, amounting (at the Royal Observatory) to 445.1 mm in 1976 as opposed to 422.4 mm in 1966 and 232.7 mm in 1972. The total recorded at Kai Tak in 1976, 513.0 mm, was higher than at the Royal Observatory suggesting that the precipitation at Sau Mau Ping might have also been higher than at the Royal Observatory and that, therefore the maximum intensity might well have been higher.
