# Environmental Factors in Triggering Slope Failures

S. W. C. Au & R. Y. C. Suen

*Geotechnical Engineering Office, Civil Engineering Department, Hong Kong*

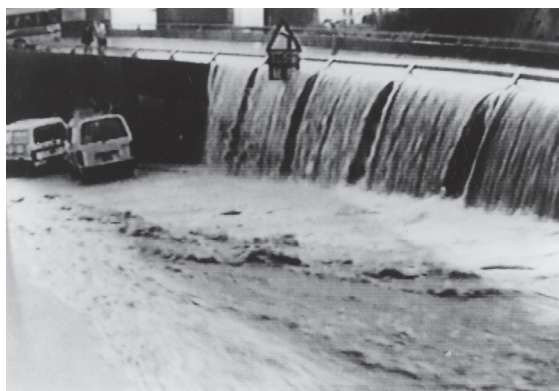
Figure 1. An example of surface water concentration

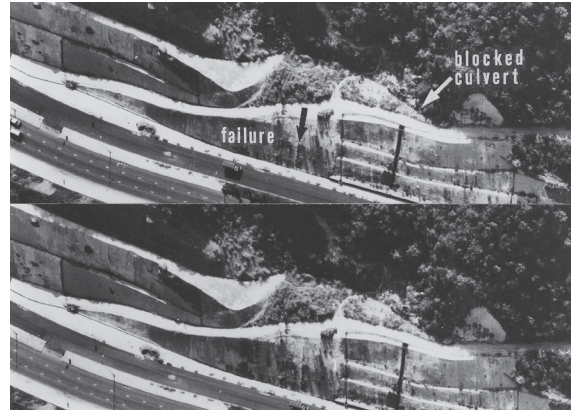
A slope failure occurred on a cut slope of colluvial material supporting a level open platform which abutted a natural hillslope at its rear. A general view of the site prior to the failure can be seen in the stereo-pair aerial photographs in Figure 3. The failure occurred as a washout (see Figure 4) during an extremely heavy rainstorm (the highest 1-hour rainfall intensity was 100 mm/hr) at which time the 1 000 mm

Figure 3. Stereo-paired aerial photograph of the site - case 1

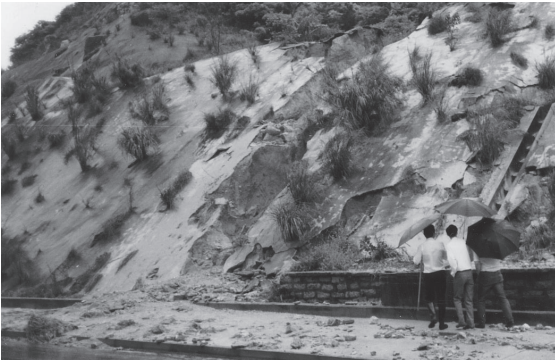
culvert, which served to intercept surface water discharged from the 30 000 sq. m upslope natural catchment area, had been blocked with sediments.

The catchment area provided the source for a large quantity of surface water. The crest platform was bare and the chunam surface protective cover to the slope which subsequently failed had deteriorated. The topographic depression of the crest platform had allowed flooding of the platform and also overflow across the slope crest if the culvert was blocked (Figure 3). An examination of the site after the failure revealed that the sediments in the culvert were covered with vegetation suggesting that the culvert had been silted up for sometime. The vegetation had reduced the self-flushing capability of the culvert and exacerbated the blockage.

Figure 4. General view of failure - case 1

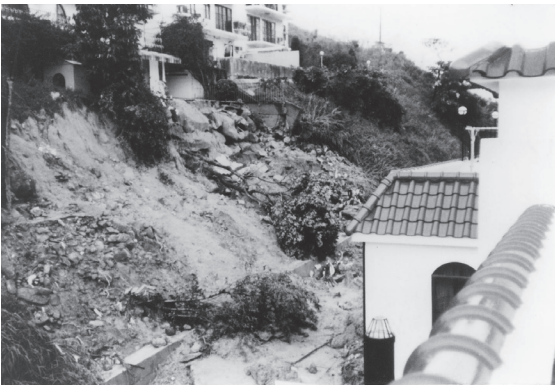
The failure of a retaining wall supporting a garden terrace occurred during the same storm. The failure is shown in Figure 5. The failure occurred at the front garden of one of the houses located at the end of a cul-de-sac road. A flat area at this end of the road provided car parking spaces (Figure 6) and this part of the road was collecting runoff from a fairly large catchment area.

Discussion with a resident of the house affected revealed that the wall failed as water overflowed the kerb line of the car park into his allotment. The car park was inundated by the surface runoff accumulating on the road. Drains serving the car park were either blocked or simply overwhelmed at the time. Considerable flooding occurred and water flowed towards the failed retaining wall as was evident from the level of dead leaves that had accumulated on the wire fences (Figure 7). The garden terrace was constructed with a parapet wall which promoted further flooding of the garden platform.

Figure 5. General view of failure - case 2

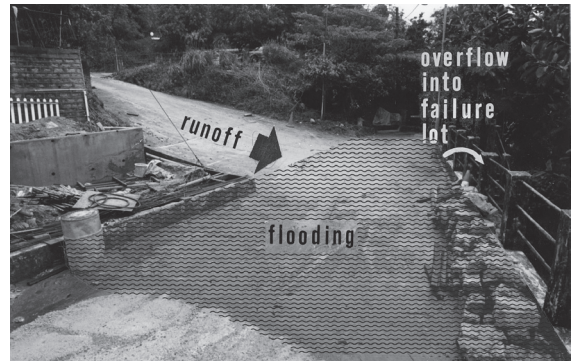
Figure 6. The carpark platform at rear of the houses - case 2

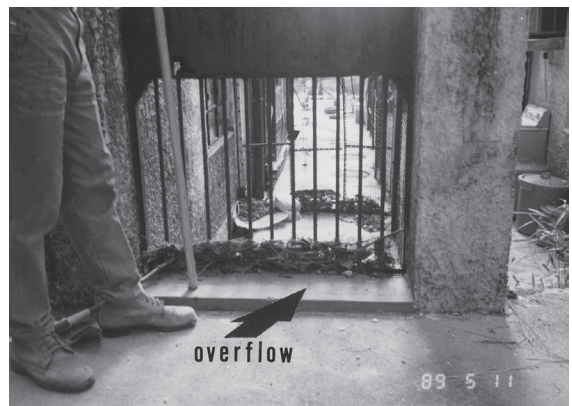
Figure 7. Accumulated dead leaves as evidence of overflow - case 2
