The 23 July 1994 Landslide at Kwun Lung Lau, Hong Kong

H. N. Wong & K. K. S. Ho

Geotechnical Engineering Office, Civil Engineering Department, Hong Kong

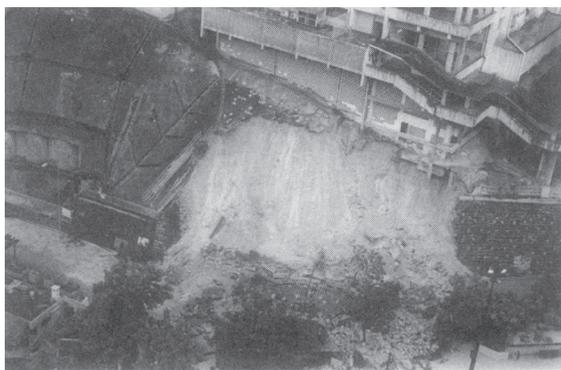
The landslide occurred following a period of heavy rain. The full height of the masonry wall above the footpath level collapsed, together with the slope above the masonry wall, resulting in a scar that measured 28 m wide and 14 m high. The average depth of failure was about 3 m, with a maximum depth of 6 m. About 1000 m³ of debris was released in the landslide, comprising mainly soil, fragments of chunam, blocks of masonry, and trees. The soil in the debris was a

Figure 1. View of the landslide at Kwun Lung Lau

A broken 300 mm diameter underground foul-water sewer was exposed at the crest of the landslide scar. A large volume of water was discharging from the sewer onto the failure scar after the landslide.

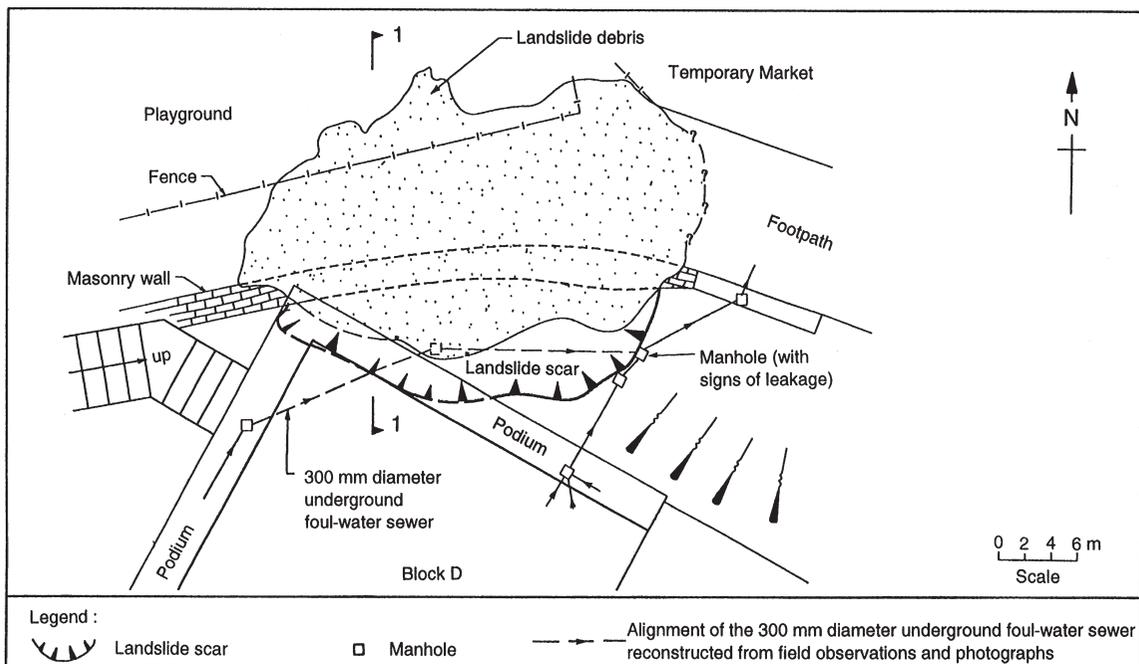
As shown in Figure 4, the majority of the landslide debris came to rest on the footpath, with some being deposited on the playground. A large portion of the upper part of the failed masonry wall was found on the surface of the debris, without major disintegration or significant relative displacement of the masonry blocks. The remains of the masonry wall were displaced well forward, with the front surface of the upper part facing upward. A cross section through the landslide site, showing the ground profiles before and after the failure, is given in Figure 5.

Figure 4. Plan of the landslide. See Figure 5 for details of section 1-1. Information in this figure is based on topographic surveys, engineering geology mapping, and field observations

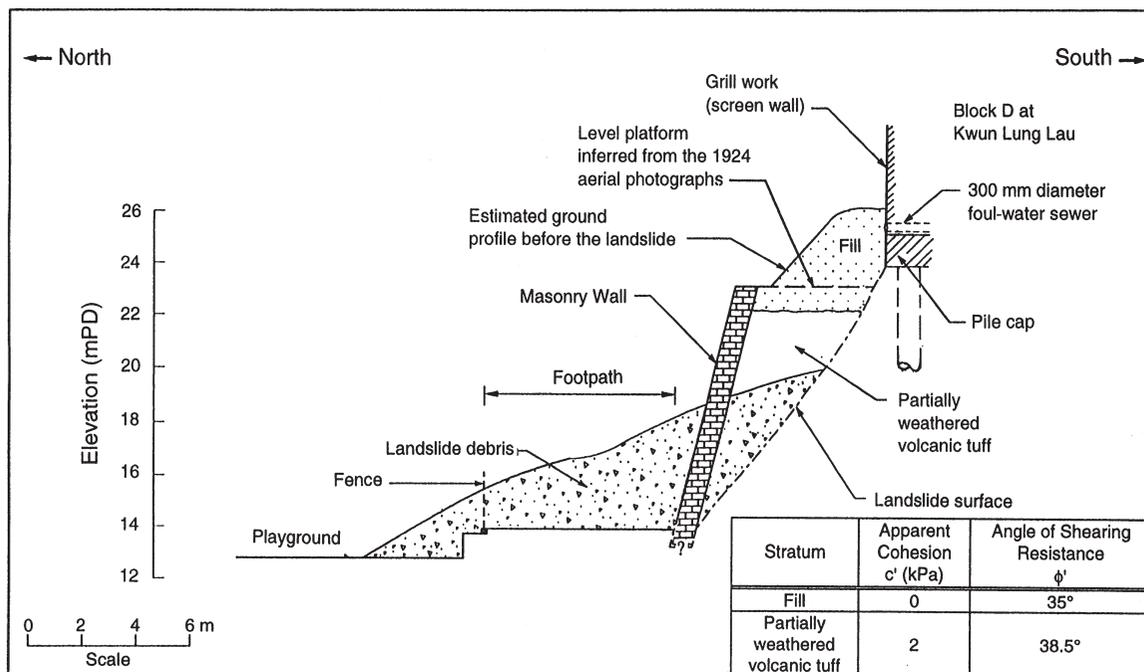
Figure 5. Section 1-1 through the landslide. See Figure 4 for location. For clarity, podium of Block D is not shown. mPD, metres above Hong Kong Principal Datum

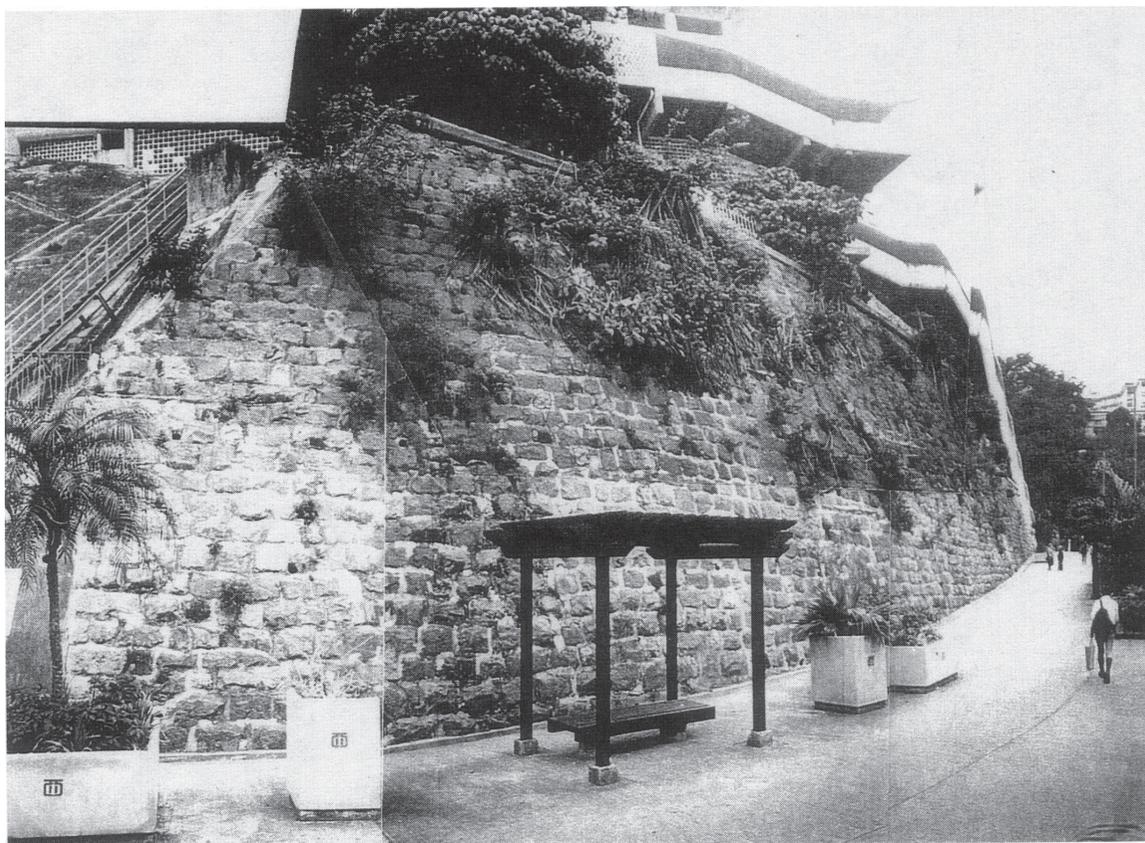
Figure 6. Masonry wall 11SW-A/R309 in January 1991

The masonry wall and the slope above were inspected by a number of professional parties between 1980 and 1994. The masonry wall was found to be in fair or good condition during the visual inspections, and no signs of distress were ever recorded. Recommendations made as a result of routine maintenance inspections were only for relatively minor maintenance works, such as removal of unplanned vegetation and clearance of weepholes.

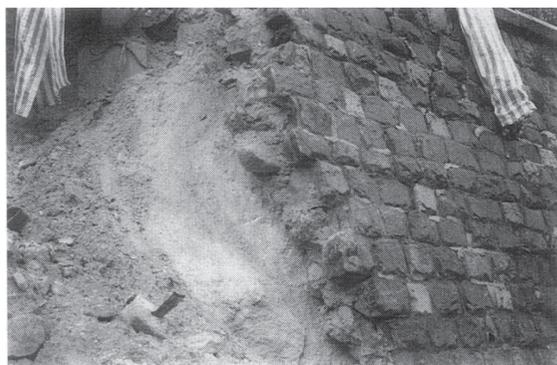
At the failure location, the masonry wall was 700-800 mm thick (Figure 7), and was constructed against a cutting into natural ground. The thickness was substantially less than that shown on the site formation plans referred to earlier. It was also far below what could reasonably have been expected on the basis of previous experience of old masonry retaining walls in Hong Kong. In order to judge this “thinness” in the context of old masonry retaining walls in Hong Kong, reference was made to the available database. The records for 100 old masonry walls were examined, but only 76 of these have sufficient information on dimensions, 57 of which were studied in detail. The slenderness (i.e., height to base width) ratios of the 57 structures are plotted in Figure 8.

Figure 7. Unfailed part of the masonry wall immediately to the west of the landslide area (photograph taken on 25 July 1994)

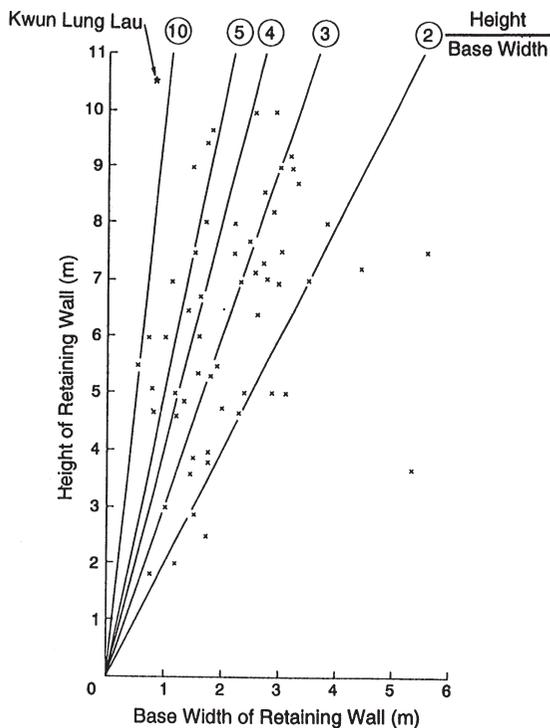
The majority of the walls have a slenderness ratio of less than four. Those with a slenderness ratio greater than four generally have some special reasons for their slenderness (e.g., part of the wall retaining slightly to moderately weathered rock). The masonry wall at Kwun Lung Lau had a maximum height of 10.6 m and a base width of 0.8 m (i.e., a slenderness ratio

of > 13). As can be seen from Figure 8, the wall was exceptionally slender.

Figure 8. Dimensions of masonry retaining walls examined in previous GEO studies. The circled numbers refer to the slenderness ratio

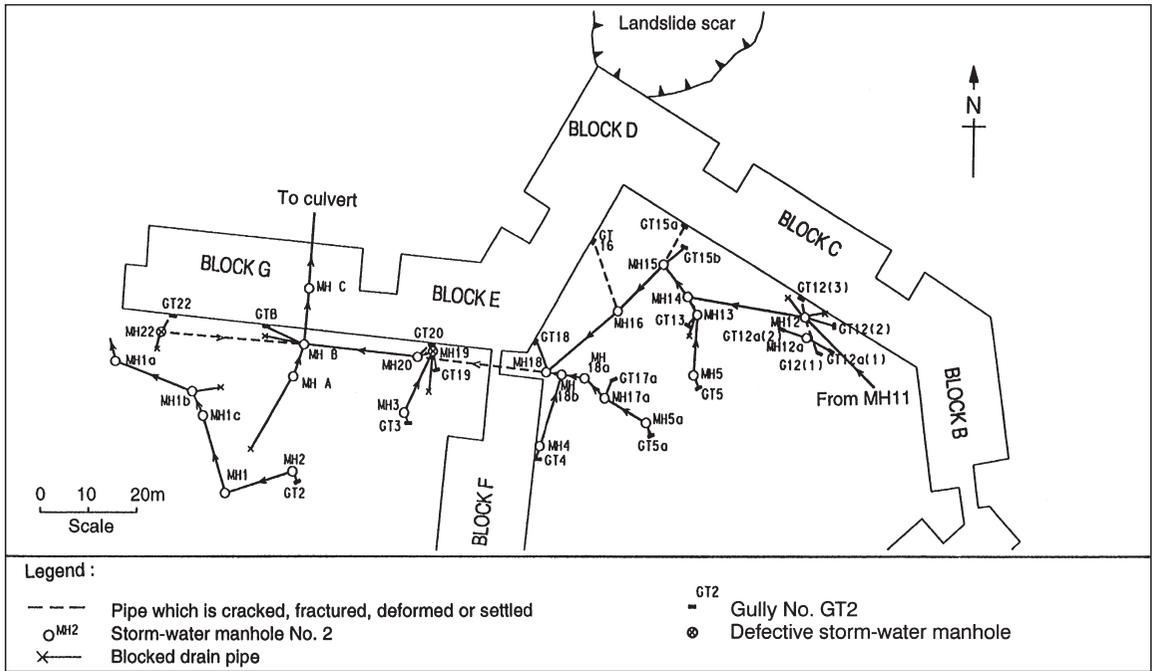
Figure 13. Layout and condition of the storm-water pipes at the time of the postfailure investigation. The drains between gully GT15a and manhole 15 and between gully GT16 and manhole 16 were found to suffer from major leakages

An examination of the Kwun Lung Lau sewer and stormwater sewer systems in the vicinity of the landslide, including extensive closed-circuit television (CCTV) surveys, revealed defects such as local settlement, cracked pipes, and dislocated or open joints. In particular, two sections of the underground storm-water pipes in the yard area to the south of Block D (Figure 13) were found to be suffering from major leakages.

Based on the seepage analyses, leakage from the defective storm-water drains beneath the yard area is likely to have been the principal source of subsurface seepage flow towards the landslide location.

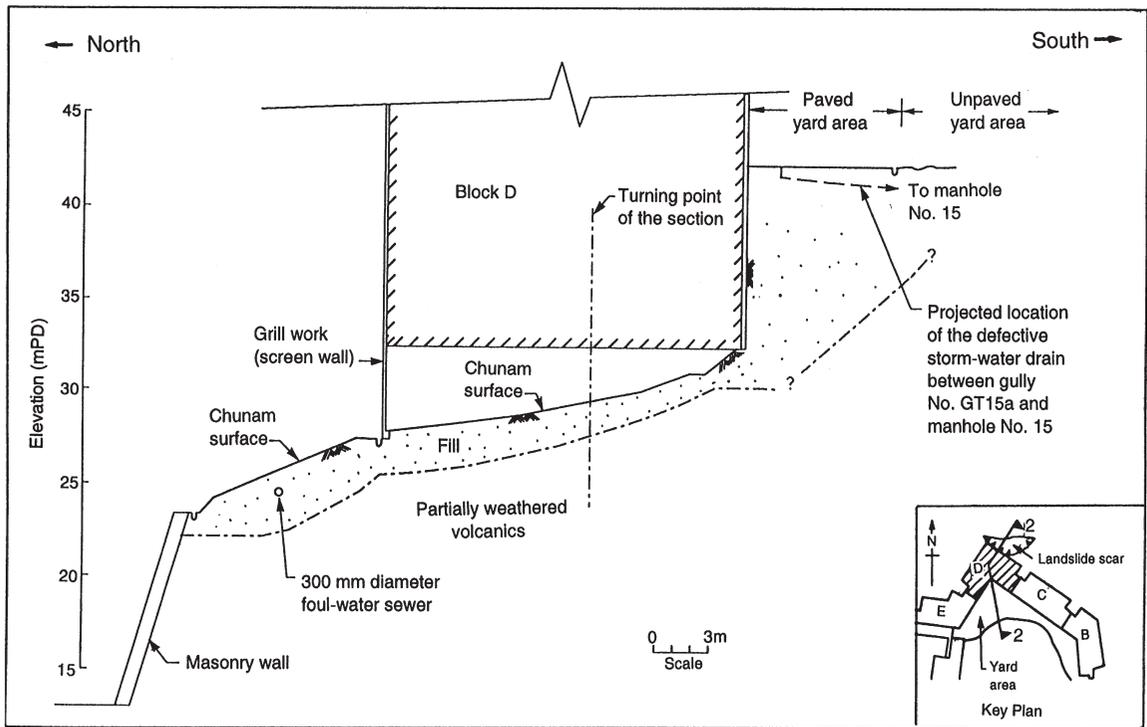
Figure 15. Section 2-2 through the landslide location, Block D, and the yard area

The layout of the pile caps and structural walls of the substructure of Block D is shown in Figure 14. Block D is underlain by two large pile caps founded on weathered volcanic tuff, with fill placed within the gap between the caps. The fill extends to the landslide site and the yard area to the south of Block D, as shown in Figure 15.

The fill material was observed to be loose and to contain voids through which subsurface seepage flow could take place preferentially. Water tests carried out after the landslide confirmed that the fill was permeable. During the water tests, a large amount of water came out within the fill near the crest of the landslide area shortly after water had been introduced into the ground below Block D.

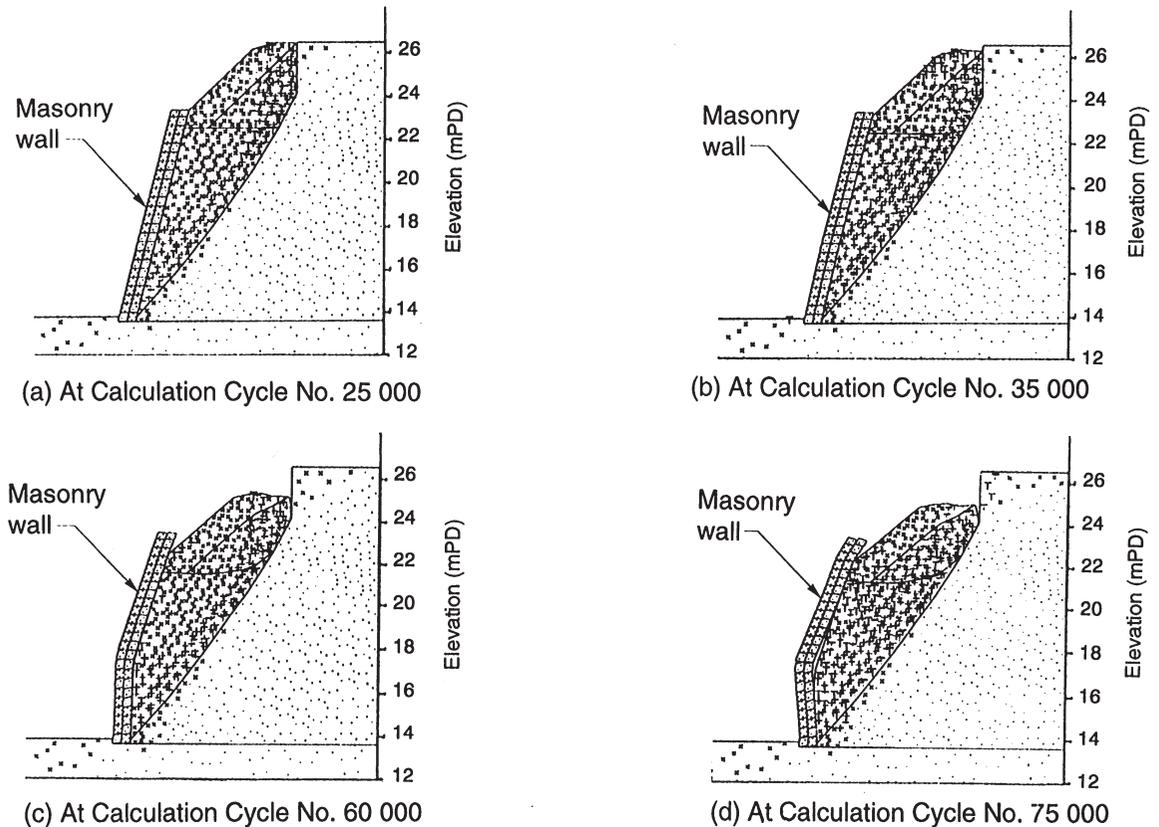
The analyses predict that the masonry structure would fail in a complex mode. The mode of masonry wall deformation and slope movement during the landslide is depicted in Figure 16. The masonry wall is found to bulge initially at about mid-height, accompanied by overturning of the portion of the masonry wall below this level. These deformation modes combine to lead to tensile failure and consequential reduction of the shear strength of the mortar joints. Bulging and overturning continue, resulting in brittle fracture of the masonry wall at about mid-height. The ground behind the masonry wall

Figure 16. Results of UDEC analyses (wall condition and stress state of case KC-1 during bulging failure)

loses support and slides forward. The analyses suggest that the upper part of the masonry wall would rotate backward as a result of the displacement of the sliding mass and is predicted to come to rest on the surface of the debris, with the front surface facing upward. The lower portion of the masonry wall is predicted to disintegrate and become buried by the debris.

An important finding was that once failure of the mortar joints was initiated, the masonry wall would deform rapidly and instability would develop in an uncontrolled manner.

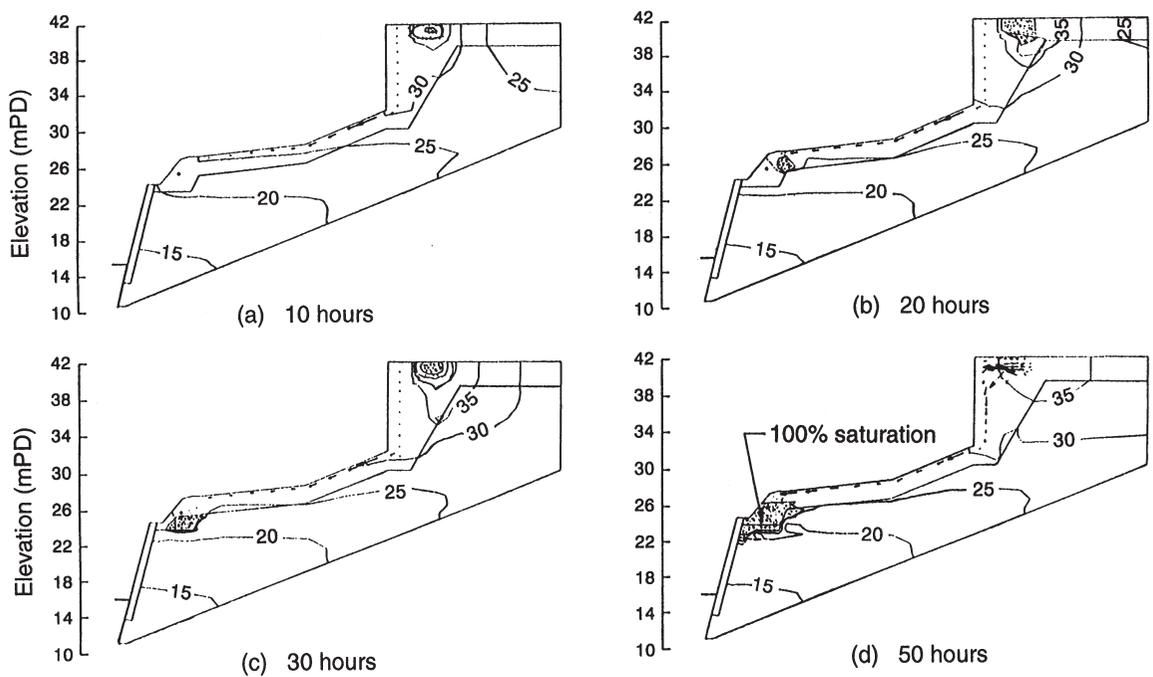
Figure 17. Extent of wetted zone at different times due to storm-water leakage. Contours give total head in metres

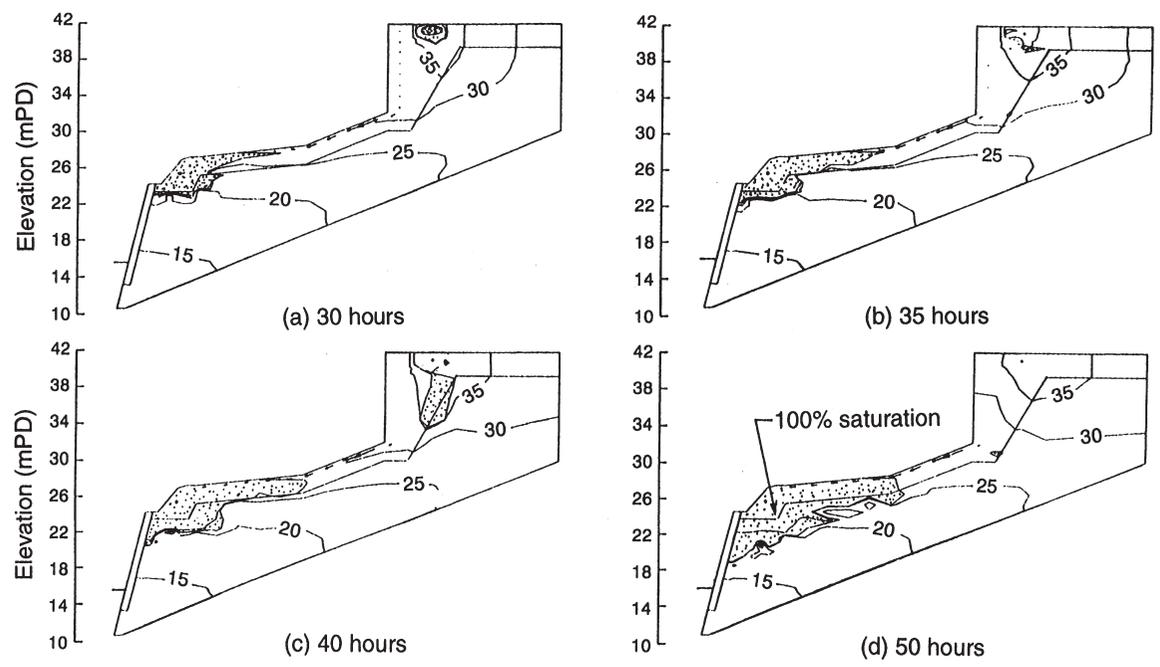
Figure 18. Extent of wetted zone at different times due to storm-water and foul-water leakages. See Figure 19 for extent of the wetted zone before 30 h. Contours give total head in metres

- (3) Substantial saturation of the fill would occur about 1 day before the landslide due to leakage from storm-water drains, and given major leakage from the foul-water sewer following wetting of the fill stratum, a large part of the retained weathered volcanic tuff could become substantially saturated by the time of the landslide (Figure 18).

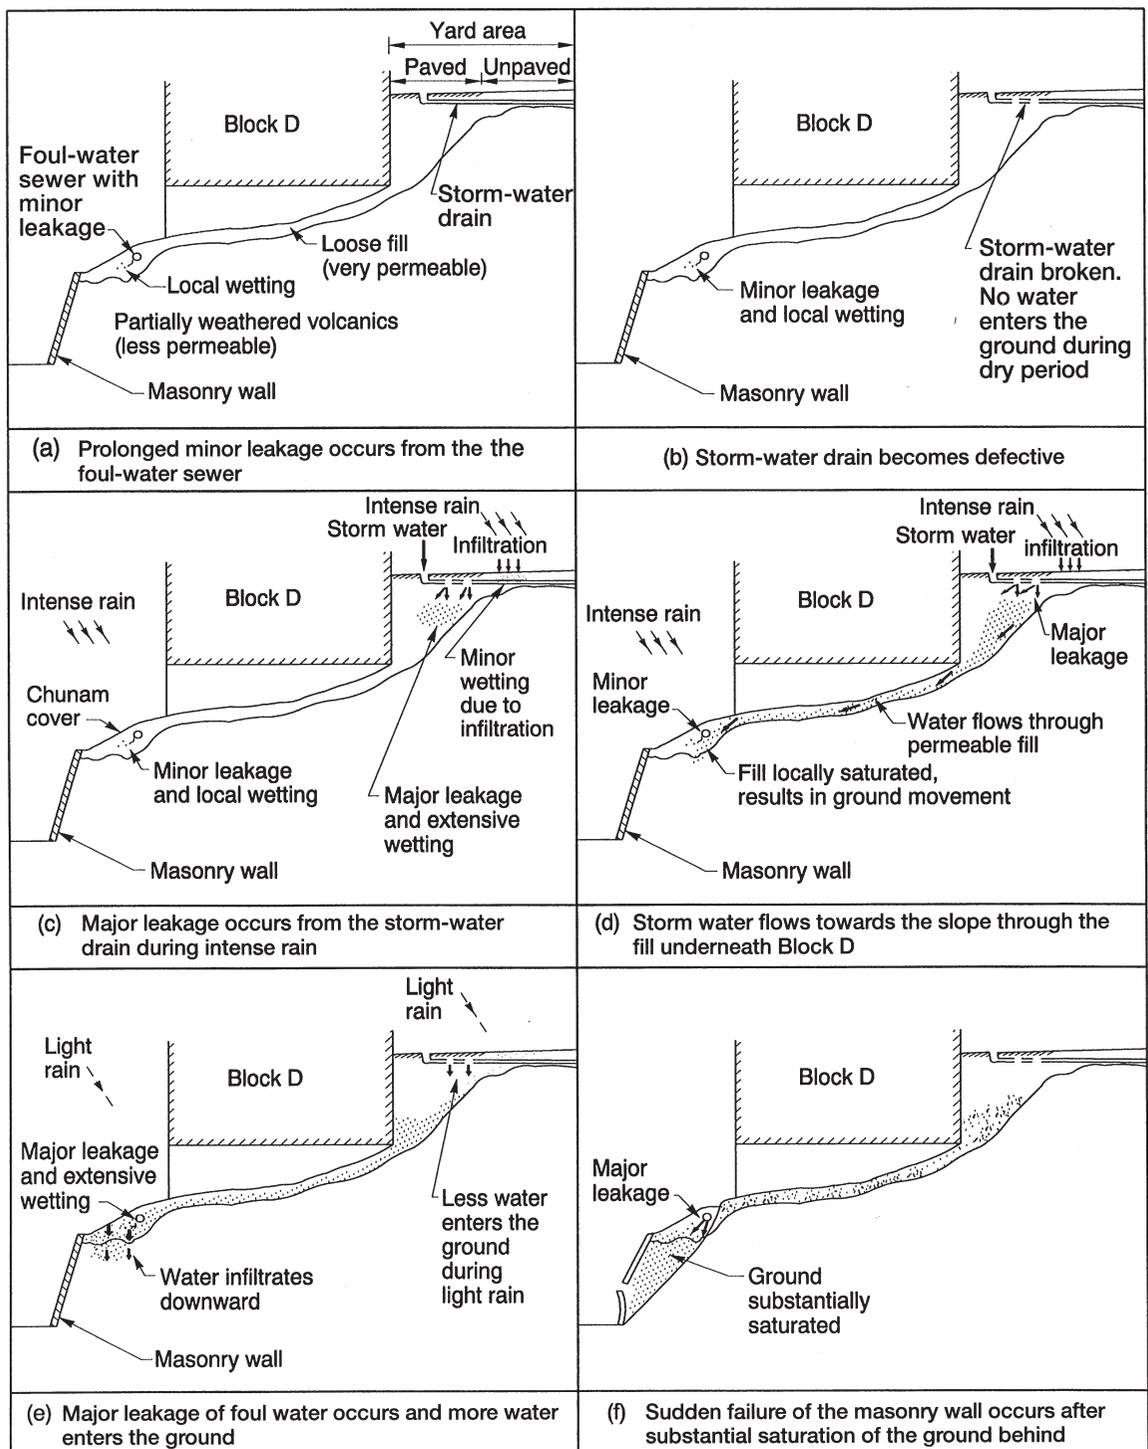
Figure 19. Probable mechanism of the landslide

Based on the investigation, it is considered that the landslide was most likely to have been caused by the ingress of a large volume of water as a result of leakage from defective underground services in the vicinity of the slope. The water would have led to a loss of soil suction with accompanying reduction in soil strength, with the consequent increase in earth pressure causing brittle failure of the thin masonry wall. Direct surface infiltration through the unpaved areas in the yard to the south of Block D and through minor defects on the surface cover to the slope above the masonry wall could have been a contributory factor, but not the major cause.

Scenario 3 implies that both leakage of the foul-water sewer and subsurface seepage flow were together responsible for substantially saturating the ground mass. If this were so, the loose fill behind the masonry wall would have been wetted by subsurface seepage arising primarily from the leakage of defective storm-water drains during times of prolonged and high-intensity rainfall, perhaps supplemented by some minor and localized leakage from the foul-water sewer. This would have caused deformation in the loose fill, which would have led to distress or rupture of the rigidly jointed sewer, resulting in major leakage of foul water. This, together with subsurface seepage flow, would have provided a sufficient quantity of water to saturate the soil behind the masonry wall. Seepage analyses have shown that it was possible for the subsurface seepage flow to reach the fill in the slope above the masonry wall in about 1 day after heavy rain, and that it would take another day for the water (both storm water and foul water) in the fill to substantially saturate the weathered volcanic tuff. This is considered to be the most likely scenario leading up to the landslide. The probable mechanism of the landslide is illustrated in Figure 19.
