Slope Movement and Failure: Evidence from Field Observations of Landslides Associated with Hillside Cuttings in Saprolites in Hong Kong

A. W. Malone

The University of Hong Kong

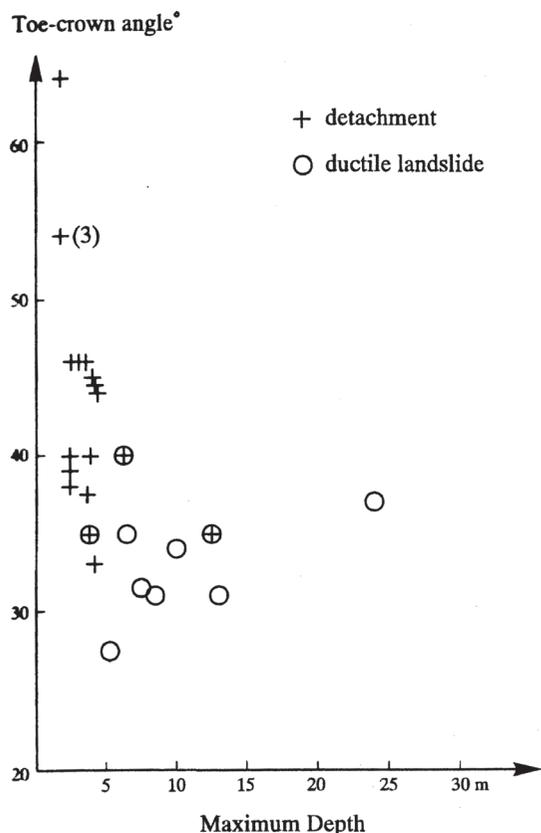
Figure 1. Geometry of the landslides

investigator for stability analysis are plotted in Figure 1. Only 17 detachment points appear on the plot because one point (54°, 1.7 m) represents three detachments at Tin Wan Hill Road in 1985 and the geometrical parameters for the detachment ‘near KCR Fo Tan Station’ cannot be determined from information available.

The detachments and ductile landslides are geometrically distinct save for three detachments plotted coincident with ductile landslides. These are detachments occurring partly in previously sheared ground (Island Road Government School, Fei Tsui Road and Ching Cheung Road 1997, see Appendices 2 and 3). Excluding these three cases, the average toe-crown angles and ‘depths’ are 45°/2.8 m (detachments) and 33°/9.7 m (ductile landslides, including the questionable Fei Tsui Road), and the detachments are less than 5 m in ‘depth’ whereas the ductile landslides are greater.

In the sample of 23 cases, the steep-shallow landslides (‘depth’ < 5 m, toe-crown angle > 37.5°) moved a large distance extremely rapidly after main failure whereas generally the deep landslides (> 5 m) moved a small distance after main failure before coming to rest (Fei Tsui Road is the one exception, assuming main failure occurred on 13.8.95, which

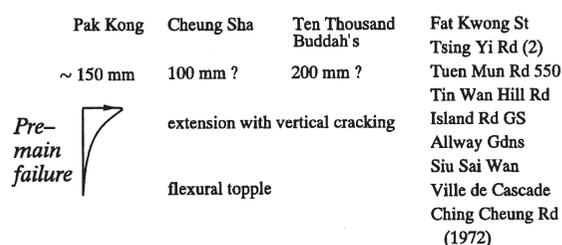
Figure 3a. Measured and estimated movements (Pre-main failure)

The evidence of slope movement in the 23 cases and one other is summarised in Figure 3. Measurements of displacement with depth in a borehole inclinometer at the Pak Kong Water Treatment Works (Lam, 1995) are included. These are the only known measurements at a hillside cutting in Hong Kong of movements with depth before main failure.

It is apparent from the evidence in Figure 3 that the profiles of movement with depth before and after main failure in ductile landslides are markedly different. Before main failure, when a complete rupture surface has yet to form, the greatest movement takes place at the surface. After main failure significant movement also takes place at depth, as the landslide moves on the rupture surface.
