Forty Years of Slope Engineering in Hong Kong

H.N. Wong

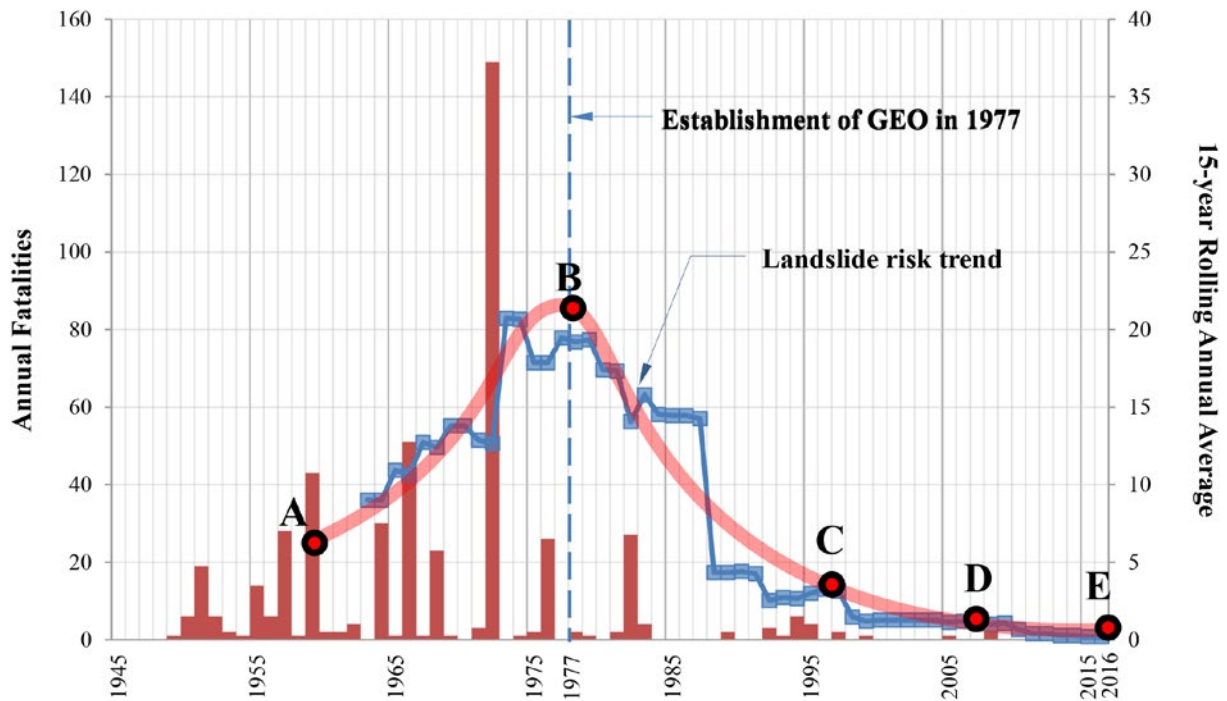
The landslide risk trend in Hong Kong based on 15-year rolling average annual landslide fatalities is shown in Figure 1. In the 1960s and 1970s, landslide risk was increasing significantly. This was mainly attributed to the extensive formation of man-made slopes as part of the rapid urban development in the period. The slopes were mostly formed according to empirical rule of thumb with little geotechnical input. They failed frequently, particularly during heavy rain.

Figure 1: Landslide risk based on annual landslide fatalities in Hong Kong

engineering in Hong Kong. This marked the starting point of a complete revamp of the slope engineering practice in Hong Kong (Point B in Figure 1). It resulted in territory-wide application of state-of-the-art geotechnology to slope engineering and setting up of the Hong Kong Slope Safety System to regulate the application. Under the Slope Safety System, landslide risk is also being managed via other measures, e.g. retrofitting substandard slopes, landslide warning and emergency services, and public education on slope safety (Malone, 1998).

The concerted effort of the geotechnical profession has not only brought about continuous development in slope engineering practice, but also significant reduction of the landslide risk in Hong Kong. By 2016 (Point E, Figure 1), Hong Kong has experienced 8 consecutive years of zero landslide fatality, and 22 consecutive years with no multiple-fatality landslide. While the good slope safety performance provides an assurance of the effectiveness of our slope engineering practice in achieving the intended safety objectives, the profession is aware of the need to stay vigilant about the fact that our man-made slopes and natural hillsides still have a finite chance of failure, and that Hong Kong is still vulnerable to widespread and serious landslides particularly during extreme rainfall events. With the recognition that the global and local weather conditions are being affected by climate changes, meteorologists have assessed that this would not only increase the annual rainfall, but also escalate the frequency and severity of extreme rainfall events in Hong Kong (ENB, 2015). There are indications that the short-duration rainfall, e.g. 1-hr rainfall, in Hong Kong has already been significantly affected (Figure 11).

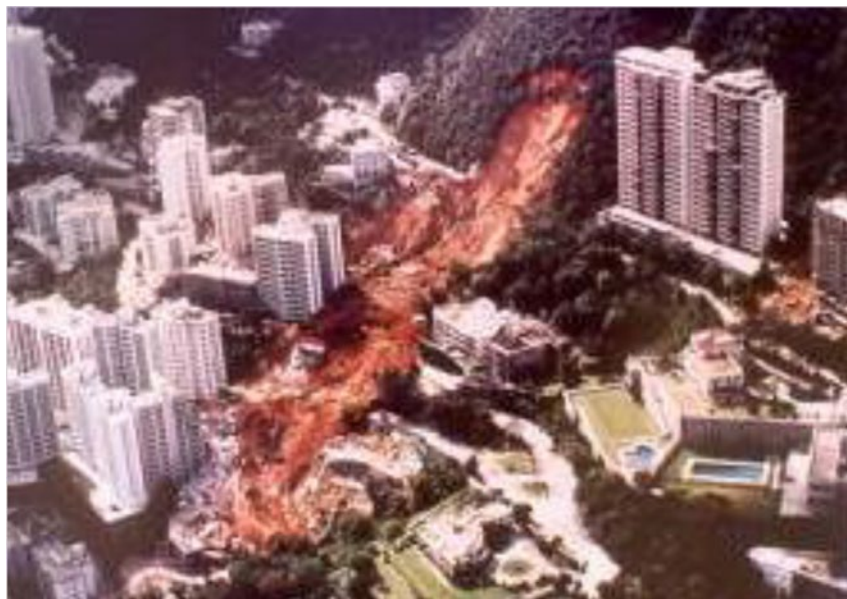
The disastrous consequence of the Po Shan (Figure 2) and Sau Mau Ping landslides in 1972, followed by the occurrence of a similar failure in Sau Mau Ping in 1976 (Figure 3), revealed to all the serious deficiency of this rule-of-thumb approach of slope engineering. With the awareness that the level of slope safety in Hong Kong should be improved to meet the community's expectation, the Geotechnical Control Office (renamed Geotechnical Engineering Office, GEO, in 1992) was set up in 1977 to regulate slope

Figure 2: Po Shan Landslide in 1972
(resulting in 67 fatalities)

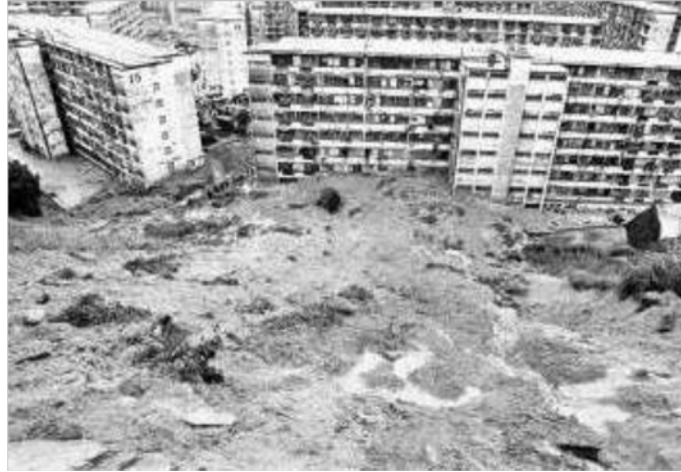
Figure 3: Sau Mau Ping Landslide in 1976
(resulting in 18 fatalities)

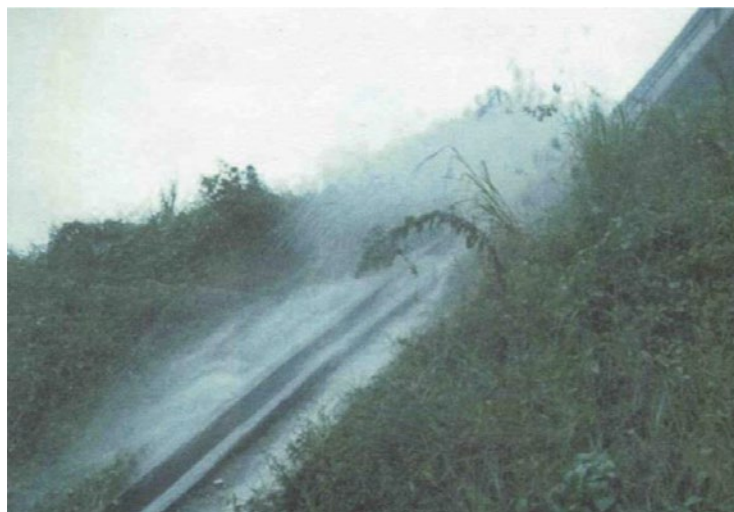
Figure 4: Concentrated flow of surface water commonly due to lack of slope maintenance or deficient drainage provisions

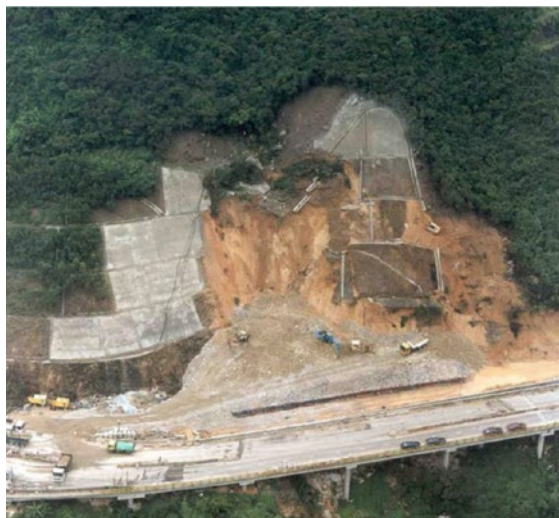
Figure 6: Ching Cheung Road Landslide in 1997 (~5,000m³)

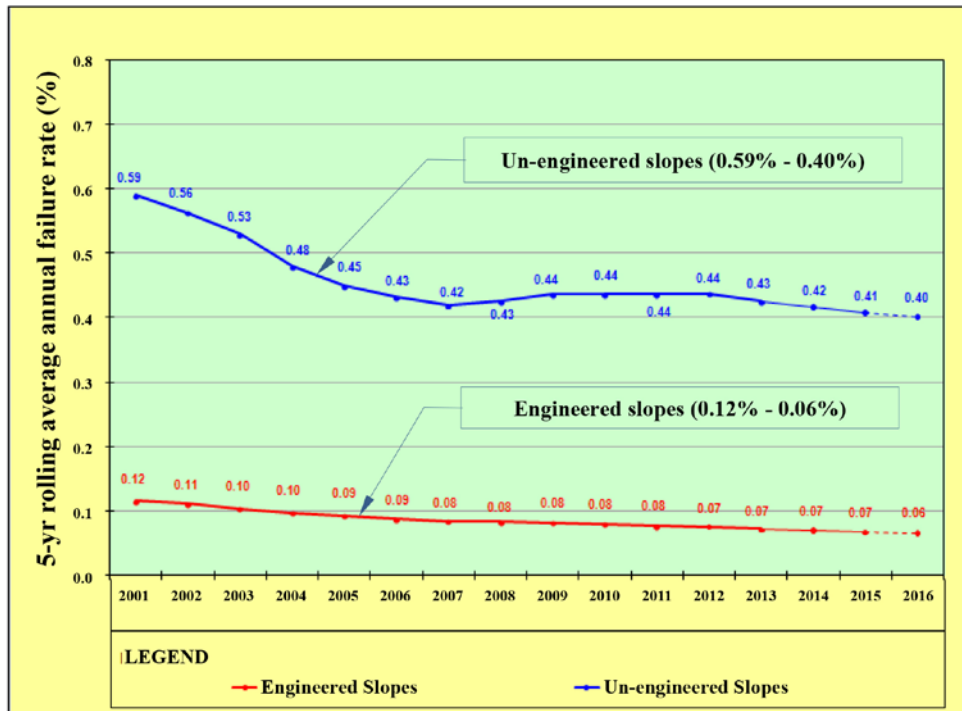
The 5-year rolling average annual failure rates of engineered slopes and un-engineered slopes, based on the comprehensive data collated since 1997, are shown in Figure 7. The average annual failure rate of engineered slopes, which was 0.12% in the 5-year period from 1997 to 2001, was not negligible. Such a failure rate implies that over a notional design life of, say, 120 years, about 15% of the engineered slopes would fail at least once.

Figure 7: 5-year rolling average annual failure rates of engineered and un-engineered man-made slopes

thereby making the slopes less vulnerable to adverse effects from concentrated surface water flow and subsurface seepages, and (iii) maintaining slopes to minimize deterioration and upkeep their stability condition (Wong, 2001). These took the engineering of man-made slopes to a higher level of reliability and safety. The improvement achieved is reflected in the progressive reduction in the 5-year rolling average annual failure rate of engineered slopes, up to about 50% by 2016 (Figure 7).

It is note-worthy that the failure rate of un-engineered slopes (i.e. slopes formed before 1977 without proper geotechnical input and verification that the required geotechnical standards are met), which was within about one order of magnitude higher than that of engineered slopes (Figure 7), was not exceedingly high. This probably reflects the contribution of the priority ranking system adopted in selecting the more vulnerable un-engineered slopes for priority retrofitting and the effectiveness of maintaining all slopes (including the bulk of the existing, un-engineered slopes which have not been given the priority for retrofitting) in minimizing their chance of failure. It should also be considered under the context that the rule-of-thumb approach adopted in forming the un-engineered slopes in the old days, being empirically based, nevertheless serves some useful engineering purposes.
