Predicting the Performance of Residual Soil Slopes

E. W. Brand

Geotechnical Control Office, Engineering Development Department, Hong Kong

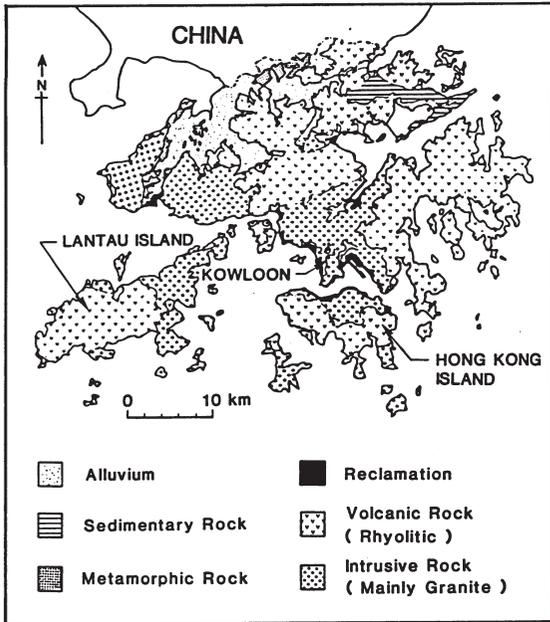
Figure 1. Map of the territory of Hong Kong showing the geology

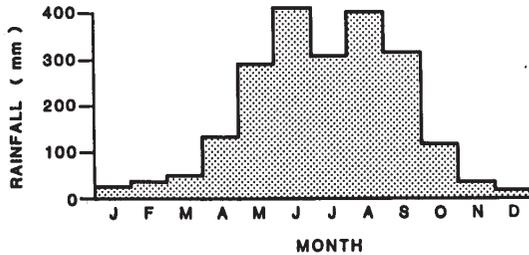
Figure 4. Average monthly rainfalls in Hong Kong

The rainfall in Hong Kong averages 2 225 mm annually, and more than 80% of this falls during the period May to September (Figure 4). Intensities can be high, with 50 mm per hour and 200 mm in 24 hours being not uncommon.

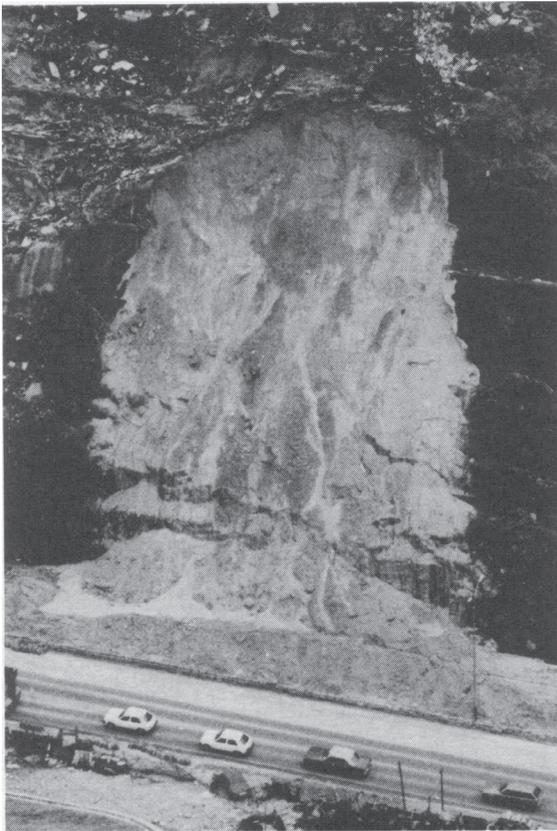
Figure 5. Typical Hong Kong soil cut slope failure caused by heavy rainfall

Cut slope failures in soil, or in mixed soil and rock, now constitute by far the most common form of landslide. The volcanic rock profiles are more susceptible to failure than the granite profiles, and colluvium is frequently involved. The failures nearly always occur suddenly during intense rain without prior warning (Brand, 1984, 1985b), and most slip surfaces are shallow, the thickness of the failed zone usually being less than 3 m. A typical example is shown in Figure 5.

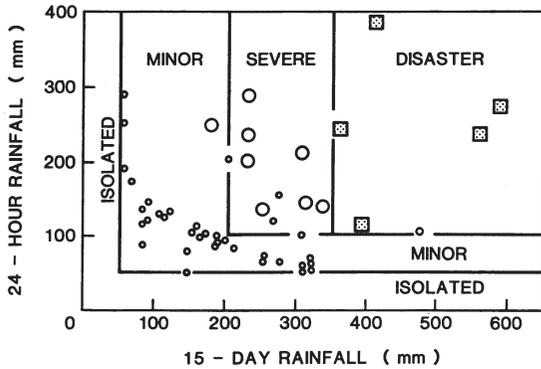
Figure 6. Relationship between rainfall and landslides established by Lumb (1975)

On this basis, Lumb correlated the landslide events for the period 1950 to 1973 with the one day rainfalls and the 15-day antecedent rainfalls to obtain the interesting results shown in Figure 6.

In incorporating antecedent rainfall into his correlations, Lumb (1975) in effect took account of the well-known phenomenon of soil moisture deficit and its relationship to shear strength. His one-day rainfalls, however, were taken as being the calendar-day rainfalls measured at the Royal Observatory (see below), and it is now known that better correlations are possible if account is taken of the localised variations in rainfall. A further correlation study was therefore undertaken recently in Hong Kong (Brand et al, 1984) which had the benefit of extremely detailed data not previously available. The results of this have greatly aided our understanding of rain-induced slope failures, and may have application elsewhere.

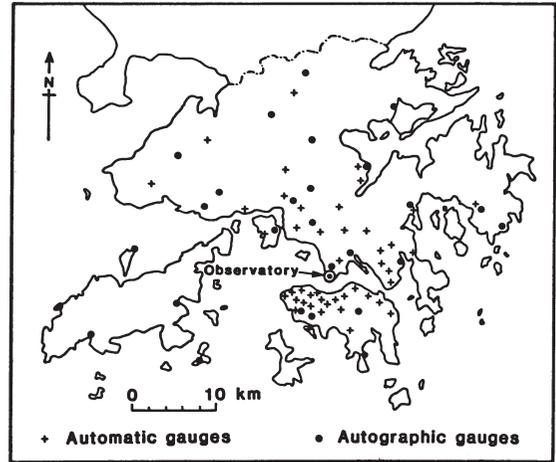
Figure 7. Locations of continually recording raingauges in Hong Kong, July 1985

Since 1978, a sophisticated system of automatically recording raingauges has come into use to provide data for the Geotechnical Control Office's rainfall-landslide correlation programme. At present, 46 automatic gauges transmit rainfall measurements continuously through telephone lines to a central micro-computer. The locations of these, and other continuously reading gauges, are shown in Figure 7.

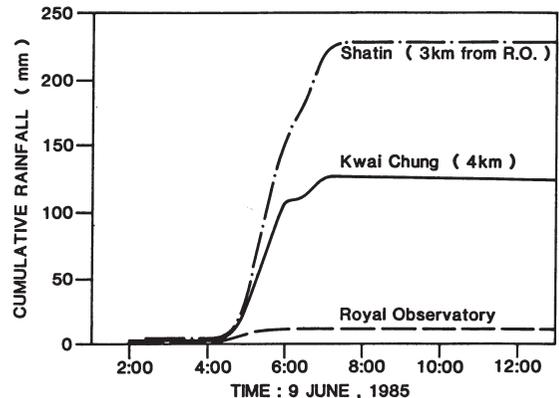
Figure 8. Example of large variations in rainfall over short distances in Hong Kong

Large geographical variations in rainfall occur over the Territory during any rainstorm event, as dramatically illustrated by rainfall records shown in Figure 8 for three automatic gauges during a very recent rainstorm. These variations are attributable to the effects of topography. A common feature of a Hong Kong rainstorm is that the highest rainfalls occur near the tops of large hills, and that the rainfall isohyets tend to follow the ground elevation contour lines. These features are illustrated in Figure 9, which shows the contours of two separate three-hour rainfalls during a severe storm in May 1982.

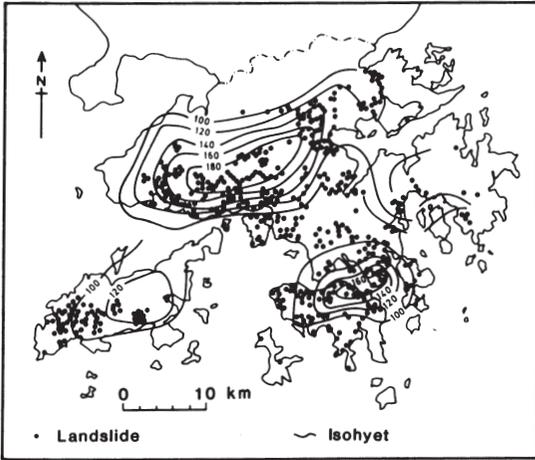
Figure 9 Locations of landslides in relation to the 3-hour isohyets in the May 1982 rainstorm

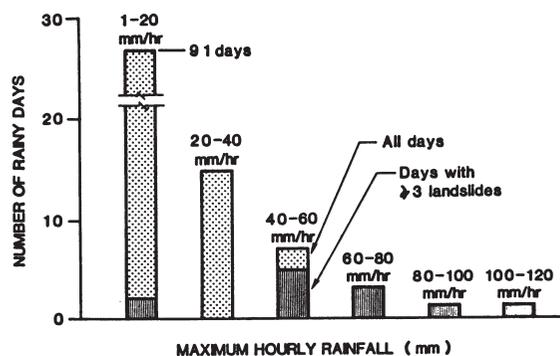
Figure 15. Correlation of landslide occurrence during 1982 with the maximum hourly rainfall intensity anywhere

During 1982, 3 248 mm of rain fell in Hong Kong, the highest annual rainfall on record. The distributions of all rainy days and of days with three or more landslides are shown in Figure 15, plotted against the maximum hourly rainfall anywhere on each day. When the maximum hourly rainfall was less than 20 mm, no slope failures usually occurred. In contrast, failures nearly always occurred on the few days on which the maximum hourly rainfall intensity exceeded 40 mm per hour. The failures that occurred were also found to be in the vicinity of the area that experienced the highest rainfall intensity.

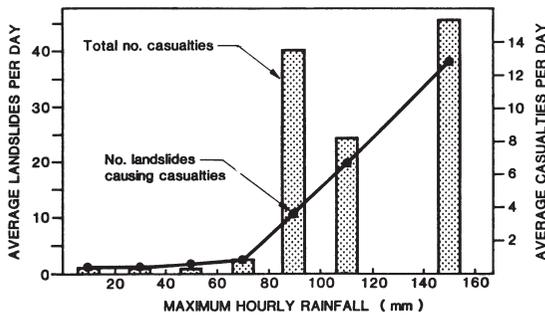
Figure 17. Correlation of landslides causing casualties and number of casualties during 1963-83 with maximum hourly rainfall anywhere

The dependence of landslide occurrence and casualties on hourly rainfall intensity is clearly shown in Figure 17. Throughout the twenty-year period, the number of landslides that caused casualties was very small unless the maximum hourly rainfall anywhere in the Territory approached 70 mm. Above this figure, the number of landslides with casualties increased sharply

with increasing maximum hourly intensity. The actual number of casualties caused by landslides shows a similar but even more dramatic correlation with hourly intensity.

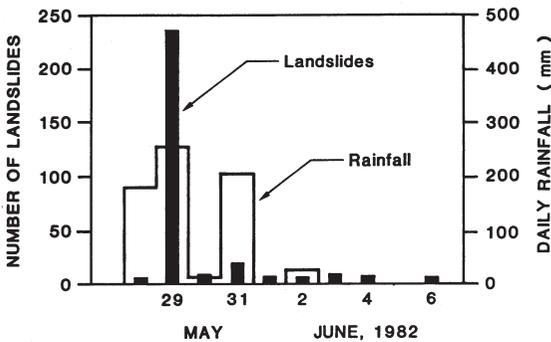
Figure 18. Relationship between the daily rainfall at the Observatory and the occurrence of landslides during the May 1982 rainstorm

For the May 1982 rainstorm, Figure 18 shows the daily rainfalls at the Observatory for the event, together with the occurrence of all landslides for which the dates of failure are known. This shows that the large majority of landslides occurred on the 29th May, the day of the heaviest rainfall. The few failures that occurred up to a week later were probably caused by delayed groundwater build up (Hudson & Hencher, 1984).

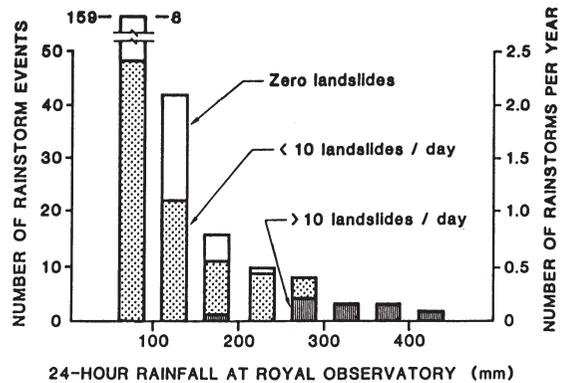
Figure 19. Correlation of number of landslides with the 24-hour rainfall at the Observatory during the period 1963-83

Correlations between landslides in Hong Kong and the Observatory 24-hour rainfall are shown in Figure 19 on the basis of two categories of event. A 'minor' event is one for which there are less than ten recorded landslides in one day, and a 'major' event is one for which there are more than ten landslides in one day. The 'minor' category is identical to that used by Lumb (1975), while the 'major' category corresponds to his combined 'severe' and 'disastrous' categories. Figure 19 demonstrates clearly that, where the 24-hour rainfall at the Observatory is below 100 mm, only a few minor events and no major events occur. With increasing 24-hour rainfall, the proportion of landslide days increases, with major events increasingly dominating at higher rainfalls. When more than 270 mm of rain falls in 24 hours, every rainstorm event results in a major landslide event.

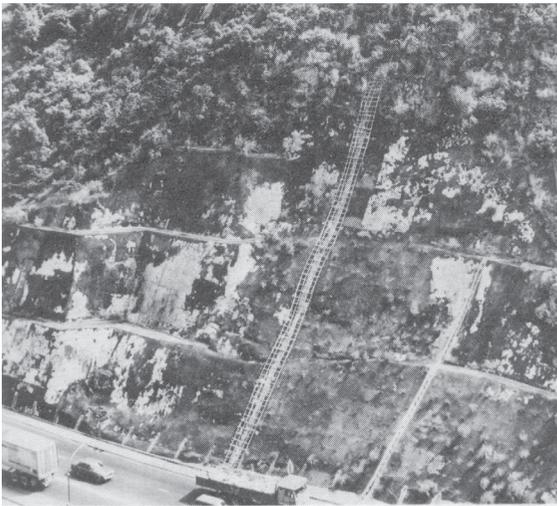
Figure 26. Typical stable Hong Kong cut slope included in the CHASE Study (Brand & Hudson, 1982)

A typical CHASE slope is shown in Figure 26. This is 45 m high and is cut at an angle of about 60° into a steep natural hillside covered with dense vegetation. The material of the slope comprises 5.5 m

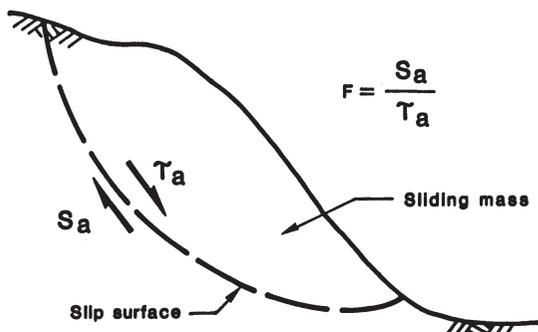
Figure 29. Basis of the limit equilibrium method of stability analysis for slopes

Slope stability analysis is usually based on the limit equilibrium approach, for which the equilibrium of a sliding mass is examined (Figure 29). The degree of stability is quantified in terms of a 'factor of safety',

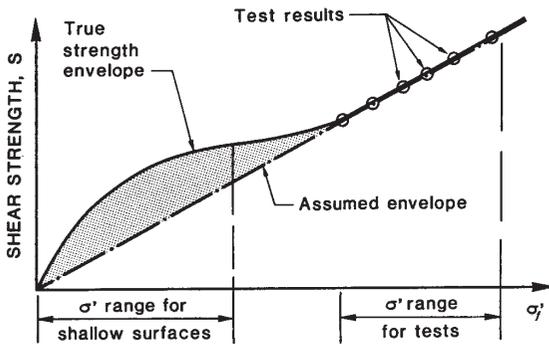
Figure 30. Underestimate of shear strengths because of incorrect strength envelope deduced from data obtained at too high normal stresses

for stability assessment (Figure 30). It is possible to follow the correct stress path in the laboratory simply by decreasing the cell pressure, but this does not simulate the correct mechanism of failure in the field. This can only be done by means of a constant load test in which the pore pressure is increased from an initial negative value until failure occurs. Tests of this kind have been carried out by the Geotechnical Control Office for some time, but the experimental difficulties are considerable, and this test procedure cannot be

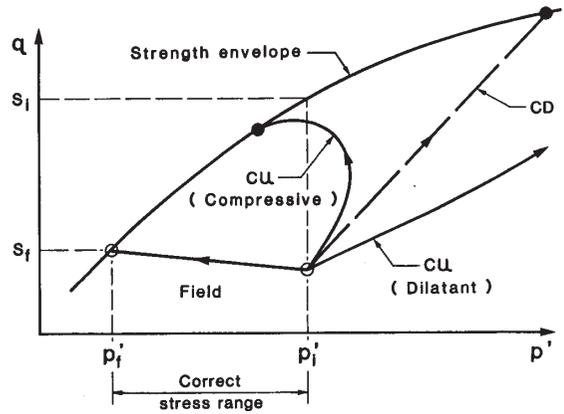
Figure 31. Comparison between stress paths for rain-induced slope failure and those for triaxial tests (Brand, 1981)

Figure 31 illustrates that the stress paths commonly followed in the triaxial test are quite different from that which pertains in the field, and that the stress ranges over which triaxial tests are usually conducted are generally not appropriate to the field stress conditions. Where the strength envelope of a soil is markedly curved, this disparity will result in an appreciable underestimate of the correct shear strength

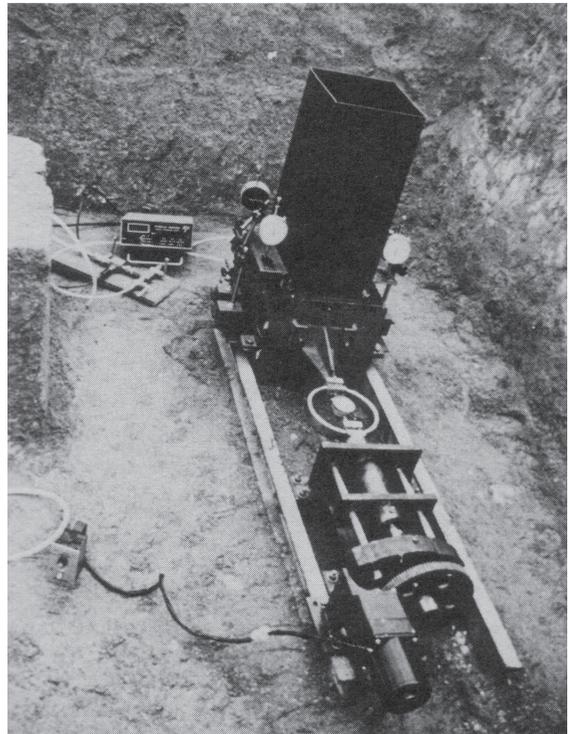
Figure 32. Insitu direct shear test apparatus used on Hong Kong residual soil (Brand et al, 1983b)

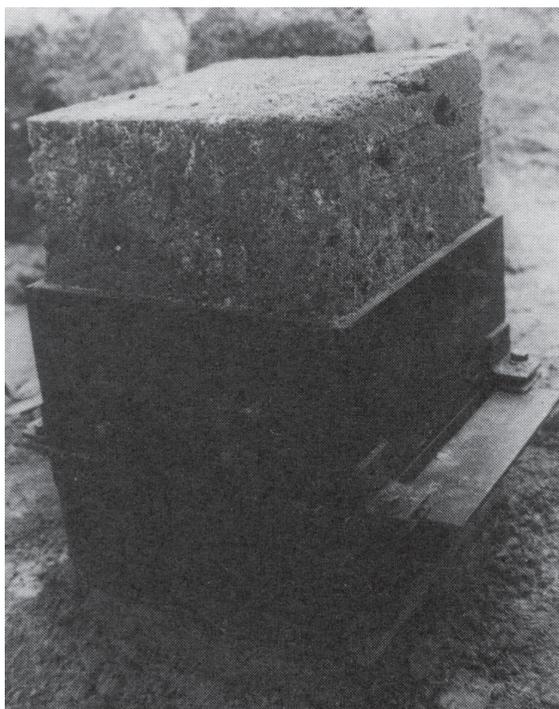
Figure 33. Block sample of grade V Hong Kong granite used in the apparatus shown in Figure 32

Direct shear (shear box) testing is deservedly becoming more commonly used for the strength assessment of residual soils. Apart from its relative simplicity, this method has obvious merits over the triaxial test when determinations of strengths along relict joints are required, because orientated specimens can be prepared. However, there is no certain method of saturation, and pore pressures cannot be measured during shear. Despite its lack of theoretical 'purity', the direct shear test is seen by some as providing a means of obtaining shear strength data under conditions which model those in the field more closely than the triaxial test. It is also readily adaptable for insitu measurements of shear strength on relatively large masses of material. The equipment shown in Figure 32 has been used successfully for testing 300 x 300 mm soil and soft rock specimens in Hong Kong (Brand et al, 1983b). A typical test specimen of grade V granitic soil is shown in Figure 33.

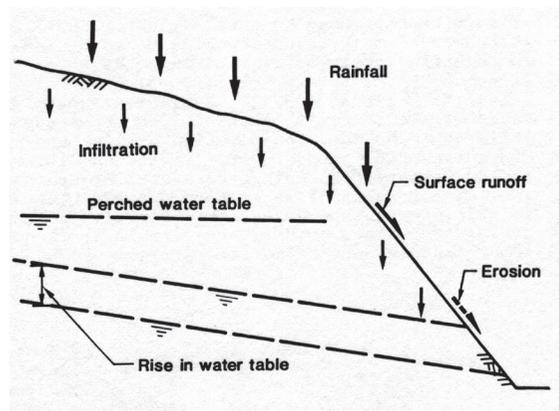
Figure 34. Diagrammatic representation of the effects of rainwater on a slope

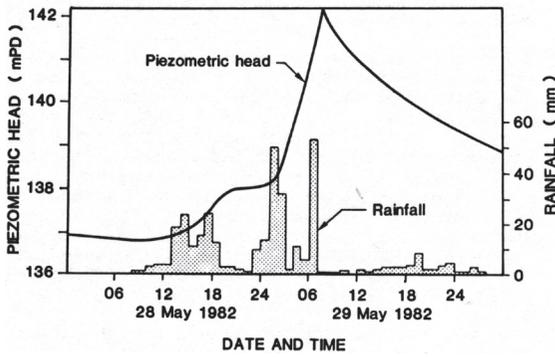
Figure 35. Rapid changes in the groundwater table measured in a Hong Kong slope

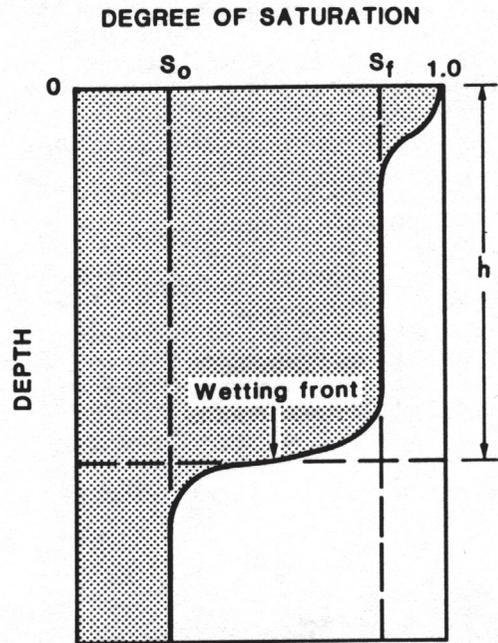
Figure 36. Representation of the advance of the wetting front as water infiltrates into soil (Lumb, 1962b, 1975)

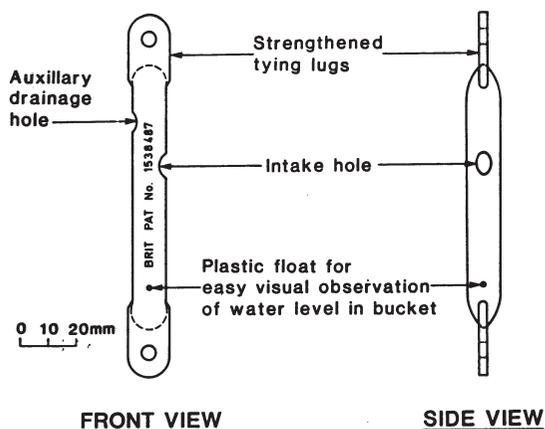
Figure 37. Halcrow plastic 'buckets' used for recording the maximum water elevation attained in a standpipe piezometer

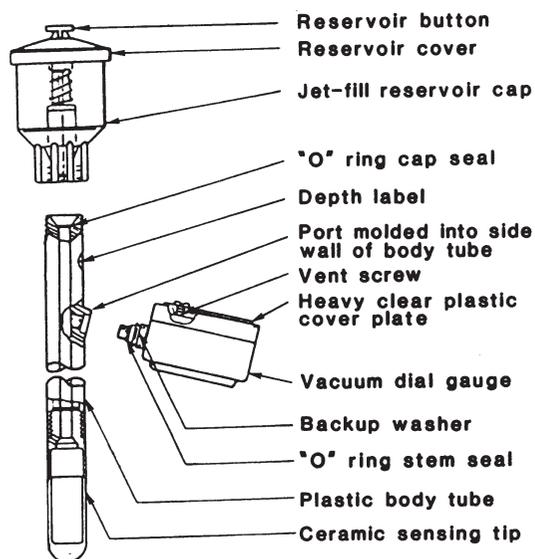
Figure 38. Agricultural tensiometer for the measurement of insitu soil suction

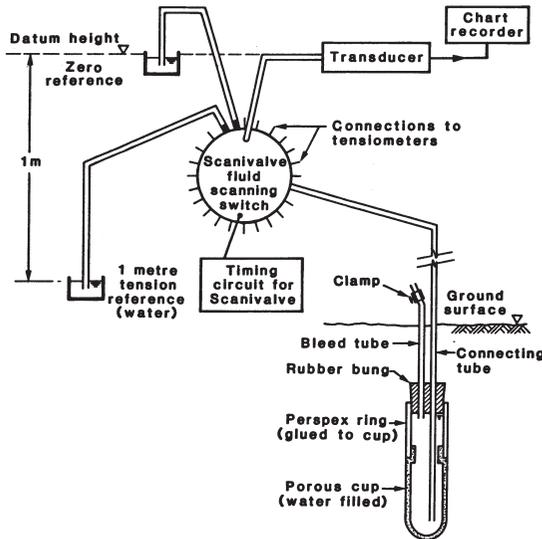
Figure 39. Automatic Scanivalve System used in Hong Kong for the measurement of positive and negative pore pressures (Pope et al, 1982)

as the most reliable. The system is powered by a twelve volt battery, and all measuring and recording components are housed in a water-tight metal box. Although installation and maintenance costs are high, the systems have been found to be reliable for periods of up to three years.

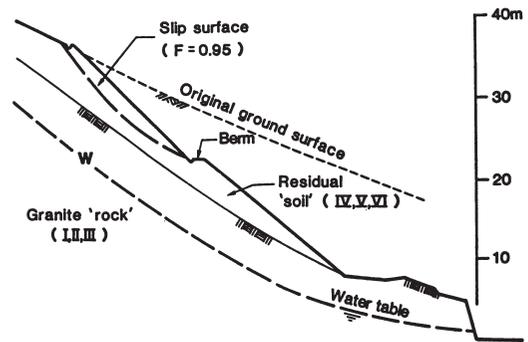
Figure 40. Case 1 : Stable cut slope with $F < 1.0$

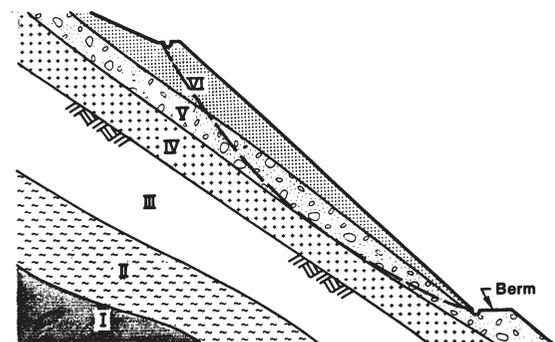
Figure 41. Detailed weathering profile for the Case 1 slope showing the grades IV, V & VI Soil

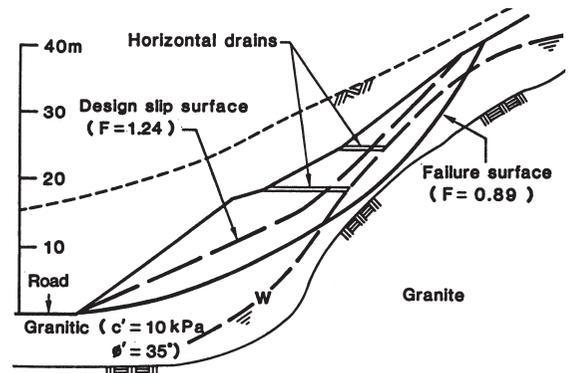
Figure 44. Case 4: Unstable cut slope previously predicted as being stable ($F = 1.24$?)

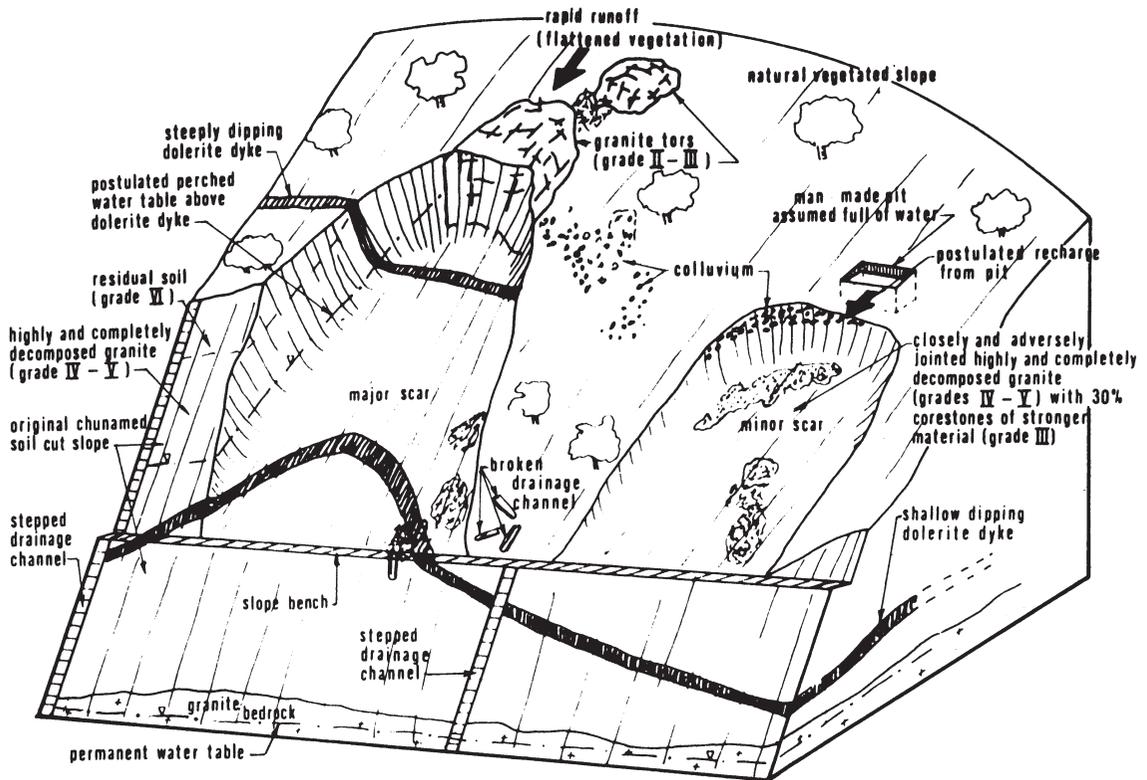
Figure 50. Diagram showing the complex geological conditions at the failure site studied by Hencher & Martin (1984)

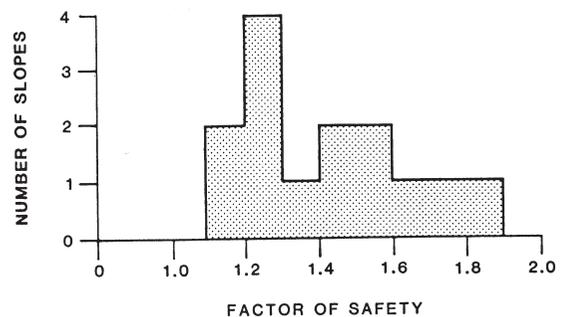
Figure 52. Distribution of factors of safety for the 14 Tuen Mun Highway slopes studied in detail
