Boulder Treatment in Hong Kong

S. W. C. Au & C. F. Chan

Geotechnical Control Office, Civil Engineering Services Department, Hong Kong

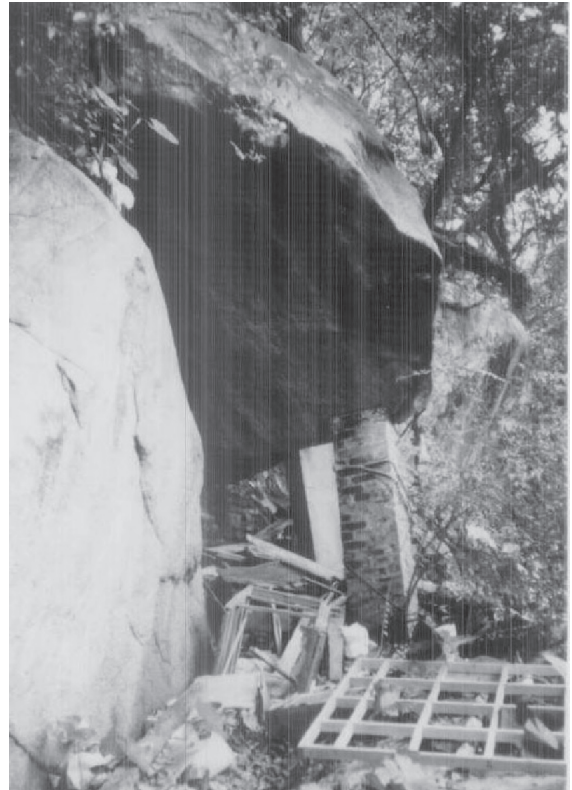
Figure 1. Boulder supported by old brickwork columns

Before 1980, virtually no provision for boulder treatment was explicitly included in site formation packages, and the old treatment works described above were piecemeal and exceptional.

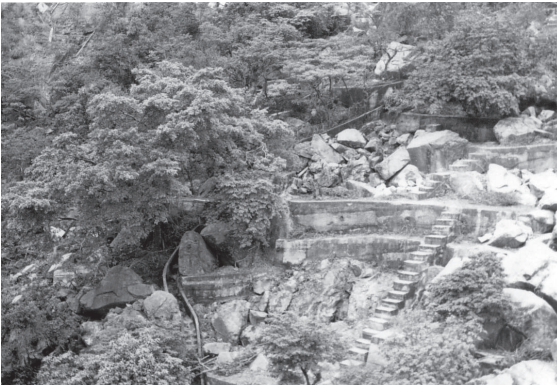
Figure 2. Concrete blanket in the form of terraces

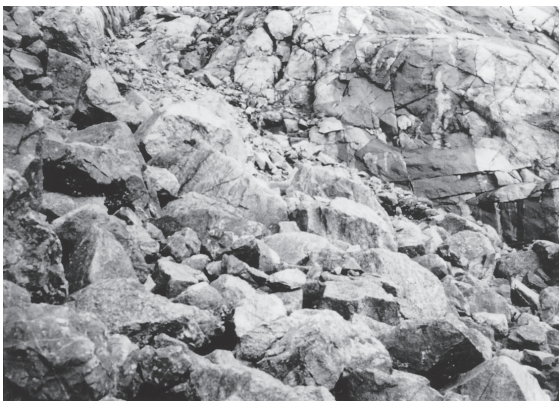
Figure 5. Surface boulders derived from rockfall

- (a) The country rocks were subject to a series of tectonic movements, intrusions and unloading. These resulted in intense jointing of the rocks. Joint-bounded blocks from exposed location like natural cliff, when dislodged, give rise to rockfalls which become surface boulders downhill (Figure 5).

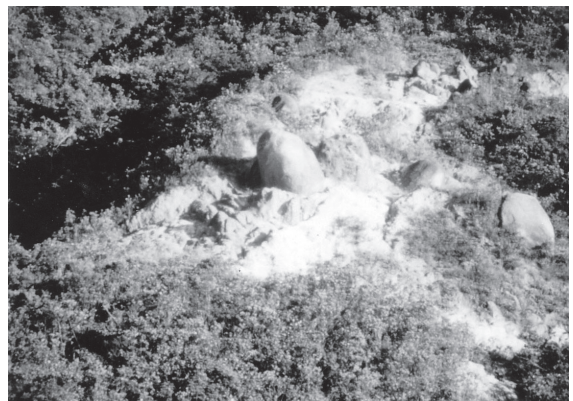
Figure 6. Corestones exposed due to erosion of matrix material

- (b) As mentioned earlier, corestones are present in the decomposed matrix of granites or some coarse-grained volcanic rocks. Should the soft mantle be eroded away, the corestones will be exposed and become perched on the ground surface (Figure 6).

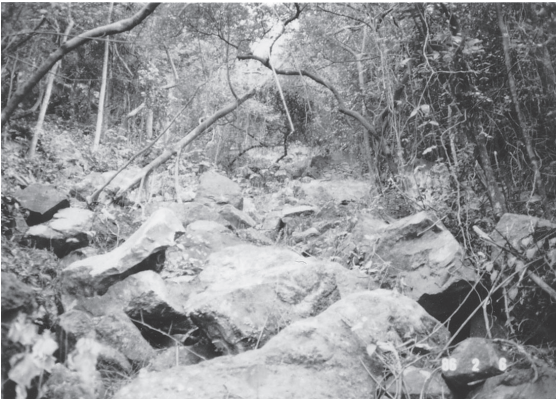
Figure 7. Detrital boulders of a colluvial deposit along a drainage line

- (c) Colluvium in Hong Kong, be it volcanic or granitic in origin, contains detrital boulders. Erosion in colluvial deposit, likewise, will expose the boulders. Figure 7 shows a small drainage line in a volcanic colluvial deposit. The concentration of boulders along the drainage line was a result of acute erosion due to high stream flow caused by torrential summer rains.

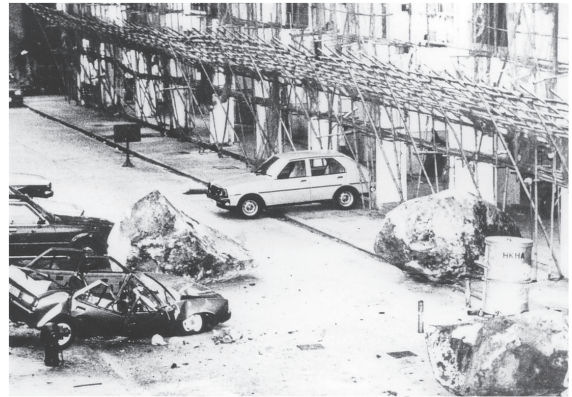
Figure 9. A car badly damaged by a boulder fall

Boulder falls pose an appreciable threat to life and property in Hong Kong because developments are constructed extremely close to the natural hillslopes where surface boulders are produced. In 1926, a falling boulder, presumably of colluvial origin, was reported to have caused five fatalities at Elliot Pumping Station at Pok Fu Lam (GCO, 1987). Figure 9 shows the damage that may be caused by a boulder fall.

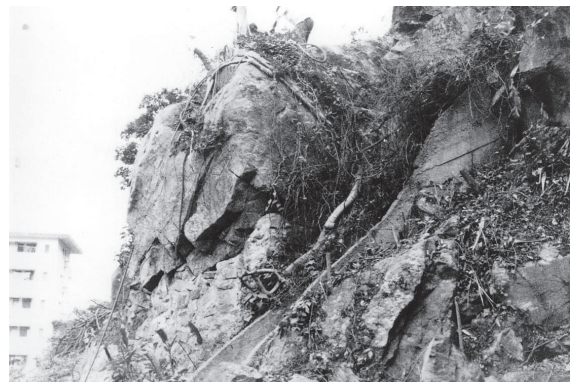
Figure 10(a). Splitting to remove overhang (before)

This covers either wholesale or partial removal of a boulder. Splitting of a boulder can be achieved by pneumatic percussive drilling and wedging. Explosives may be used in areas sufficiently far away from the public. Expanding agents such as Bristar, have also been used with success, but a rock trap should be provided because it is not certain when the boulder would split apart and drop downhill. Figures 10(a) and 10(b) show a typical example of splitting work. This method is most cost-effective when the split rock fragments can be reused to form buttress or in filling up voids.¹

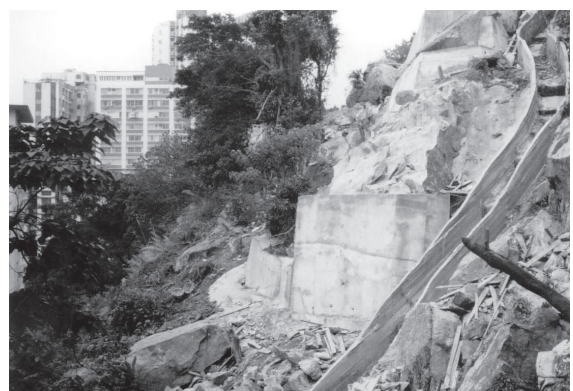
Figure 10(b). Splitting to remove overhang (after)

In many cases, the best solution is a sensible combination of the methods described below (e.g. see Figure 10(b), where splitting was coupled with buttressing). However, because the potential causes of movement are extremely difficult to determine (say, for example, the erosional/scouring effects of overland water flow due to a rainstorm) and individual boulder stability is hardly amenable to rigorous quantitative assessments, engineering judgement based on common sense, experience, and sound engineering principles (and sometimes suitable conservatism) are therefore of overriding importance for a decision.

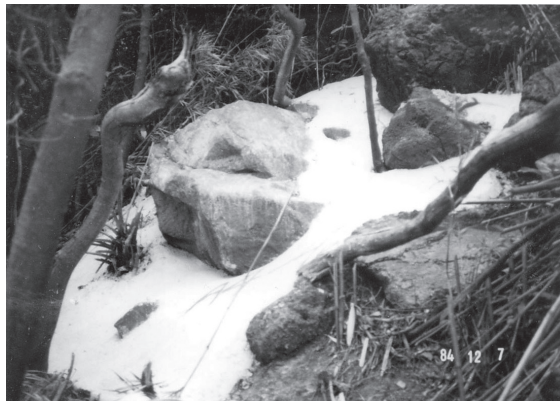
Figure 11. Surface protection

Ground surface around the boulder can be covered or strengthened to prevent erosion which would otherwise undermine the boulder and cause instability. This can be in the form of a rock fill apron, chunam (a mixture of cement, lime and residual soil) layer or concrete paving. A surface channel is sometimes added uphill to divert the surface run-off away from the boulder. Figures 11 and 13 show examples of surface protection

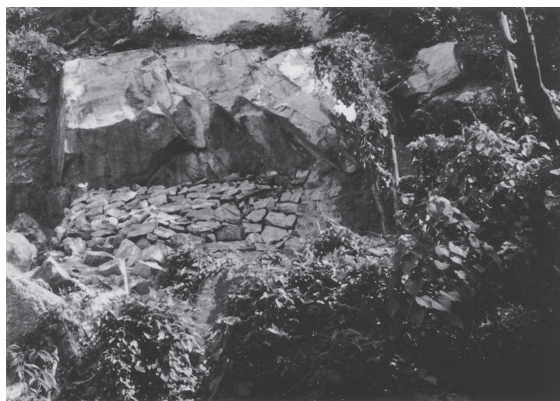
Figure 12. Masonry buttress

used to improve the boulder stability. Masonry and concrete buttresses (Figures 12 & 13) are widely seen. Masonry buttress, though structurally less effective, can be readily built with split rock. This is especially cost-effective where concrete transportation or disposal of split rock is a problem.

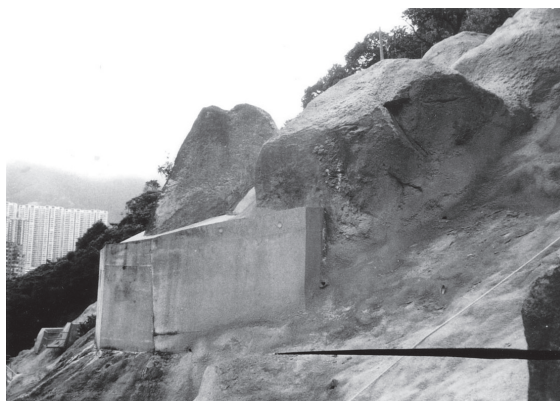
Figure 13. Mass concrete buttress (see also the surface protection)

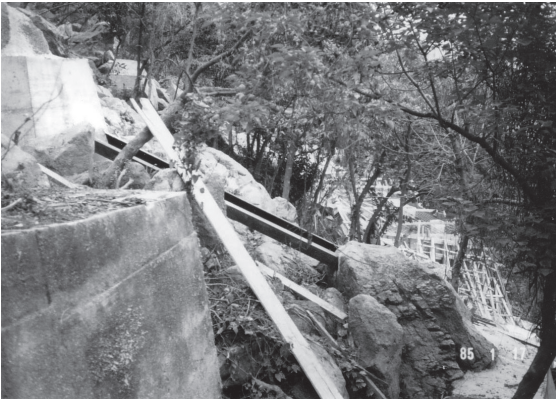
Figure 14. Steel strut

A potentially unstable boulder can be rendered stable through strutting it against or tying it to another stable boulder. Reinforced concrete beams or structural steel sections have been used for this purpose (Figures 14 & 24(b)). This method is particularly useful for treating boulders near the crest of high steep slopes where rock splitting or heavy surcharge are prohibited.

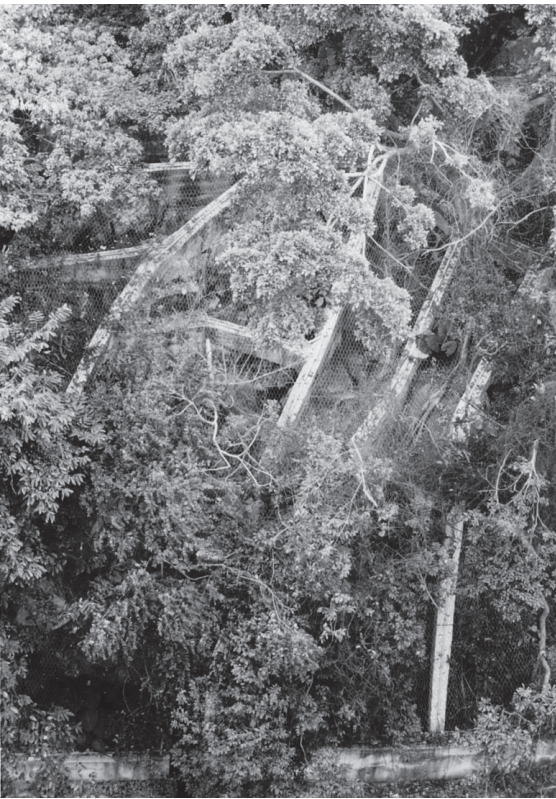
Figure 15. Reinforced concrete grid-beam system with wire netting infill

Sometimes, strut/tie beams can be used collectively to link or tie up a group of unstable boulders to give a stable unit. The grid-beam system on a slope in the Mid-levels area of Hong Kong Island typifies this extended application (see Figure 15). The area concerned contained numerous potentially unstable boulders overlooking highrise building blocks. The system was an approximately 3 x 3 m grid of reinforced concrete beams, 300 x 400 mm in cross-section, cast against the boulders in-situ with wire mesh infill whereby the potentially unstable boulders were held together. Boulders not intercepted directly by the beams were prevented from falling downhill by the wire mesh netting firmly secured onto the beams. To maximise the effectiveness of the system, the grid beams were aligned to intercept as many of the potentially unstable boulders as possible. On the other hand, the beams were also aligned to intercept those large but stable boulders to maximize the overall stability.

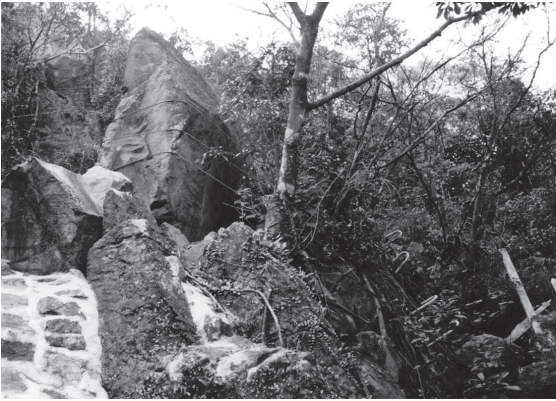
Figure 16. Wire rope lashing

Where access is extremely difficult, galvanised steel wire ropes have been used to tie the potentially unstable boulders to the stable ones (Figure 16).

These methods differ from the others in the materials used. Since the wire nets and steel ropes are flexible materials, slight boulder movements, without necessarily leading to a failure, can occur after construction.

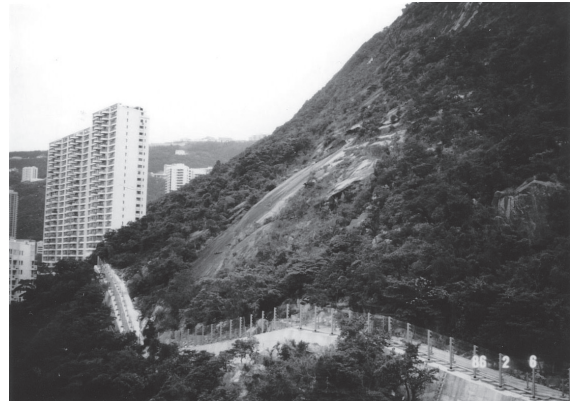
Figure 19. Boulder fence in Mid-levels

A number of structures of this kind have been built. They include a series of seven massive boulder barriers in the Northern Kowloon Peninsula below the eastern end of Lion Rock Ridge, a reinforced concrete rock trap ditch also in North Kowloon but below Beacon Hill and a collapsible fence on concrete foundation in the Mid-levels of Hong Kong Island. All these structures were built to intercept falling boulders below a certain size from reaching the areas of concern. Threadgold & McNicholl (1984) have described the first installation, Grigg & Wong (1987) the second and Chan *et al* (1986) the third. Figures 17 to 19 show the general appearance of these structures. Figures 20 to 22 give their respective details.

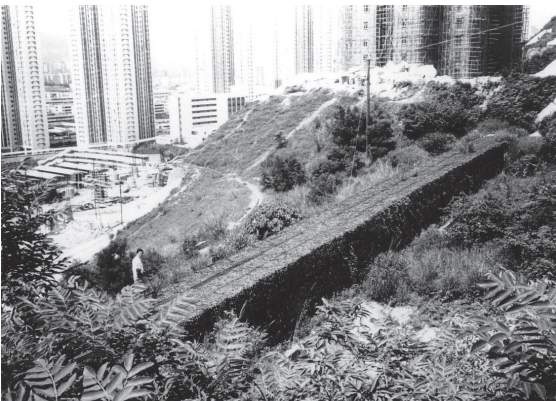
Figure 17. Boulder barrier below Lion Rock

² Four of the seven massive barriers were badly damaged in a hillfire in 1989. The outer geogrid sheetings were burnt/melted and the retained rock infill collapsed as a result. The damaged barriers were replaced using Maccaferri gabions while the undamaged ones were covered with sprayed concrete as a protection against further hillfires.

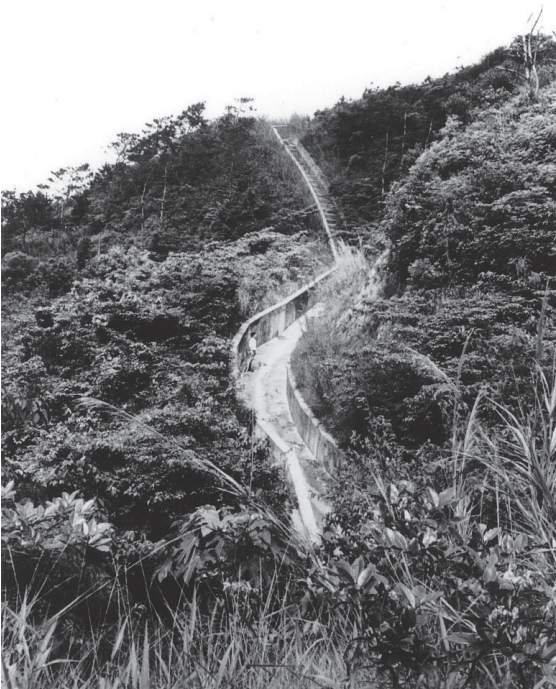
Figure 18. Reinforced concrete rock trap ditch below Beacon Hill

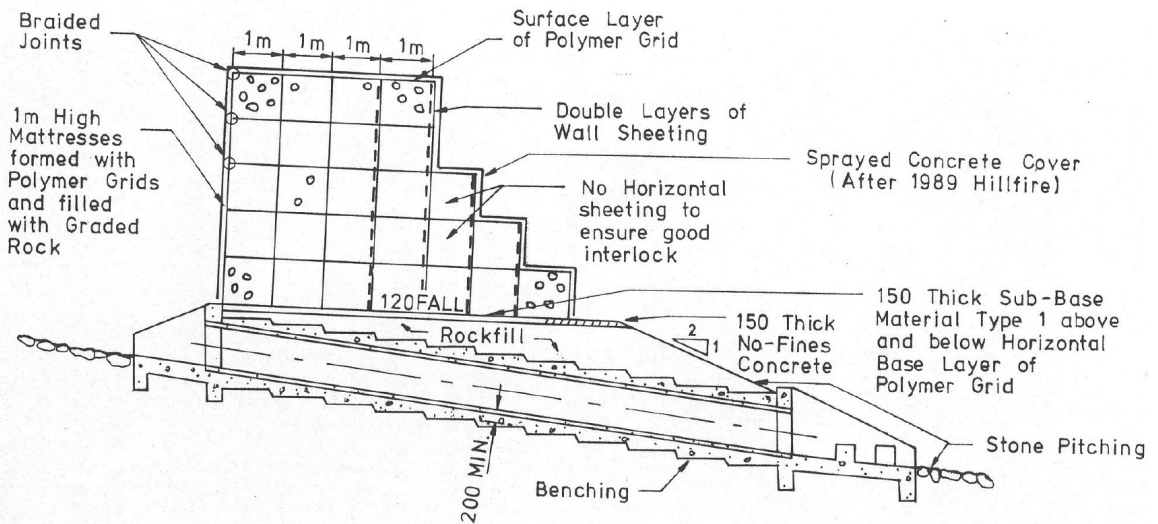
Figure 20. Boulder barrier details (after Threadgold & McNicholl, 1984)

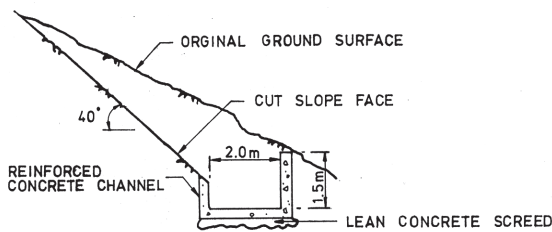
Figure 21. Rock trap ditch details (after Griggs & Wong, 1987)

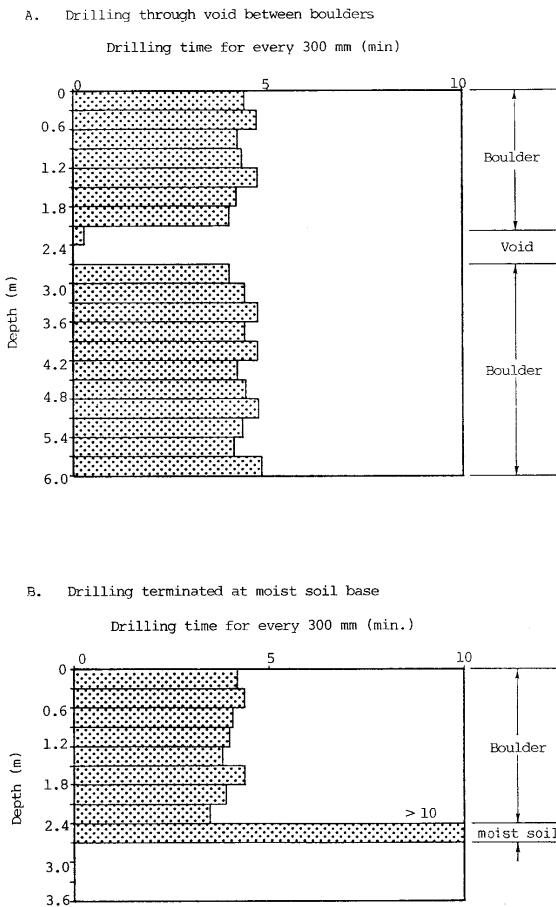
Figure 23. Pneumatic percussive drill – typical drilling rates

However, to determine the stability of a surface boulder properly, it is not enough just to obtain the exposed dimensions. The geometry of the embedded portion should also be determined so that its centre of gravity with respect to the buried base under the most adverse loading/support condition can be ascertained. For small boulders, rigorous investigation is generally not justified. It is usually more practical and expedient to simply adopt conservatism in the design. This “err on the safe side” approach is not applicable to large boulders. To determine the embedment of a large boulder, pneumatic percussive drills are commonly

employed. This method is limited by the length of the drill rod which is typically not longer than 7 m. For very large boulders, drilling has to start closest to the “soil line”. Normally, with inclined holes, the drilling can reveal an embedment of 6 - 7 m in this manner. In most cases, this method can give adequate information for design purposes. Figure 23 gives some typical drilling rates of pneumatic percussive drilling through surface boulders, from which the position of their bases could be determined.

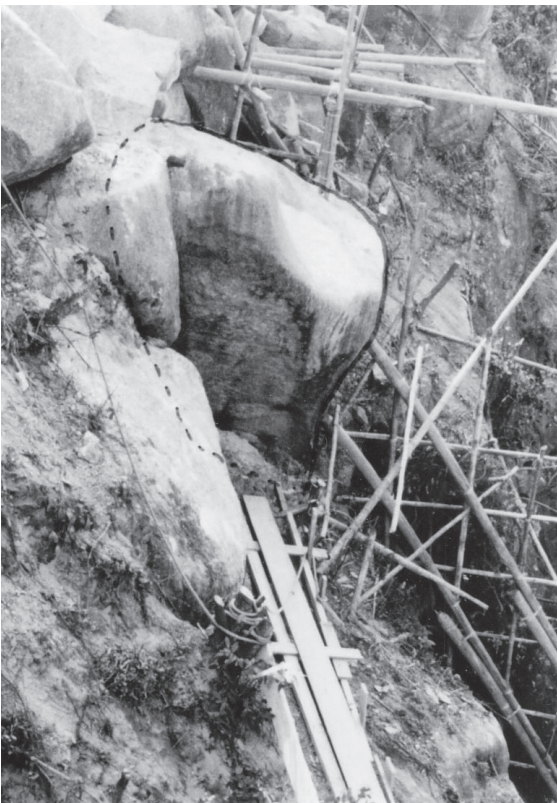
Figure 24(a). The shaking boulder (highlighted) (before treatment)

The work originally intended was the removal of a stack of interlocking boulders at the crest of a rock cut face overlooking a high density residential block. No specific instruction on the method of removal was given to the contractor, who naturally commenced by removing the top boulders first. After about five or six boulders had been removed, a workman reported that a large overhanging boulder below was shaking and work was stopped. (Figure 24(a) shows the situation just after the work was stopped.)

Investigation revealed that the overhanging boulder was in a state of “unstable equilibrium”, and any further loss of weight on top of it would inflict toppling. Due to its size, the consequence of any failure would be disastrous. Contrary to the original design, this large boulder was retained by stabilising it with a mass concrete buttress. Removal of the boulders on its top was then resumed. To provide for the buttress a firm foundation on the underlying rock, a layer of weak material immediately in front of the boulder had to be stripped off. To enable stripping of the material without jeopardising the stability of the boulder any further, a reinforced concrete strut plus two drive-wedge type rock bolts were installed to secure the boulder temporarily. Figure 24(b) shows a general view of the completed work. The job was delayed for two months for a contract period of only three months.

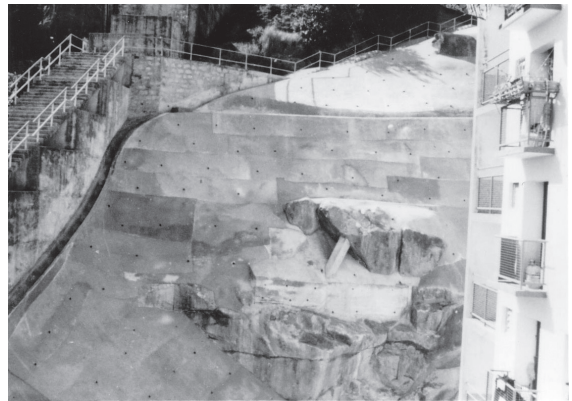
Figure 24(b). The shaking boulder (after treatment)

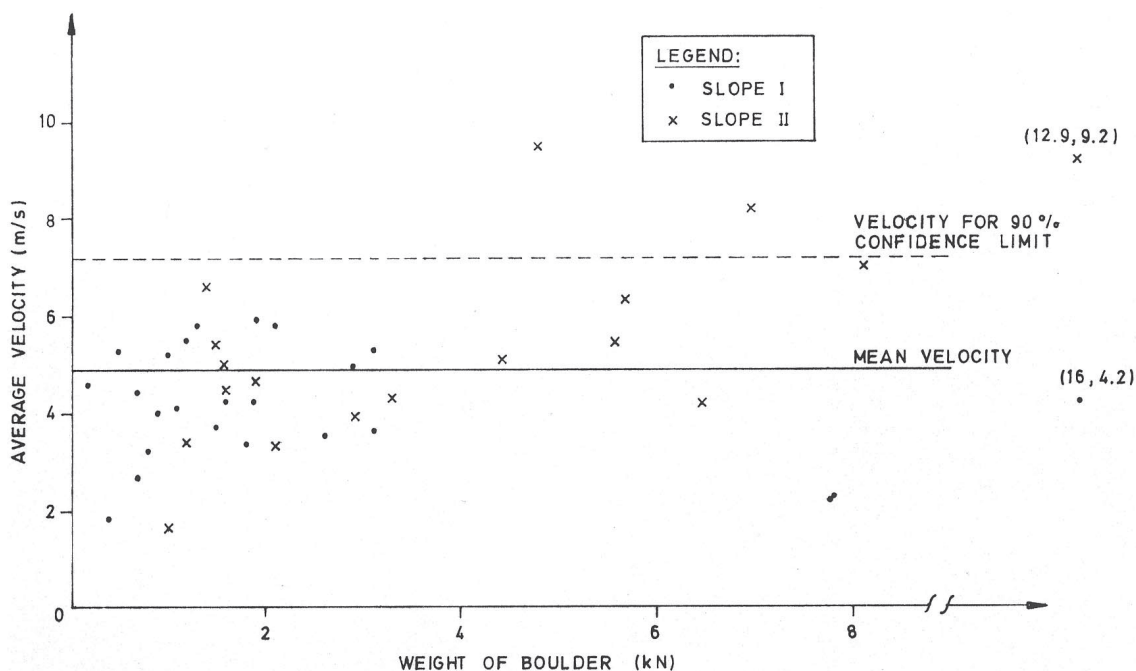
Figure 25. Full-scale boulder experiment: velocity versus boulder weight (after Chan *et al*, 1986)

To better understand the boulder fall and to facilitate design of the boulder fence in the Mid-levels of Hong Kong Island, Chan *et al* (1986) carried out a full-scale boulder fall experiment on two 30° slopes. The slopes were similar, one being a moderately decomposed rock outcrop with thin vegetation cover in

places (Slope I) and the other, a highly to completely decomposed rock slope with sparse vegetation and some surface boulder deposits (Slope II). A total of 70 boulders of sizes ranging from 30 kg to more than 1 tonne, and of differing angularity and shape, were rolled down the slopes. Boulder angularity, shape and size were found to have insignificant effect on the boulder velocities and the average velocities measured (Figure 25) were much lower than those predicted by the mathematical model (e.g. the predicted velocity of a 2 tonne subrounded boulder travelling a distance of 70 m on a 30° slope is about 10 m/sec as against the mean measured velocity of 4.9 m/sec). This is not unexpected as the lower velocity is attributed to many intangible factors which cannot be readily allowed for in the model, such as the uneven slope profile, vegetation cover, high ground deformability, humps created by the existing boulder deposits on slope, etc. Mak & Blomfield (1986) reported a similar experiment of rolling boulders down a number of steep presplit rock faces. The results are unfortunately limited to applications involving boulder falls on steep cutting batters like those illustrated in Figure 8. The majority of boulder falls in Hong Kong occurred on much gentler natural slopes.

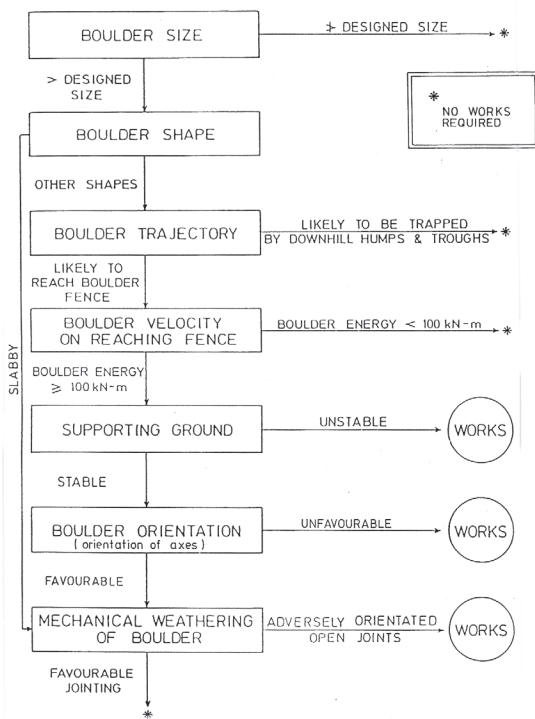
Figure 26. Flow-chart – identification of boulders for insitu stabilization.

inspected, measured and assessed, the work should be carried out in a systematic manner to avoid oversight. An example is the Mid-Levels site on Hong Kong Island, where some 2 000 boulders were inspected over an area of 45 000 m². The site was divided into panels of about 500 m² each and the boulders to be assessed within each panel were individually numbered and their positions recorded on a plan. A standard procedure as indicated in the flow chart in Figure 26 was then followed through.
