Slope Failures in Hong Kong

P. Lumb

Department of Civil Engineering, The University of Hong Kong

Summary: The recurrence of slope failures in residual soils of Hong Kong is analysed for the period 1950 to 1973, and various factors contributing to the instability are described. It is postulated that the prime cause of the failures is direct infiltration of rain water into the surficial zones of the slopes, producing a loss of effective cohesion following the saturation of the soil. Prevention of slips implies protection against excessive infiltration.

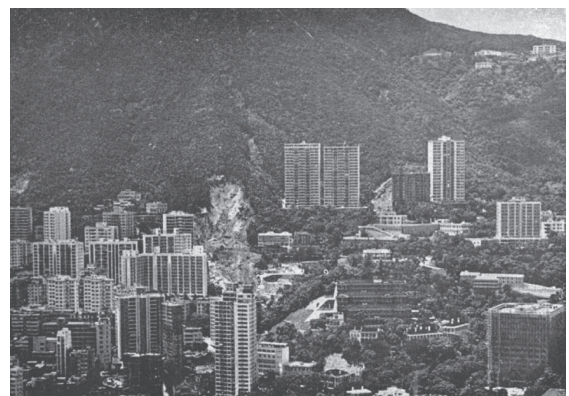
Figure 2. Mid-levels District, Hong Kong Island

An unusually severe slip of this type can be seen in the centre of Figure 2 (Mid-Levels District, June 1972). The debris from the main slip (colluvium, corestones and decomposed volcanics) fell onto saturated debris from an earlier cutting failure on a down-slope construction site, swept across two

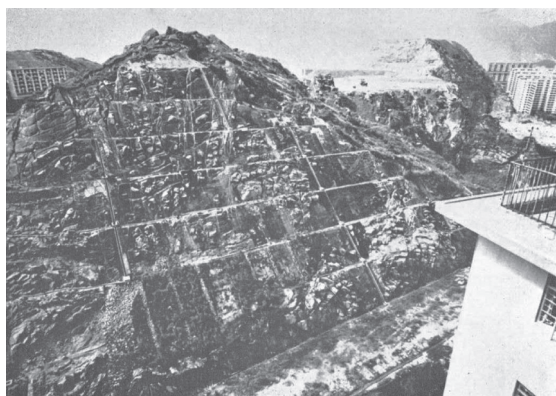
Figure 4. Road cutting, decomposed granite (shear zone)

In decomposed volcanics the *chunam* performs quite well, provided that the cement content is low enough to preclude shrinkage cracking, and an adequate bond develops between soil and *chunam*. In decomposed granite the bond is often poor, and large patches of *chunam* either spall off or cavities develop. If seepage close to the basal rock surface is persistent, the *chunam* cannot be sustained and stone pitching is often resorted to over short sections, as can be seen in the lower left-hand corner of Figure 4.

The second case, an existing cutting in residual decomposed granite, is shown in Figure 4. The cut, constructed in 1962 had successfully withstood the disastrous rains of 1966 but started to move in Sept. 1970, about nine days after heavy rain. Failure was at depth along a plane surface dipping at the surprisingly low angle of 20 degrees to the horizontal. The traces of this failure plane were clearly visible along two of the cutting faces, bounded up-slope by deep vertical tension cracks. Movements continued at irregular rates until the end of the wet season, with delays of two or three days between maximum rainfall and maximum rate of movement. The slip was attributed to increases in water pressure, the water seeping to the soil mass from a bare unprotected level area (in the right-hand middle distance of Figure 4) about 100 m from the actual failure zone (O'Rorke 1972). This level area had not been stripped until 1967, and consequently had not been a potential catchment area during the rains of 1966. The slip was stabilized by removing

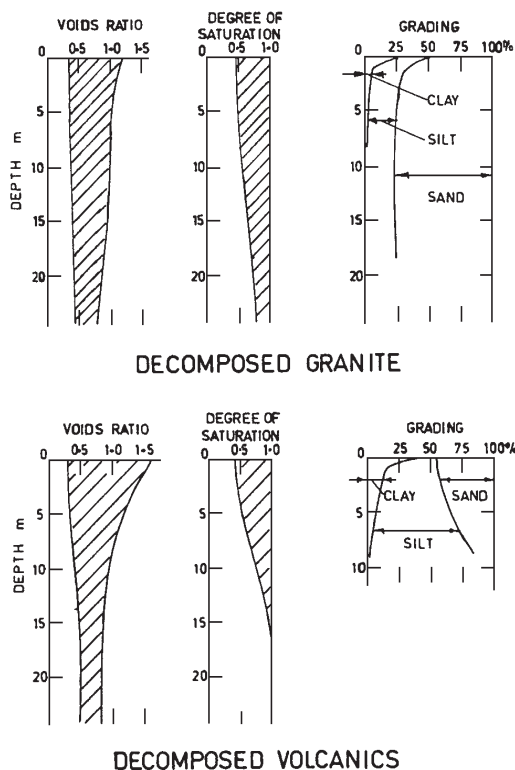
Figure 5. Bulk properties of residual soils

Although the engineering properties of the soils have been described elsewhere (Lumb 1962a, 1965), a summary of the bulk properties is given in Figure 5 for convenience. The variations with depth of the voids ratio and degree of saturation (for specimens taken above any observed water-table) are shown as envelopes of extreme values, while variations in texture (proportions of sand, silt and clay) are shown as mean trends.

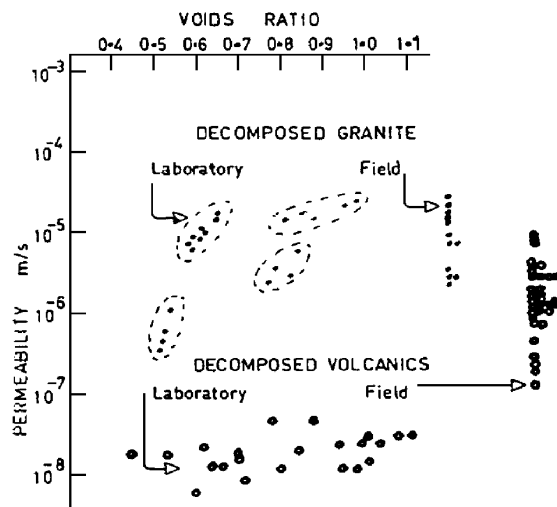
Figure 6. Permeability of residual soils

Seasonal changes in saturation from dry to wet states are controlled by the amount of water that can actually infiltrate into the soil and, for present purposes, this can be characterized by the fully saturated permeability. Figure 6 gives a summary of this property for undisturbed soil. Laboratory determinations for decomposed granite were carried out on small intact specimens carved from large undisturbed blocks, and the results are shown for four blocks to illustrate the variations which can occur with voids ratio changes and slight changes in texture. Field permeabilities, also shown, were measured by tests in boreholes and trial pits, representing the equivalent permeability over lengths of about 1.5 m. The field values are of the same order as the laboratory results, with a mean of about 8×10^{-6} m/s. The field values are probably biased to the high side, since field tests are only performed on sites where ground water problems are expected, but the broad agreement between field and laboratory results shows that the decomposed granite can be regarded as a free-draining porous mass and that the influence of joint-planes is weak.

In contrast with the decomposed granite, the field results for decomposed volcanics are two orders of magnitude greater than the laboratory results (for small intact sample-tube specimens), with a mean field value of 1.5×10^{-6} m/s and a mean laboratory value of 2×10^{-8} m/s, showing that the influence of joint-planes on permeability is strong for these soils. Assuming uniform joints at 0.2 to 1 m spacings, this difference between field and laboratory results can be attributed to joint separations of the order of 0.05 to 0.1 mm, which are plausible values.

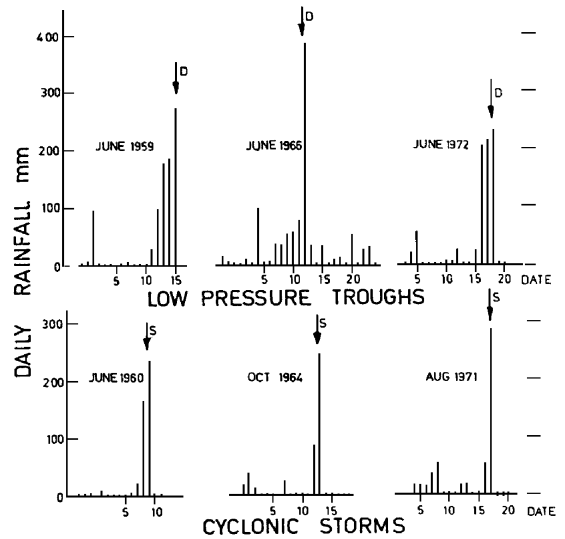
Figure 8. Daily rainfall patterns

The troughs have more significance than the storms, with regard to slope failures, as is shown in Figure 7 and Table 9, and for multiple events there must have been heavy rain for some period prior to the event together with heavy rain at the actual time of the event. To quantify the influence of rain, records

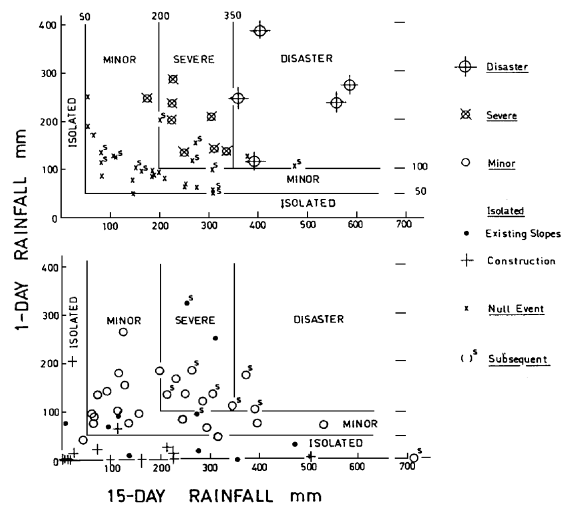
Figure 9. 1-day and 15-day rainfall, and predictive zones

taken at the Royal Observatory (see Figure 1) were studied and, after trying many combinations, the most satisfactory association was found to be between event intensity and total 24 h rainfall on the day of the event together with cumulative rainfall over the previous 15 days (excluding the rainfall on the failure day). The end results are shown in Figure 9, together with discriminatory or predictive zones for the different types of event. For example, disasters occur when daily rainfall exceeds 100 mm and the previous 15-day rainfall exceeds 350 mm.

These predictive zones are inevitably crude, since the rainfall at the Observatory is not necessarily the same as that at the location of the event, and also because there have been occasions when heavy rains

produced no failures. These latter 'null events' are also plotted on Figure 9 for cases where daily rainfall exceeded 50 mm. Some of the isolated and minor events occurred soon after a more serious event, resulting in their being plotted in a higher order predictive zone since the 15-day rainfall was inevitably large. On some occasions when heavy rains occurred shortly after a severe or disastrous event there was no consequent event, for the ripe crop had been reaped. Ignoring these subsequent null, isolated and minor events the number of results falling in each predictive zone is summarized in Table 10, grouping construction and existing isolated events together.

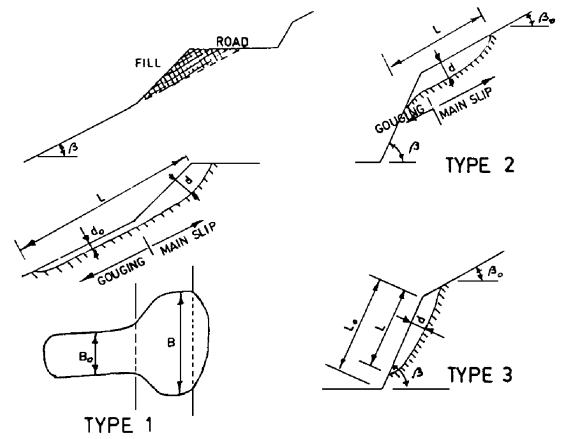
Figure 10. Types of slip

Figure 10 shows three idealized shapes of the resulting scars; Type 1 is very characteristic of slips in fill on hillside roads; Type 2 is very common in decomposed volcanic cuttings; Type 3 is characteristic of construction failures in decomposed granite. Figures 11, 12 & 13 show the actual shapes of some selected scars, and Table 11 gives a summary of the dimensions of large and small slips. The thickness of the failed zone is generally less than 3 m, and the ratio of thickness to length of scar is generally less than 0.15. After failure there is no retrogression and tension cracks above the scarp rarely develop. The scar is normally spoon-shaped, the shallow bowl being formed by the main slip and the narrow handle being formed by gouging down-slope by the debris (see Figure 11c).

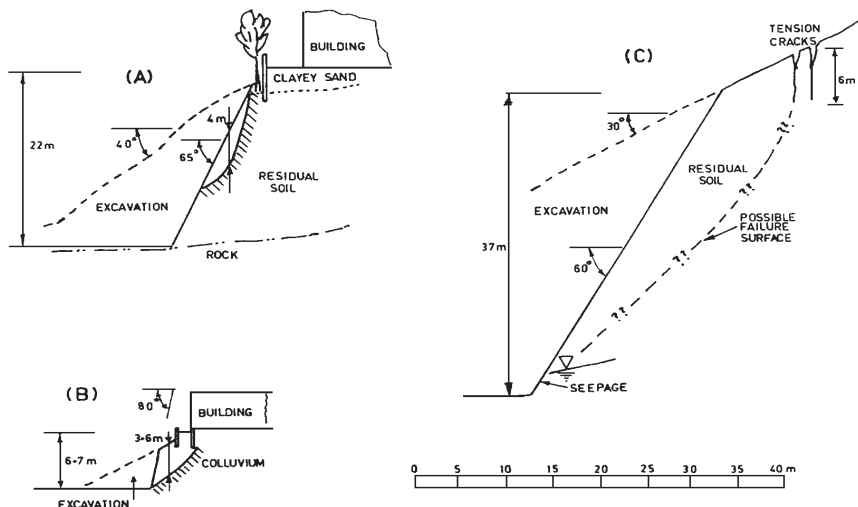
Figure 13. Type 3 slips

These failures, illustrated in Figure 13, occur within the cut face and do not extend beyond the crest of the cut, and occur more frequently during construction in dry periods than in existing cuts during the rains. The failure scar is quite small and usually does not extend over the full depth of cut, as shown in Figure 13a for a slip in a temporary excavation in decomposed granite during a dry period (May 1960). After the slip the exposed scarp remained stable, although much steeper than the original 65 degree cut and a line of trees just at the crest was unaffected, and there was no damage to the parapet wall behind the trees. The roots of the trees and the tensile strength of the clayey surficial layer at the cutting crest probably prevented extension of this slip. It is possible that failure was due to the presence of a joint-plane, although there was no direct evidence.

Possible causes often combine, of course, as happened with the low cutting in colluvial decomposed volcanics shown in Figure 13b, where failure occurred during excavation in heavy rains (June 1960). Both ponding of water behind the parapet wall and the excavation itself were necessary to produce failure in this case. This slip, exposing the foundations of the light single-storey structure shown, caused the building to collapse, but such damage to an up-slope structure is rare (compare Figures 15 & 16).

The first case (Figure 13c) was in a deep cutting in residual decomposed volcanics, being excavated during the dry year of 1962. After a wet typhoon (Sept. 1962) the chunam plaster cracked badly and on 10 Nov. 1962 deep tension cracks appeared beyond the top of the cut. No slip occurred but the slope was trimmed back to 45 degrees as a precautionary measure. Cracking of the chunam and some unravelling at the toe again occurred in April 1963 (the start of the wet season) and movements continued until July 1963. Water seepage at the toe had always been noticed throughout the whole period, but no seepage came from the upper part of the slope. The excavation had been made to allow construction of a service reservoir; this reservoir was redesigned as a buried structure and the total depth of cutting reduced by back-filling to above the seepage line. The final reduced cutting has since proved quite stable.

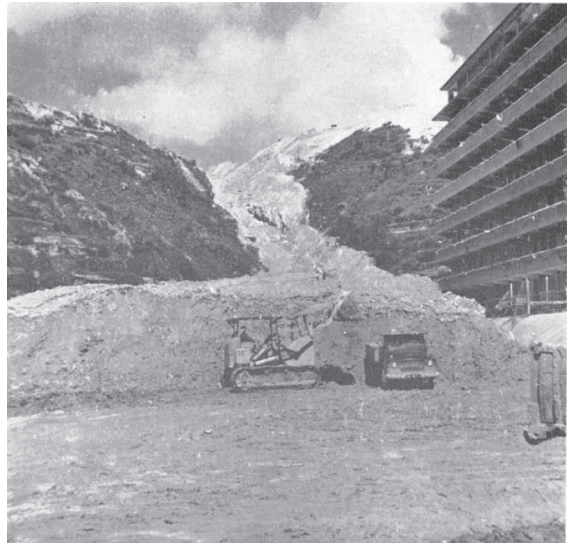
Figure 17. Debris from Type 1 slip, decomposed granite fill

to rest at the foot of the valley, where it drained and consolidated into a thick layer of colluvium (Figure 17).

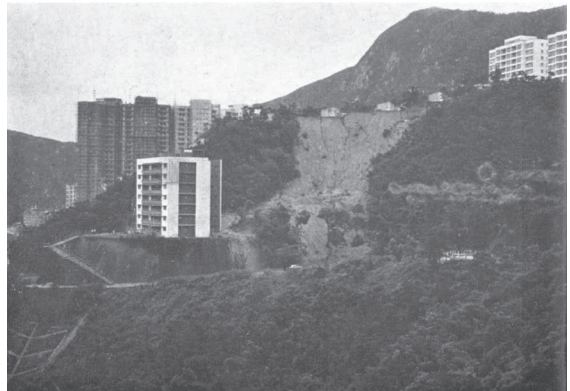
Figure 18. Scar from Type 1 slip, decomposed granite fill

of the slip shown in Figure 18 (June 1966) split into two streams at the foot of the slope and one stream, sweeping behind the seven storey building to the left, carried away several ground-floor columns and buried and killed a resident who had just stepped out to the car-park. A second slip at Sau Mau Ping (June 1972), similar to that of Figure 11a, completely buried a

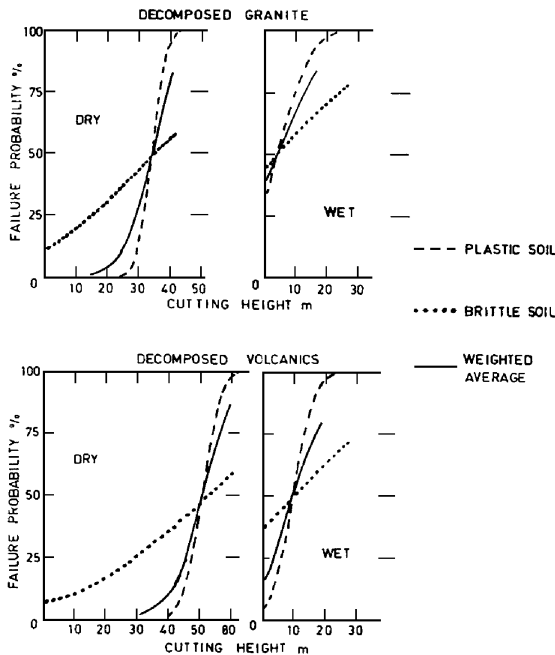
Figure 20. Probability of failure versus cutting height, 60 degree cut

It is this first conditional probability P(F|HRIX) which is given in Figure 20. Since the rainfall is only weakly dependent on location in the urban areas and the height of cut is under the control of the designer to a certain extent, the equation can be simplified a little to read:

The failure probabilities of Figure 20 do not hold unconditionally, since it has been tacitly assumed that saturation will inevitably follow heavy rains and this is not necessarily true.
