Mobile Soil and Rock Flows

N. R. Morgenstern

Department of Civil Engineering, University of Alberta, Canada

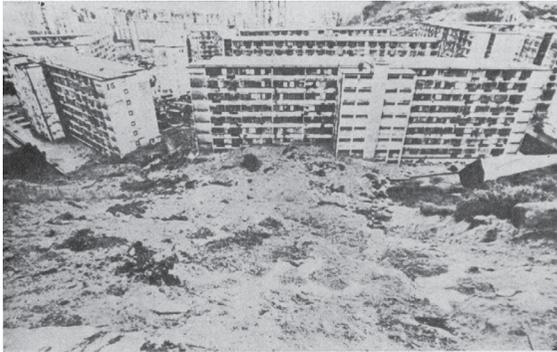
Figure 1. View of catastrophic mud avalanche of 25th August, 1976 at San Mau Ping. Photo courtesy of South China Morning Post Ltd., Hong Kong

On August 25, 1976 at about 10:00 a.m., a fill slope immediately behind Block 9 of the Sau Mau Ping Estate, Hong Kong, failed. The resulting mud avalanche buried the ground floor of the block killing eighteen people (Figure 1). Catastrophic landslides have not been rare events in Hong Kong during recent years. In June of 1972 another failure of an embankment, also at Sau Mau Ping, resulted in the death of 71 persons. At that time a Commission of Inquiry conducted an investigation into the Sau Mau Ping and other slides that had occurred. Among their various findings, they concluded that no fault was found with the manner in which the design and construction of the embankment was carried out.

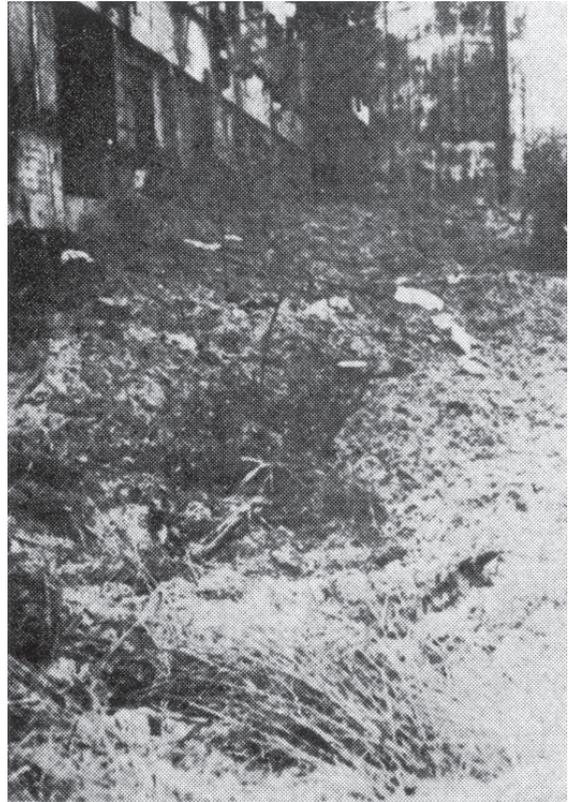
Figure 3. Characteristics of debris to the rear of Block 9, looking away from Block 15, at about 11.00 am on 25th August, 1976. Photo courtesy of Housing Authority

A cross-section of the slope that failed is shown in Figure 2. The fill slope was constructed at 1-1/2:1 to a height of about 30 m. Failure occurred following intense rain. However, the return period of the storm was about 4 to 5 years and cannot be considered abnormally severe for the conditions that prevail in Hong Kong. The debris was essentially a mud and it was extremely mobile. Its nature may be seen in Figure 3.

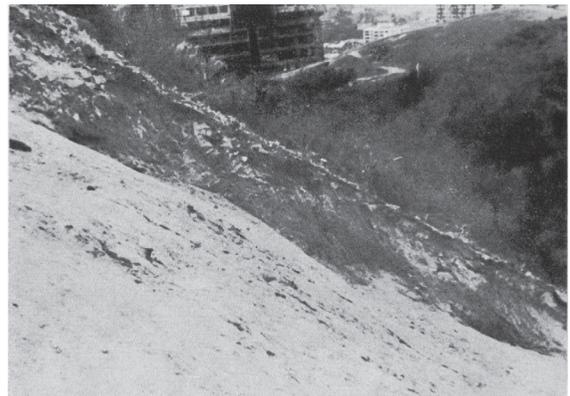
Figure 4. View showing the shallow depth of the slide and layers parallel to the slope

- (3) The soil on the slope was definitely layered parallel to the slope surface, with layers between about 100 and 300 mm thick, see Figure 4. This was the result of end-tipping with no compaction after filling.
- (4) Beyond the crest of the slope, the dry densities were low but variable to a depth of 7 m, dropping from about 1.65 t/m^3 to about 1.2 t/m^3 (90 to 70% of standard compaction) and showing a gradient of densities with depth consistent with the soil having been placed in horizontal layers 1 to 3 m thick. At greater depths, the dry densities were around 1.5 t/m^3 to a depth of 20 m below the surface.

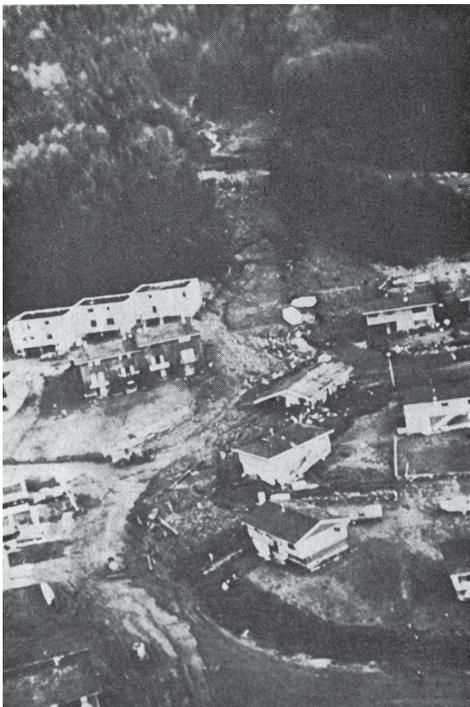
Figure 7. Mobility of 1973 flow

Figure 6 shows a view of the lower portion of the path of the 1973 flow. The volume of debris was about 26,000 m³ and 30 cm diameter trees were broken down before the flow entered the town. In Figure 7, looking toward the mouth of the gully, one sees the 1973 slide. The house near the middle of the picture was moved off its foundation, but for the most part the debris flowed around buildings and was diverted by minor topographic irregularities. In town, the slide moved at a fast walking speed, i.e. 5 to 8 km per hour.

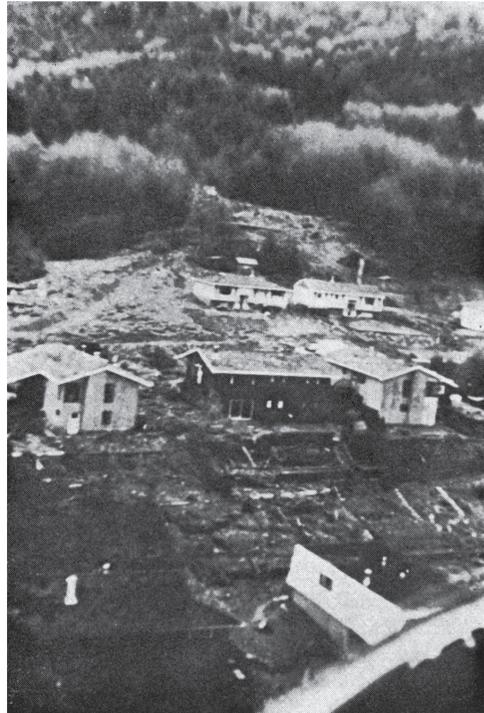
Figure 8. The 1975 debris flow

Another debris flow occurred in 1975 bringing about 7,500 m³ of material into the town from a different gully. Figure 8 illustrates the 1975 debris flow where it entered into the upper part of the town. While none of the buildings were displaced from their foundations, considerable damage occurred due to flooding after the debris flow.

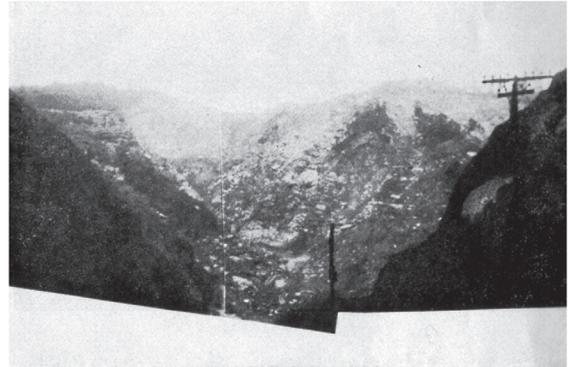
Figure 10. Source of Grota Funda flow

Figure 10 illustrates the source area of the debris. The characteristic “sugar loaf” weathering forms are discernible in the right hand side of the photograph. Figure 11 shows the source material moving down the steep slope and gathering on a bench above the deep gorge. Two railway bridges cross the gorge. The short upstream bridge connects two tunnel sections of an old funicular railway. The downstream bridge is more recent and is longer. The debris flows within the gorge impinge on one of its piers and this is the major concern associated with these flows. Both railroads are important arteries connecting Sao Paulo with the port of Santos. The channelization of the flows may be seen on Figure 12. The geometry of the channel influences both the discharge velocity and the height to which the debris will rise. Discharges of debris occur episodically and traverse the gorge carrying enormous core stones. These are pulsating, high velocity flows that have been observed to travel at 30 km/hour. Flow debris in the gorge and some of the core stones left by a flow are shown on Figure 13 and Figure 14. Figure 15 indicates the level to which debris rises when a flow is passing through the gorge. The bridge pier that is to be protected from the flows is evident in Figures 15 and 16, as is the destructive force of the surges.

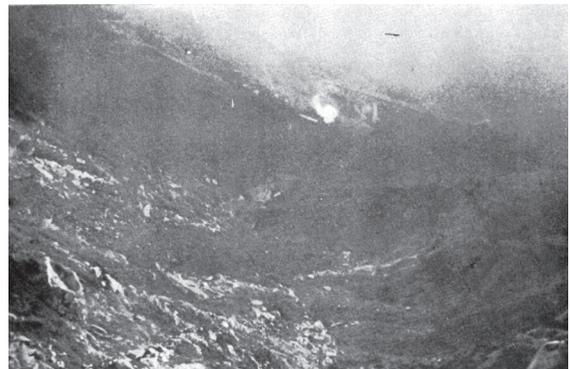
Figure 11. The Grota Funda flow

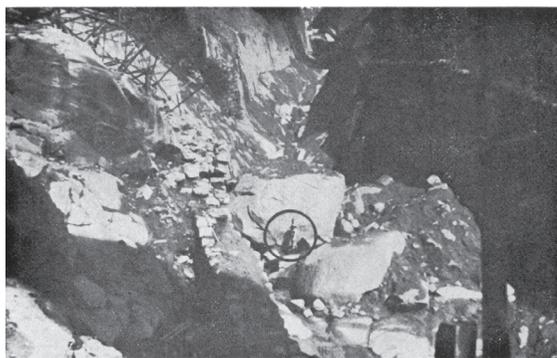
Figure 13. Core stones in gorge

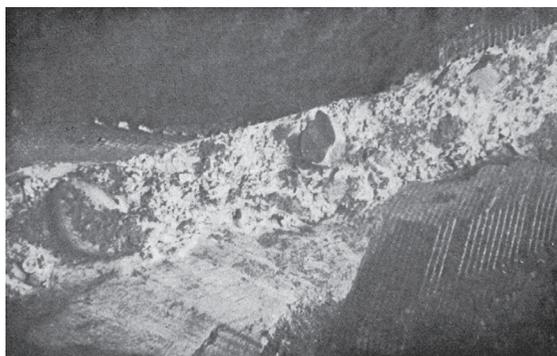
Figure 14. Debris in Grotta Funda

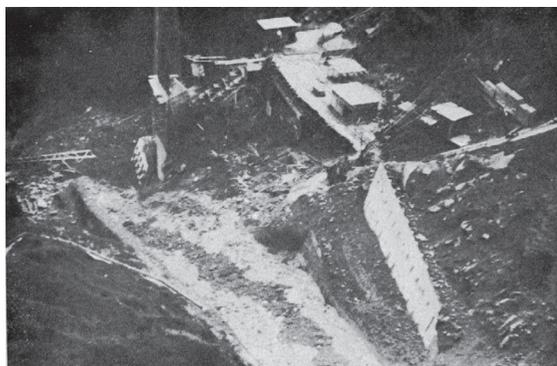
Figure 16. Flow impinging on bridge pier

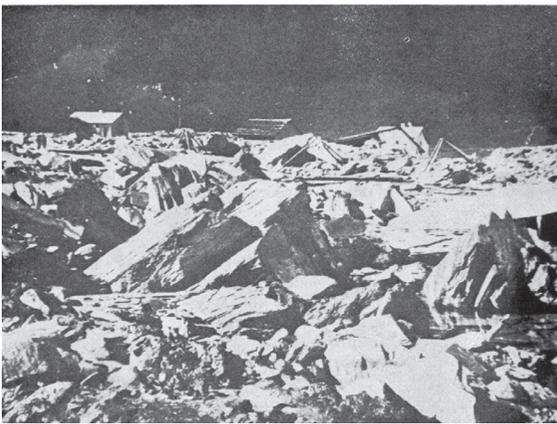
Figure 18. Debris from the Elm Slide (Heim, 1932)

Heim (1932) was perhaps the first to observe systematically the characteristics of rock debris avalanches and to suggest that they flowed like a fluid. It was the Elm slide of 1881 that initiated his interest in this behavior. The characteristics of the Elm slide are illustrated in Figure 17 which also draws attention to the mobility of the debris. The nature of the debris is shown in Figure 18. Vivid eyewitness accounts have recently been reviewed by Hsü (1975) which indicate that while the mass was essentially dry, it was fluidized. Many other examples of comparable mobility have been listed by Hsü who established a broad correlation between the Excessive Travel

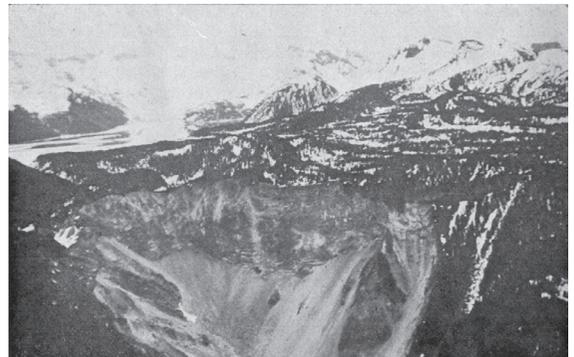
Figure 19. The Barrier

Figure 19 illustrates the source area of a historical rock debris avalanche in Western Canada that has received considerable attention recently (Moore & Mathews, 1978; Garibaldi Advisory Panel, 1978). The cliff is known as the Barrier and it is located at the head of Rubble Creek Valley, about 30 km north of the town of Squamish, near the west coast of British Columbia. In 1855 a rock debris avalanche occurred involving approximately $30 \times 10^6 \text{ m}^3$. The avalanche flowed through the narrow valley, illustrated in Figure 20, and ultimately spread out into a fan where the creek valley entered an adjacent river valley. This movement involved an Excessive Travel Distance of
