Rising to the Challenges of Natural Terrain Landslides

H.N. Wong

*Geotechnical Engineering Office, Civil Engineering and Development Department,
The Government of the HKSAR*

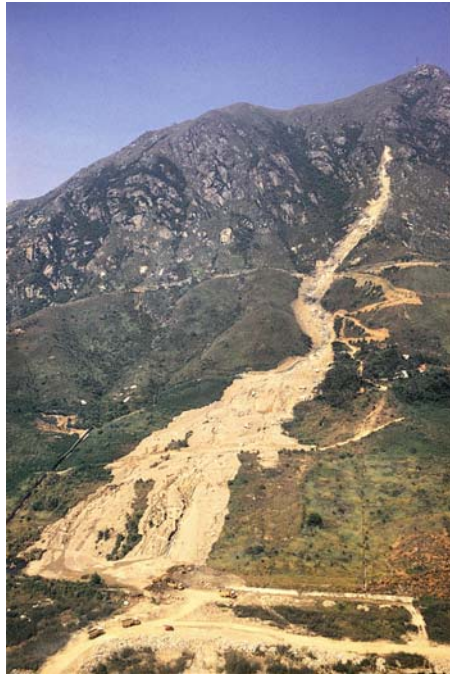
Figure 4: The 1990 Tsing Shan debris flow

- (a) **Study of the 1990 Tsing Shan debris flow:** This large channelised debris flow (Figure 4) was studied in detail by the GEO, and reported by Chan et al. (1991) and King (1996). The incident started as a debris slide of about 350 m³ at the landslide source. It developed into a 20,000 m³ debris flow through material entrainment, with a runout distance of about 1 km. The debris flow has been regarded locally as an example of a low-frequency, large-magnitude natural terrain landslide event, and quoted internationally as a case that illustrates high debris flow entrainment (Jakob & Hungr 2005). Before the debris flow, the planned development in the region was encroaching on the Tsing Shan foothills. The debris flow could have resulted in serious consequences if the site traversed by the debris flow had been developed at the time. After the debris flow, development at the site was changed to a golf driving range to minimise risk exposure. The case is a vivid illustration of the risk of debris flows and the importance of proper land-use and development planning in controlling undue increase in the risk of natural terrain landslides.

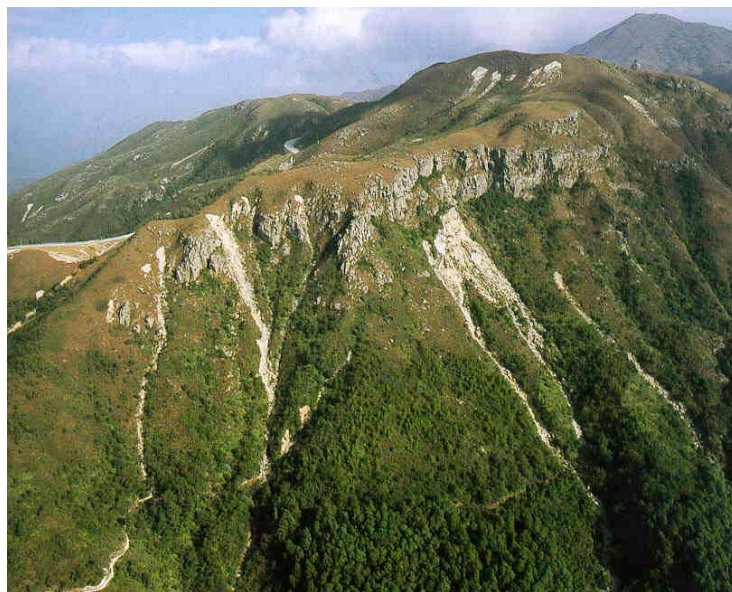
Figure 5: Natural terrain landslides on Lantau Island in the November 1993 rainstorm

- (b) **Study of the 1993 Lantau landslides:** In the rainstorm of November 1993, over 860 natural terrain landslides occurred on Lantau Island (Figure 5). The landslides resulted in blockage of roads and catchwaters. As Lantau Island was largely undeveloped at the time, there were no landslide casualties. The landslides were mapped and the data collected analysed (Wong et al. 1998). The study established that a high density of natural terrain landslides could be triggered in a severe rainstorm (about 7 nos./km² in the region affected by high rainfall intensity in this rainstorm), and that terrain at a gradient of 30° to 35° underlain by volcanic rocks was most susceptible to failure. Empirical assessment of landslide debris runout data showed that debris mobility was affected by the mechanism of debris movement, with channelized debris flows being more mobile than open hillslope failures. The study carried out by Franks (1998) on the landslides overlooking Tung Chung New Town, which was being developed in 1993, also arrived at similar observations.

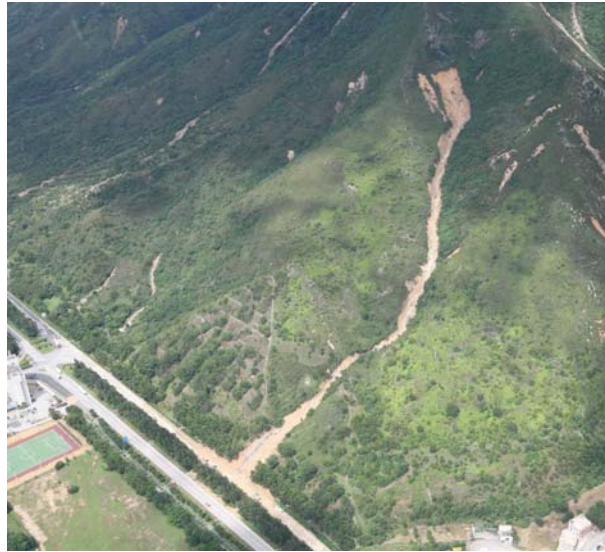
Figure 12: Debris flow affecting a road with low traffic density

- (d) **Occurrence of a landslide in a low-ranked HLC resulting in serious consequences:** This could cast doubt on the reliability of the priority ranking methodology and possible human errors in assessing the ranking scores. It could also invite criticism that the LPMitP should be speeded up. The scenario may occur in association with some ‘unfortunate’ combinations of events that lead to dire consequences, e.g. a debris flow inundating vehicles queuing on a minor road that is blocked by flooding or a minor roadside landslide (Figure 12), as in the case of the 1995 debris flow that caused 22 fatalities at a slip road in the Genting Highland, Malaysia (Abdullah et al. 2007). The public’s perception may even be worse if the failure occurs on a catchment adjoining other catchments where mitigation works have been carried out but without occurrence of any noticeable landslides in the rain storm.

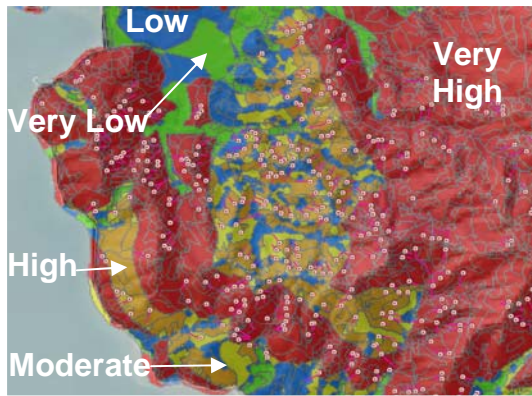
(a) 2-D landslide susceptibility map

(b) 3-D presentation

Figure 16: Terrain landslide susceptibility classification.

Statistical analyses of landslide susceptibility provide further insight into the spatial distribution of natural terrain landslides. The territory-wide landslide susceptibility analysis by Evans and King (1998), based on correlation with slope angle and geology, found that the natural terrain of Hong Kong could be differentiated into five susceptibility classes. The calculated landslide densities for the five classes vary from ≤ 10 to >100 landslides per km^2 , which corresponds to an average frequency of failure from about ≤ 0.1 to >1 landslides/ km^2/year (Figure 16). Wong (2003) diagnosed the implications of the limited resolution in the calculated landslide frequency among the classes, which spans only about one order of magnitude between the least and most susceptible classes. Such a resolution is considered insufficient for differentiation of vulnerable hillsides, given the potentially high consequence of landslides in Hong Kong. From a different perspective, the low resolution probably demonstrates a lack of understanding of the quantifiable factors that control landslide susceptibility. It may also reflect the possibility that the natural hillsides in Hong Kong are generally susceptible to failure, with a relatively small difference in the landslide susceptibility between the more problematic and less problematic terrain.

Combined rainfall-susceptibility analyses by GEO showed that spatial and temporal variations in rainfall intensity have a significant influence on landslide susceptibility. In particular, it was observed that at low rainfall intensity, landslides tend to occur predominately on more susceptible terrain. However, under high rainfall intensity, even less susceptible terrain would suffer from failures. This leads to the same inference: Hong Kong's steep hillsides are actively responding to heavy rain and are far from reaching a state of high entropy against shallow failures.

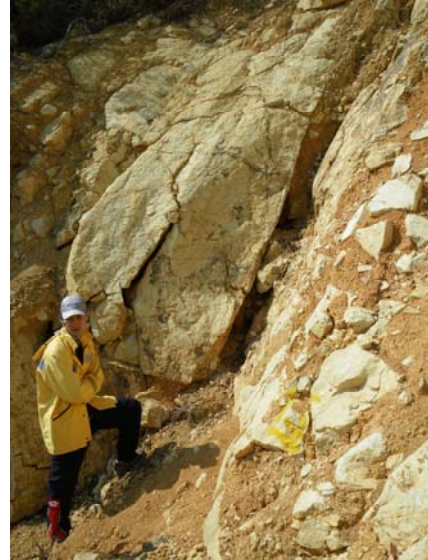
(a) Extensive tension cracking above a recent landslide in Tsing Shan foothills

(b) Open and infilled discontinuities at landslide scarp of the main source of the June 2008 Shek Mun Kap debris flow

Figure 18: Signs of deterioration of natural hillsides

- (c) **Hillside deterioration:** While field data showing evidence of hillside deterioration have become more abundant (e.g. Hughes et al. 2002; Wong et al. 2004; MGSL 2007), details of the deterioration process are still not fully known. These include possible causes and mechanisms of deterioration, time span to ripening, and factors controlling the transition from slope distress to occurrence of uncontrolled detachment. From time to time, tension cracks are found on hillsides after heavy rain or after vegetation is burnt off by hill fire (Figure 18). These may be newly formed tension cracks, or pre-existing cracks subject to intermittent movement. Development of tension cracks would affect the hydrogeology and strength of the groundmass, and significantly alter the stability conditions of the hillside. It appears that some hillsides may go through a prolonged stage of development of tension cracks, or other forms of signs of distress (e.g. slope deformation involving dilation of relict discontinuities in weathered rock, Figure 18), before occurrence of uncontrolled detachment. This offers some scope for use of continuous slope monitoring to acquire information for diagnosing the hillside behaviour and managing landslide risk. It also brings out the importance of identification of signs of distress in NTHS and the need for re-assessment after development of signs of distress on a hillside that has previously been subjected to NTHS.

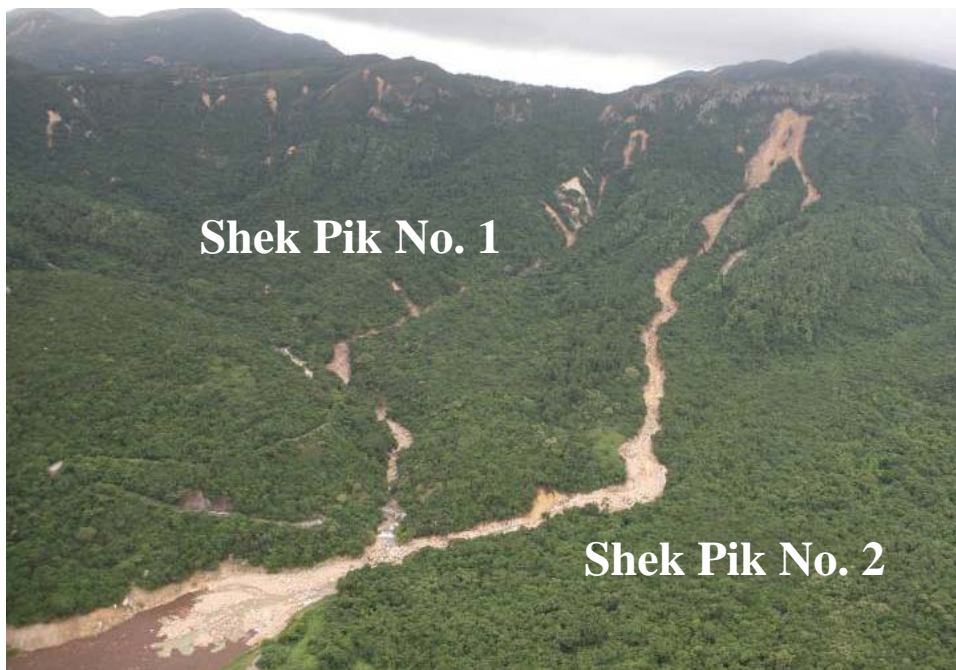
Figure 19: Large debris flows on Lantau in the June 2008 rainstorm
 (Note: Shek Pik No. 1 and No. 2 debris flows are shown; see Figure 5 for debris flows in the area in November 1993)

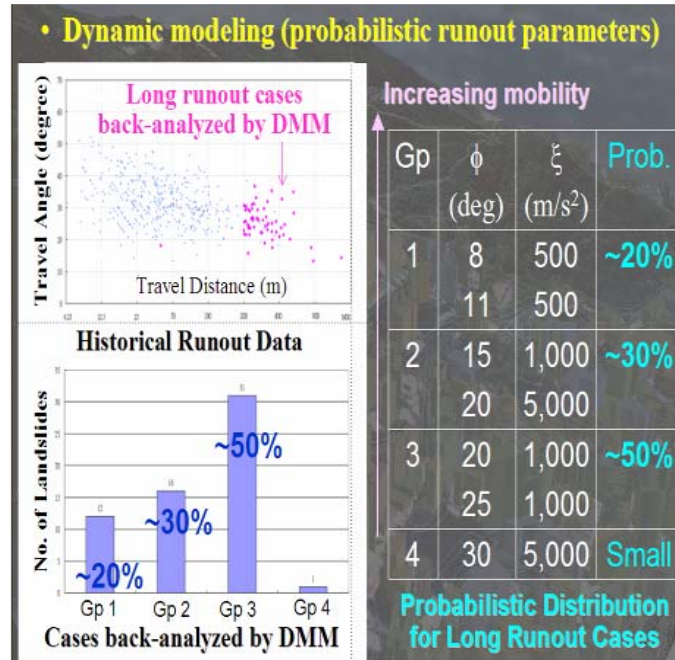
Figure 24: Probabilistic distribution of runout parameters for mobile debris flows based on back-analysis of historical long runout cases

Further back-analyses were carried out by the GEO in recent years. These included review of the empirical runout data extracted from the NTLI and systematic back-analysis of about 60 known long runout cases. The work has shown that use of the Voellmy rheology is more appropriate in simulation of debris flows in Hong Kong. The probabilistic distribution of different sets of runout parameters for mobile debris flows was derived (Figure 24), which provides improved data for use in predicting the debris impact zones and assessing landslide risk under a probabilistic framework.

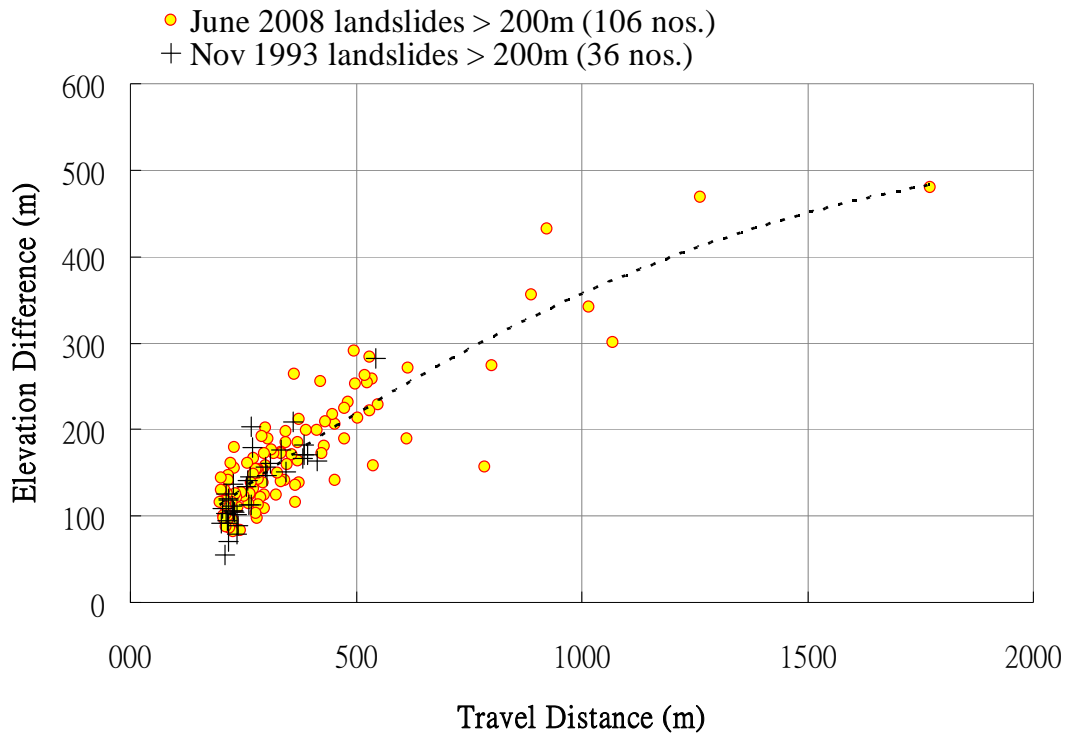
Figure 27: Data showing many long runout and high mobility landslides in the June 2008 rainstorm (Note: 18 debris flows in the June 2008 rainstorm have runout distance exceeding 500 m, while there are only 10 historical cases in the ENTLI including one case on Lantau Island; landslides with runout distance ≤ 200 m not shown for clarity)

- (a) **Increased debris mobility:** It is known that natural terrain landslide density escalates with rainfall intensity. Data from the June 2008 landslides, when compared with the previously available data on historical natural terrain landslides, indicate that debris flows in a severe rainstorm can also become more mobile. Figure 27 shows that the June 2008 landslides on Lantau have considerably higher mobility than that of the historical landslides in the ENTLI. Studies of debris runout form an important part of the field and analytical work that is being carried out on the June 2008 landslides. There is a need to revisit the back-analyses that have previously been undertaken on debris mobility, by incorporating the newly available data. The findings would help to improve the robustness of the assessment of the reach of landslide debris, as well as the debris velocity and impact forces to be considered in the design of mitigation measures.

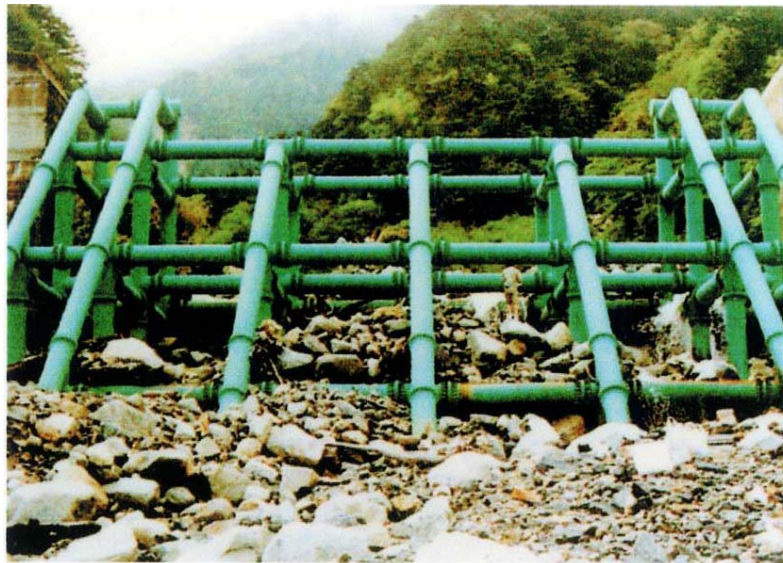
Figure 29: Grid-type steel sabo structure
 (Note: The open structure would trap sizeable clasts and allow free drainage; photo from Lo 2000)

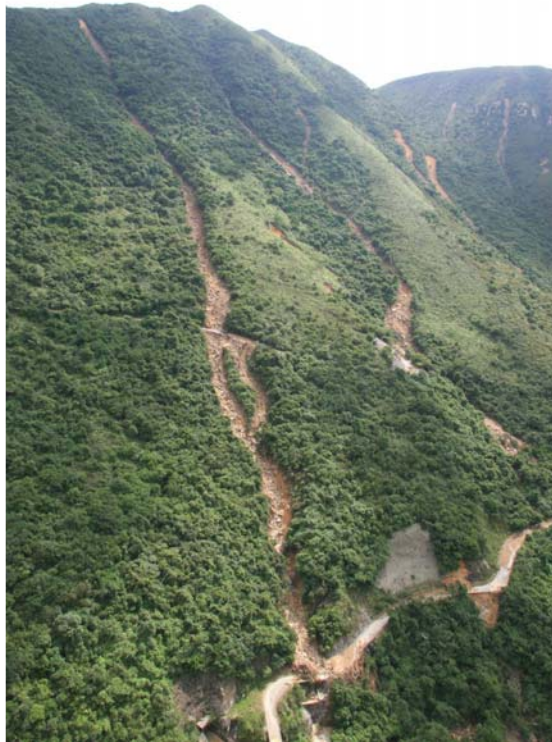
Figure 30: Debris flow with significant entrainment in the June 2008 rainstorm
(Note: Debris flow above Shum Wat Road is shown; the source volume is less than 100 m³ and the entrainment ratio exceeds 10)

- (c) **Significance of entrainment:** The 1990 Tsing Shan debris flow is known to be a case of significant entrainment, which was thought to be unusual in the past. Many debris flows with significant entrainment, e.g. entrainment ratio up to ten or even higher, occurred in the June 2008 rainstorm. Many of the long runout debris flows in the rainstorm started with a small landslide at the source, e.g. within two to three hundred cubic metres. The active volume escalated as the materials on the drainage line were entrained in the debris flows, and the eventual scale of the debris flows was largely controlled by the degree of entrainment (Figure 30). This shows the importance of assessment of the potential for entrainment in managing debris flow hazards.

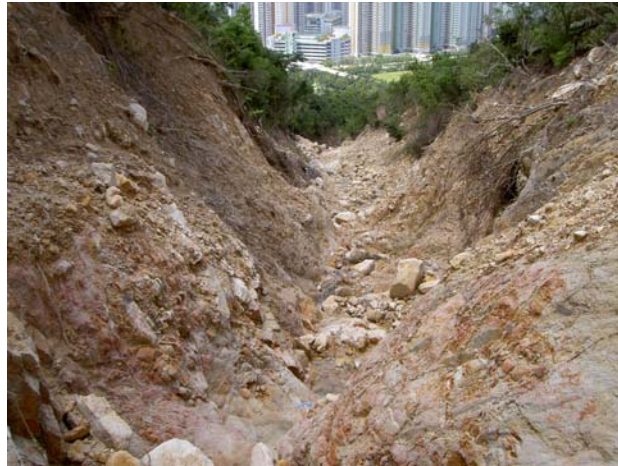
Figure 31: Complete removal of perched materials in the depletion zone of debris flow
 (Note: The June 2008 Yu Tung Road debris flow is shown; the side slopes and bed of the drainage lines not subject to significant material loss)

- (d) **Dynamic nature of drainage lines:** Mapping of the June 2008 debris flows suggests that entrainment tends to involve the materials perching on the drainage line, instead of depleting extensively into the existing side slopes and bed of the drainage line (Figure 31). This seems to suggest that the side slopes and bed of the drainage line are generally more resistant to entrainment, which may reflect their relative maturity in the formation process. Materials perching on the drainage lines, particularly in the upper part of the drainage lines within the debris flow depletion zone, are mostly sizeable boulders left in place from previous landslides. These perched materials in the depletion zone are often completely, or almost completely, swept away in the event of a mobile debris flow. The debris flow resulted in deposition of debris including sizeable boulders at the accumulation zone in the lower part of the drainage line (Figure 32). After debris deposition, and upon removal of the fines following prolonged outwash and erosion, the sizeable boulders will become perched materials again. Hence, mobile debris flows, such as those that occurred in the June 2008 rainstorm, effectively result in ‘pushing’ the perched materials downstream. This would significantly alter the entrainment characteristics of the drainage line and may arguably help to reduce the risk of entrainment in future events. On the contrary, less mobile landslides and debris flows would result in accumulation of debris on the upper part of the drainage lines (Figures 5 and 33). It would increase entrainment potential, as well as the risk of future debris flows. This suggests that the scale and characteristics of debris flow hazards at a given drainage line may not be static, but could change with time as landslides and debris flows take place intermittently in the catchment. In terms of entrainment potential and characteristics, some debris flow catchments may evolve with time from one stage to another within a life cycle. The dynamic nature of drainage lines should be understood and judiciously accounted for in risk assessment and mitigation.

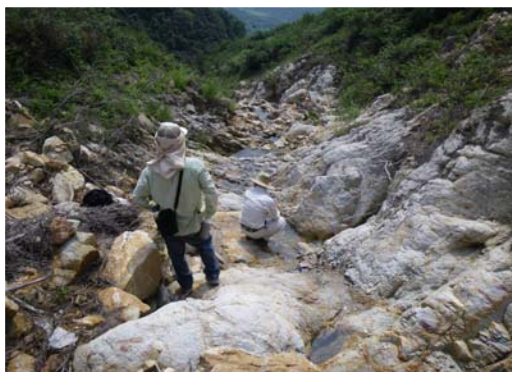
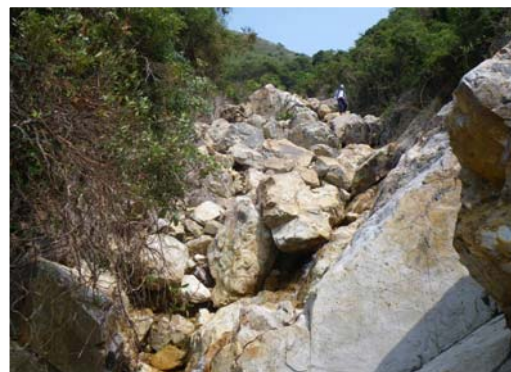
(a) Depletion of perched boulders in upper part of drainage line

(b) Accumulation of loose boulders at lower part of drainage line

Figure 32: Transport of perched materials in a debris flow
 (Note: The June 2008 Yi O debris flow is shown)

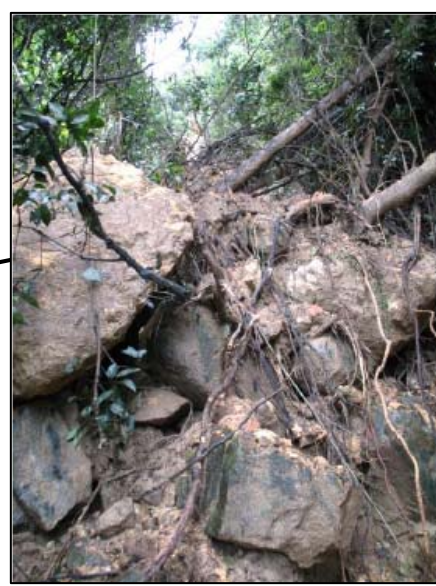
Figure 33: Less mobile landslide resulting in accumulation of loose debris on drainage line
 (Note: The June 2008 Mount David debris flow above Police Quarters Block C is shown)

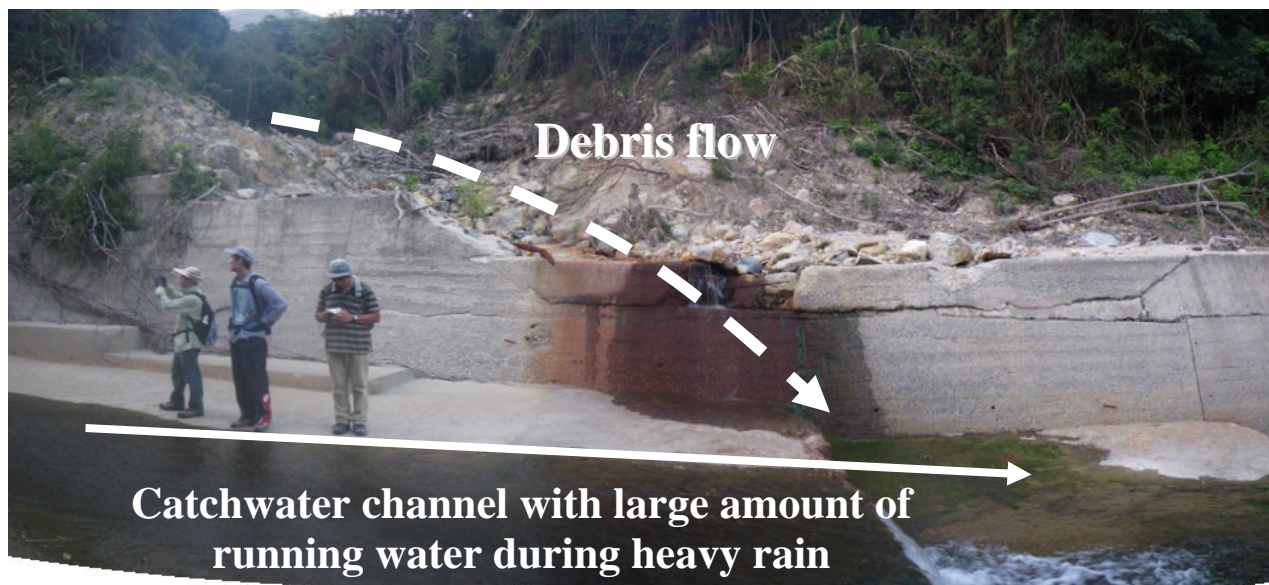
Figure 37: Debris flow entering catchwater channel
 (Note: The June 2008 Shek Pik No. 1 debris flow is shown; the debris flow turned into a debris flood after entering the catchwater channel)

- other site settings, e.g. discharge of debris onto a pool of water on the drainage line, discharge of debris from a small drainage line onto a major drainage line or a catchwater channel where a large amount of storm water was running (Figure 37)

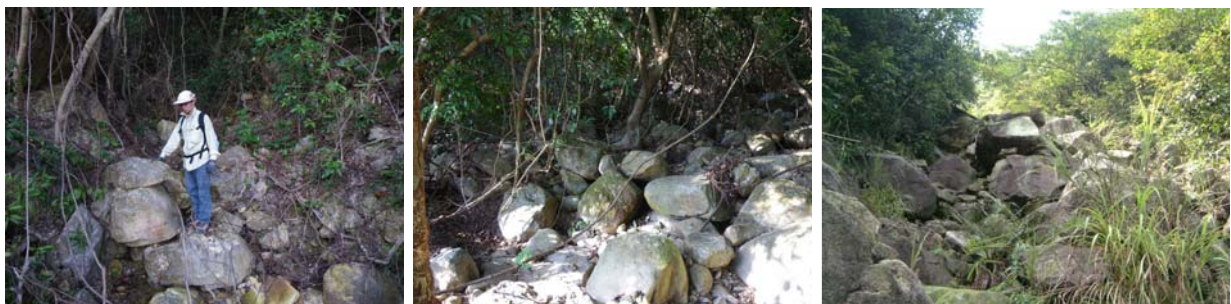
Figure 39: Drainage line filled with perched bouldery deposits that are susceptible to entrainment

- debris flow in a drainage line with a large amount of perched boulders (Figure 39), which are susceptible to entrainment; this may coincide with a specific life-cycle stage of the drainage line, in which a large amount of entrainable materials have been stored up in the drainage line for eventual discharge downstream in a sizeable and mobile debris flow that is due to occur

(a) Adjoining Shek Pik No. 1 (b) Adjoining Shek Pik No. 2 (c) Adjoining 1990 Tsing Shan debris flow site

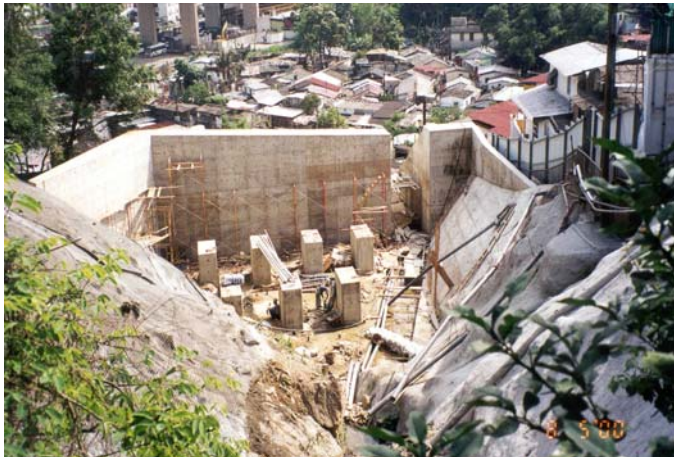
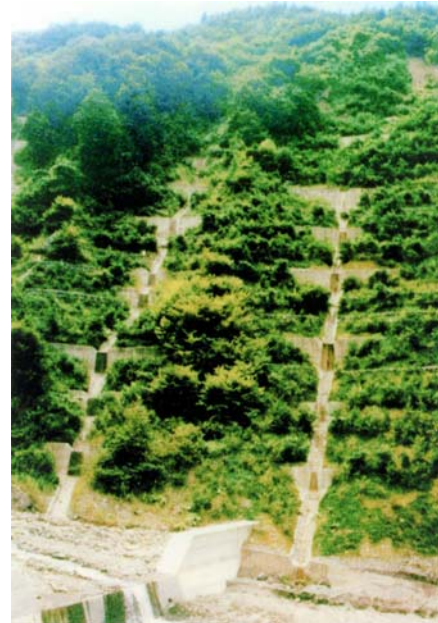
(a) Single debris-resisting barrier at the toe of drainage line

(b) Series of debris-resisting barriers along the drainage line (Photo from Lo 2000)

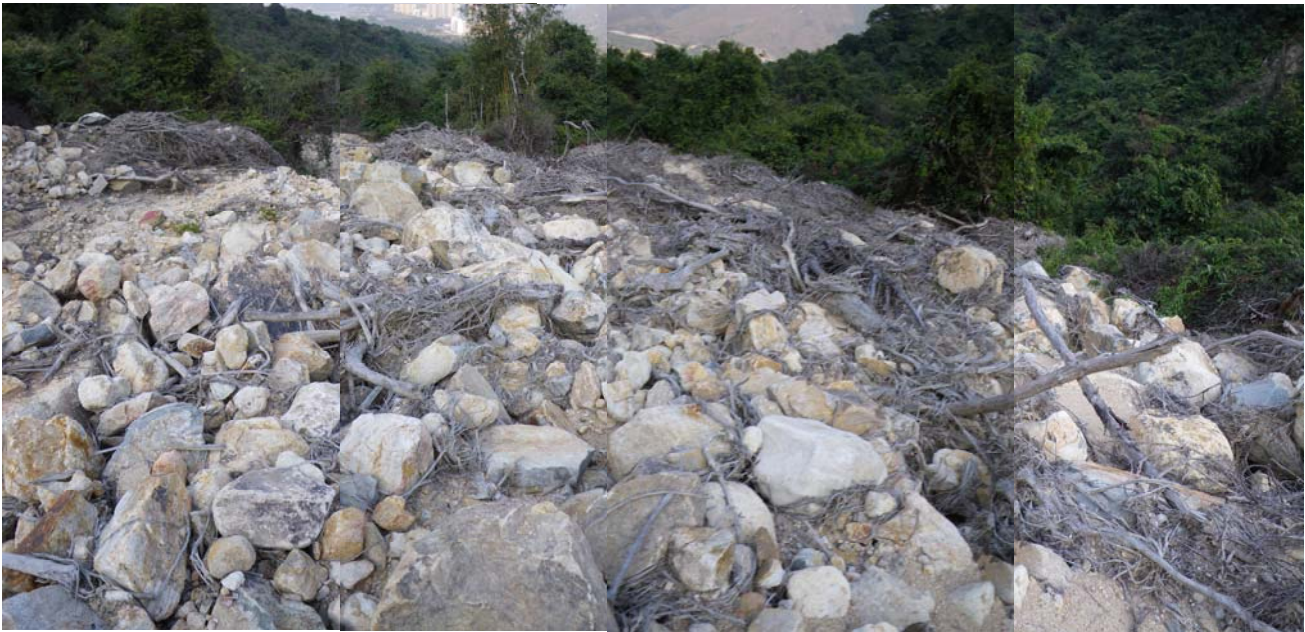
Figure 41: Large boulders and woody debris at the snout of debris flow
(Note: Distal end of the deposition zone of the June 2008 Shek Mun Kap debris flow at about 1 km from the landslide source is shown)
