Evolution of Natural Terrain Hazard Assessment Strategy in Hong Kong

Geotechnical Engineering Office, Civil Engineering and Development Department, The Government of the HKSAR

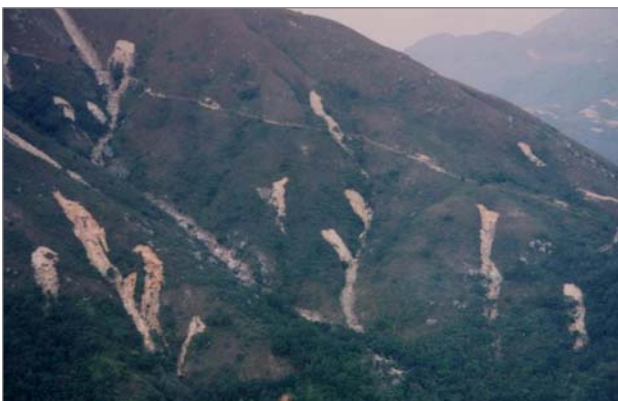
Fig. 1. Landslide-prone natural terrain in Hong Kong

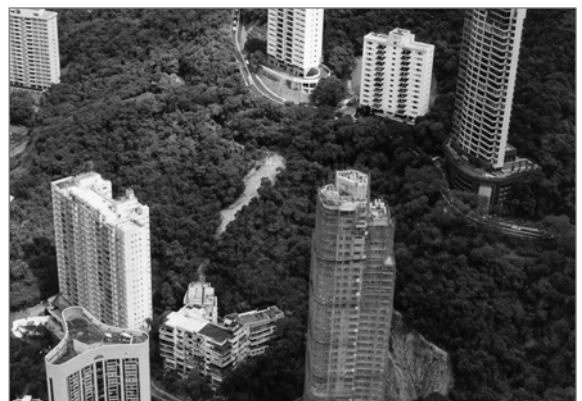
Fig. 2. A relatively modest 50 m³ landslide in 1998 had resulted in damage to property

Most of natural terrain landslides in Hong Kong are triggered by intense rainfall whilst in some cases very short-duration rainstorm can trigger numerous landslides. Hong Kong's natural terrain is especially susceptible to shallow (typically <3 m), small to medium-sized (typically several hundred cubic metres) landslides (Fig. 1), which could develop into debris flows when the debris enters into drainage lines (Wong *et al.*, 1998, Wong & Ho, 2000). Sizeable failures are rare but when they occur, they are mostly related to the presence of adverse geological conditions (e.g. Shum Wan Road Landslide in 1995) or significant entrainment along the debris flow path (e.g. Tsing Shan Debris Flow in 1990). In densely developed hillsides, there could be serious consequences even if the volume of the landslide is relatively small (Fig. 2).

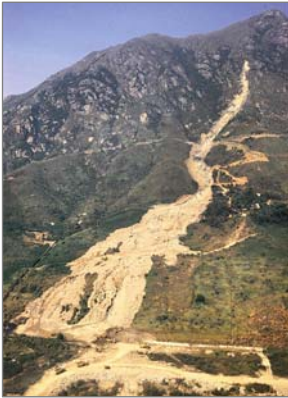
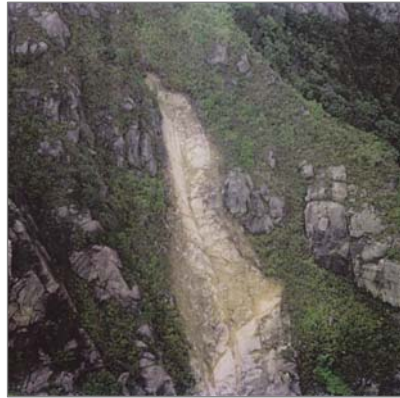
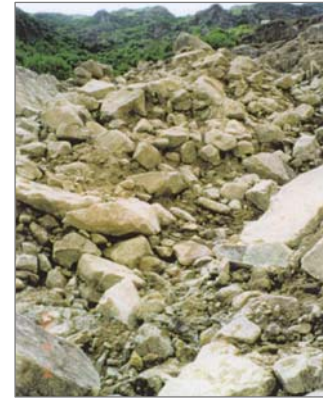
Fig. 3a. General view of the 1990 Tsing Shan debris flow

Fig. 3b. Trigger landslide

Fig. 3c. Eroded remains of the valley-side fan

The landslide started off as a relatively modest debris avalanche of about 350 m³ at the landslide source. It developed into a 20,000 m³ mobile debris flow through material entrainment along the drainage line, with a total runout distance of about 1 km (Figs. 3a, 3b, 3c). This debris flow is regarded locally as an example of a low-frequency, large-magnitude landslide (King, 1996), and has been referenced internationally as a case that illustrates very high debris flow entrainment (e.g. Jakob & Hungr, 2005).

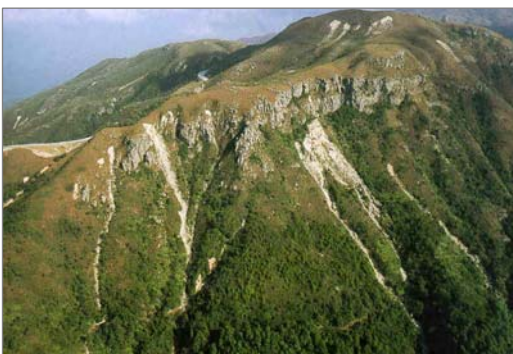
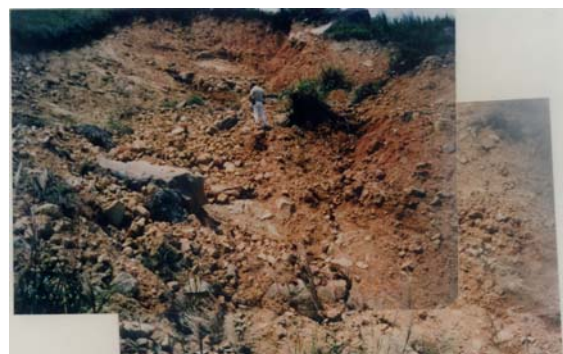
Fig. 4a. The 1993 natural terrain landslides on Lantau Island

Fig. 4b. View of a landslide scarp from the debris trail

In early November 1993, over 800 natural terrain landslides on Lantau Island (Figs. 4a, 4b) were triggered by a severe rainstorm. The landslides resulted in blockage of roads and catchwaters. As Lantau Island was largely undeveloped at that time, there were no landslide related casualties. In early 1994, the GEO commenced a study on the natural terrain landslides, with the objectives to collect information on the landslides, assess the characteristics and mechanisms of the failures, and to examine the mobility of the debris movement.

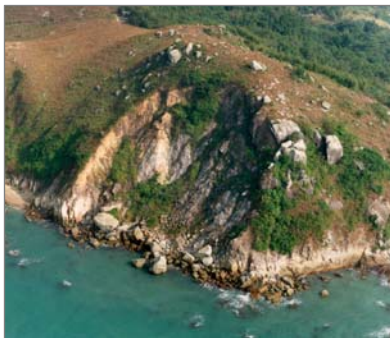
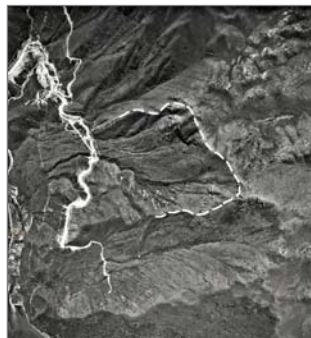
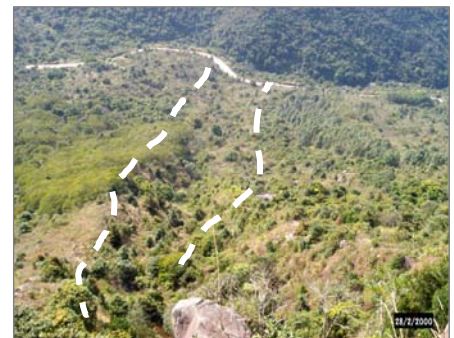
Fig. 6a. Large coastal landslide on Lamma Island

Fig. 6b. Massive debris lobe at Sham Wat, Lantau Island

Fig. 6c. Large relict landslide above Tung Chung Road, Lantau Island

About 1,900 large natural terrain landslides were compiled based on the interpretation of aerial photographs and hillside geomorphology (Scott Wilson, 1999a, b). These large landslides included large relict morphological features, as well as recent natural terrain failures. Some examples of the identified large relict landslides are shown in Figs. 6a, 6b, 6c.

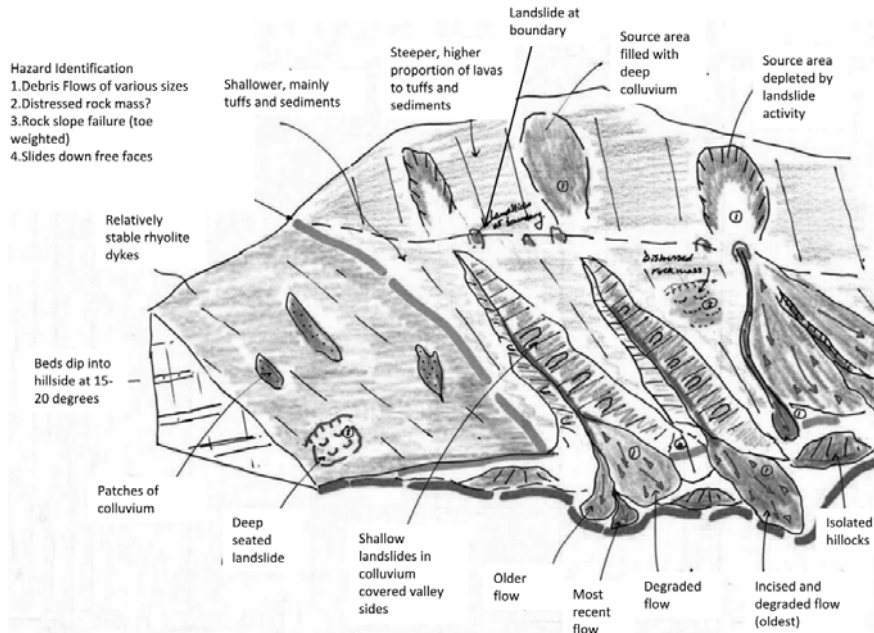
Fig. 11. Reconnaissance geomorphological map for North Lantau (Arup, 2004)

The natural terrain hazard assessment may be conducted using either the QRA approach or the Design Event approach. Regardless of the approach, engineering geological / geomorphological assessment was considered essential in assessing the potential landslide hazards for the sites. There has been continual development of natural terrain related engineering geological / geomorphological mapping techniques in this period. Valuable results were reported with the use of geomorphological assessments, e.g. Arup (2004) (Fig. 11). Along with various regional and site specific NTHS, valuable experience and enhanced engineering geological / geomorphological mapping skills were developed which led to consolidation of knowledge and experience on geomorphological mapping for NTHS (GEO, 2004; Parry & Ng, 2010; Parry, 2011).

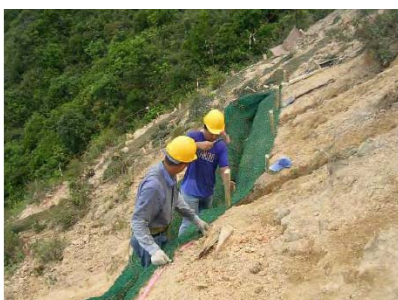
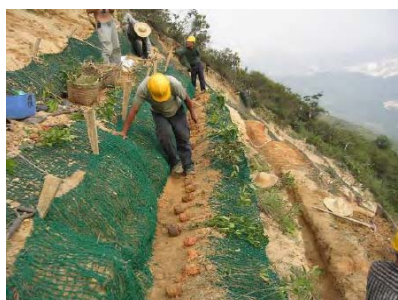
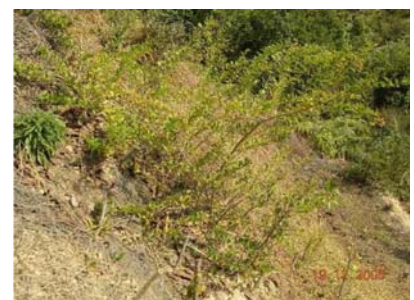
(a) Lining the hedgelay bench with degradable erosion control mat

(b) Laying out rooted plants for hedgelay installation

(c) Established hedgelay after one year

Fig. 12. Some bioengineering works carried out in Cloudy Hill as part of the soil bioengineering study

In April 2003, the GEO undertook a pilot project to assess the suitability of soil bioengineering measures for minimising the deterioration of natural slopes in areas of natural terrain affected by recent, shallow landsliding and related gully erosion. The objectives were: (i) to identify measures that are capable of reinforcing the soil mass, and thereby increase the resistance of the slope to further erosion, and (ii) to identify means of accelerating the natural re-vegetation of deteriorating slopes, which in turn would enhance the local ecosystems. This project, which included field trials on several natural hillsides (Fig. 12), has led to the development of the 'Guidelines for Soil Bioengineering Application on Natural Terrain Landslide Scars' (Campbell *et al.*, 2008).

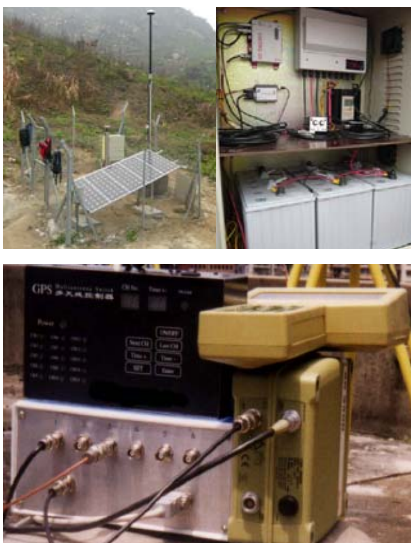
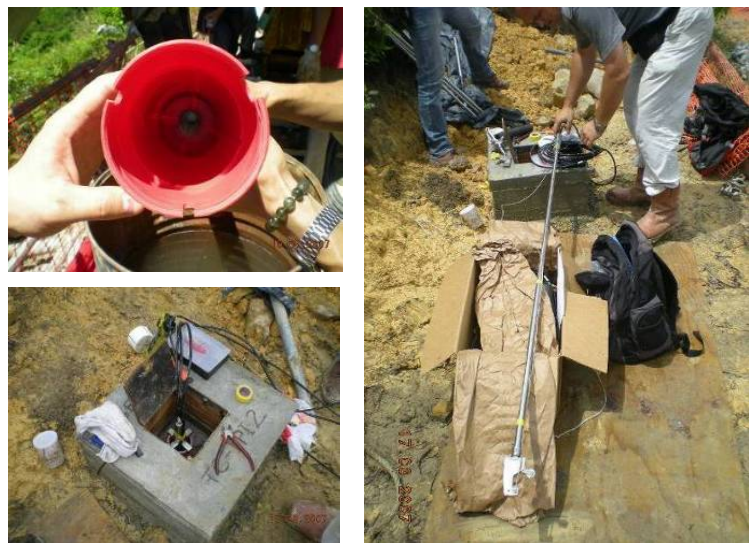
Fig. 13a. DGPS (top) monitoring equipment and (bottom) multi-antenna system (Millis *et al.*, 2008)

Fig. 13b. Inclinometer monitoring system (Millis *et al.*, 2008)

The field instrumentation works were completed in late 2007 and the real-time monitoring system at the four selected hillsides was operational from March 2008 for a period of three years. The monitoring data collected included records from several notable rainstorms in 2008. A wide range of conventional and state-of-the-art geotechnical sensors, e.g. multi-antenna type differential global positioning system (DGPS) (Fig. 13a), ground movement Time Domain Reflectometry (TDR), in-place inclinometers (Fig. 13b), real-time data communication and geotechnical data processing system were installed. Collaborative studies were also carried out with local tertiary institutions (e.g. Leung *et al.*, 2011).

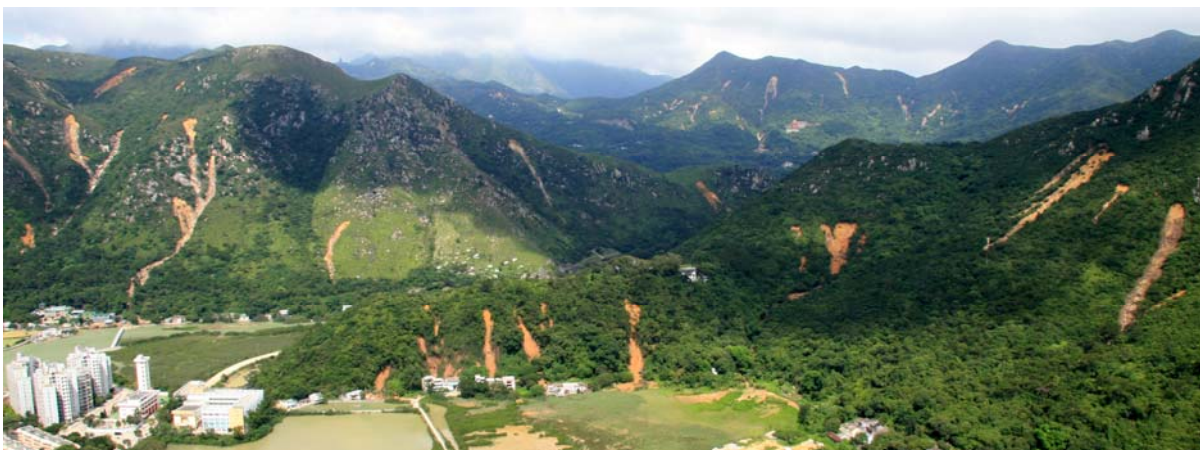
Fig. 19. Example of landslide clusters in West Lantau from the June 2008 rainstorm

The severe rainstorm of 7 June 2008 had its peak over the western part of Lantau and caused over 1,000 natural terrain landslides in the region. Many of the sizeable natural terrain failures developed into debris flows and affected developed areas (Fig. 19), resulting in evacuation of village residents and road closures. Following this rainstorm, the GEO commissioned a regional natural terrain hazard study of West Lantau (c.18.5 km²). Its main purpose was to undertake a regional scale natural terrain hazard review for the study area with the purpose of ranking landslide risk within natural hillside catchments and prioritising the implementation of more detailed hazard studies and where necessary, mitigation works.

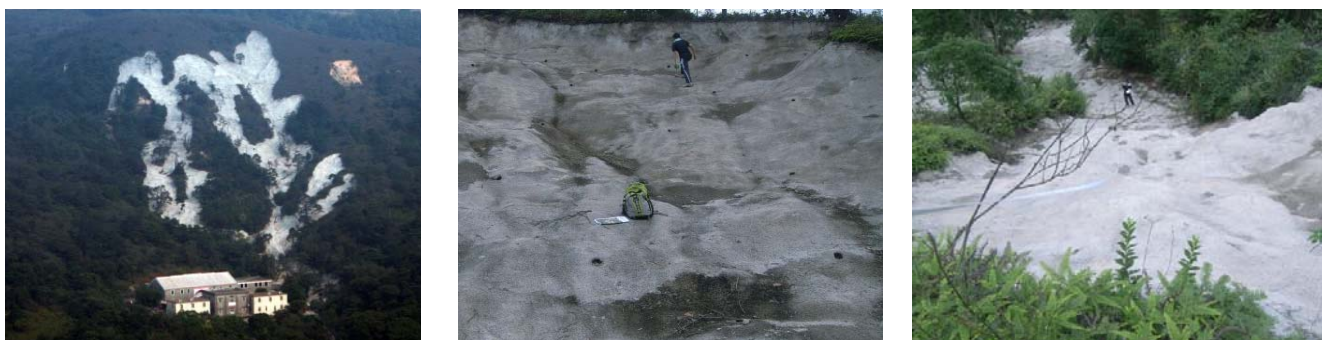
(a) General view
 (b) Landslide scar
 (c) Landslide trail
 Fig. 23. Shotcreting works on the landslide scar in Upper Keung Shan

The review indicated that a study area at Upper Keung Shan has potential for the implementation of soil bioengineering measures. The study area was subjected to extensive landsliding during the June 2008 rainstorm, resulting in a large portion of the catchment (some 3,900 m² in plan area) being covered in shotcrete as a result of landslide emergency works (Fig. 23). As such, it provides an ideal site for comprehensive implementation and long-term monitoring of the effectiveness of soil bioengineering measures. Following the implementation of soil bioengineering measures, detailed review of the performance and effectiveness of the works will be carried out. The completion of such works will enhance the state of knowledge regarding the effectiveness of soil bioengineering works in Hong Kong and will facilitate further review and updating of existing guidelines, where appropriate.

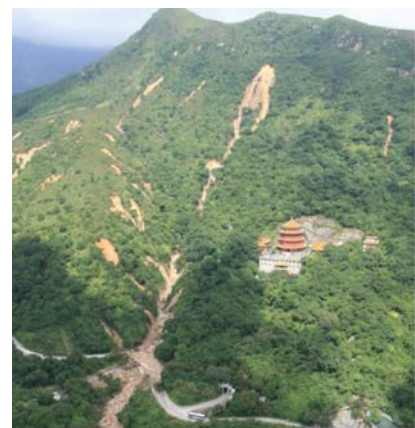
Fig. 26. Oblique photo of the Keung Shan Road site after June 2008 rainstorm

Under the same rainstorm, the drainage catchment at Keung Shan Road site experienced some 18 landslides (Fig. 26). As a result, a rigid barrier was built at the mouth of the drainage line which is considered sufficiently robust to mitigate hazards within the catchment. Given the propensity of the terrain above the rigid barrier to channelised debris flows and the fact that such hazards have been mitigated against, this catchment is considered suitable for instrumentation purposes. The proposed instrumentation works include surface and sub-surface ground movement, rainfall, groundwater levels, fluvial activity along the drainage lines and potential debris flow behavior.

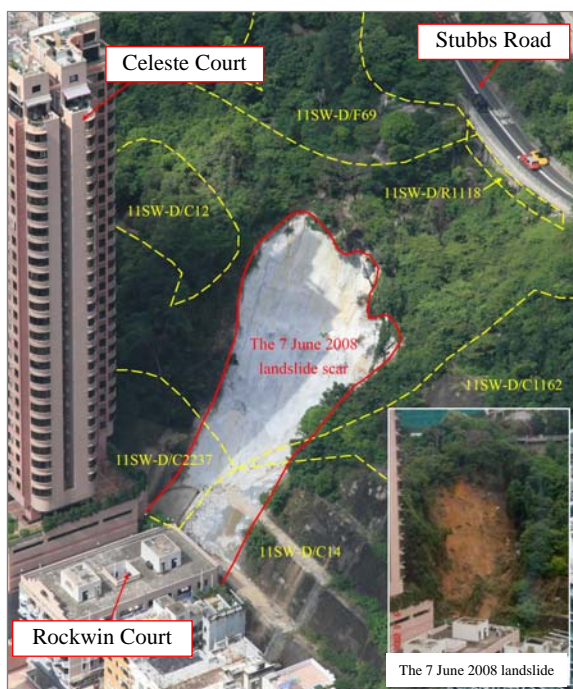
Fig. 27. Examples of failures within hillside pockets

Given the history of infrastructure and building developments at Hong Kong's foothills, small tracts of hillsides flanking developed areas (referred to as 'hillside pockets') are common. These hillside pockets are affected by human disturbance to varying degrees (e.g. construction of roads or building platforms). Landslides are found to occur at the hillside pockets from time to time, e.g. landslide that occurred below Broadwood Road and above San Francisco Towers as well as landslide below Stubbs Road and above Rockwin Court, Fung Fai Terrace (Fig. 27) during the severe rainstorm on 7 June 2008 (see Section 5.4.2). For the one at San Francisco Towers, a subsequent landslide investigation revealed that the failure was initiated from an unregistered fill body below Broadwood Road.
