Is landslide risk quantifiable and manageable?

H.N. Wong

Civil Engineering and Development Department, Geotechnical Engineering Office, Government of the Hong Kong Special Administrative Region, Hong Kong, China

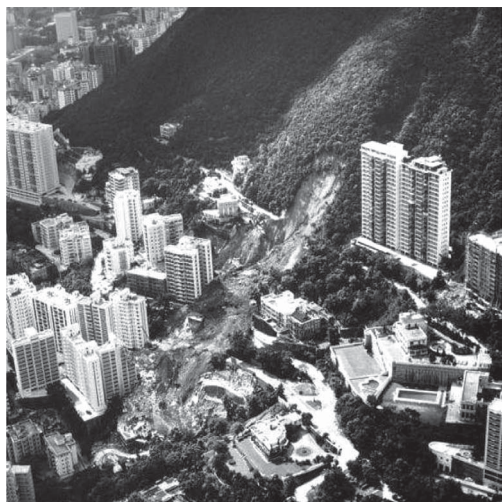
Figure 2. The Po Shan landslide on 18 June 1972.

Heavy rainfall is often one of the aggravating factors of construction-induced landslides. The most notable example in Hong Kong is the Po Shan landslide on 18 June 1972 (Fig. 2), which resulted in the collapse of the 15-storey Kotewall Court and 67 fatalities. The cause of the landslide was attributed to poorly executed site formation works which undermined the stability of the hillside and resulted in a catastrophic failure when hit by heavy rain.

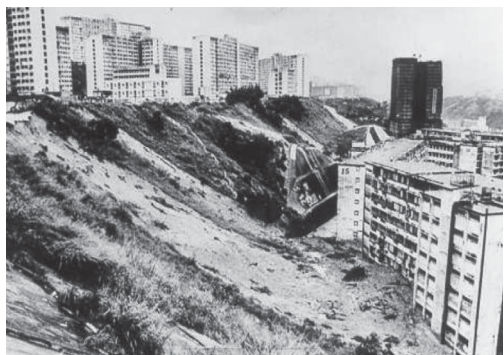
Figure 3. Fill slope failure at Sau Mau Ping on 25 August 1976.

A notable example of failure of unengineered slope triggered by heavy rainfall was the collapse of a fill embankment at Sau Mau Ping in 1976 where landslide debris punched through the ground floor of Block 9 of Sau Mau Ping Estate

killing 18 people (Fig. 3). Subsequent investigation revealed that the loose sandy fill materials in the surface 3 m of the slope had undergone liquefaction failure when it became saturated in the heavy rain (Morgenstern 1978).

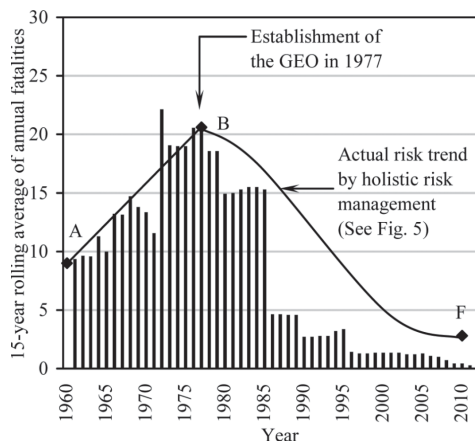
Figure 4. 15-year rolling average of historical annual landslide fatalities in Hong Kong.

Figure 4 shows the rolling 15-year average values of the annual fatalities, which depict the historical landslide risk trend in Hong Kong. Figure 5 presents diagrammatically the calculated

The global QRA conducted on the unengineered slopes in Hong Kong has given results with good reliability, as is also illustrated by the good match of the calculated risk figures with the historical landslide risk trend (Fig. 4).

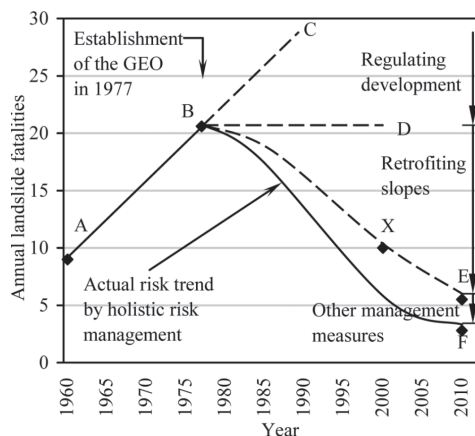
Figure 5. Landslide risk trends in Hong Kong.

landslide risk trend for this category of slopes in Hong Kong, as assessed by global QRA.

In 1977, territory-wide geotechnical control was introduced by the GEO to ensure that newly formed slopes in Hong Kong are designed and built to the required standards of safety. Since then, the increasing risk trend has levelled off, i.e. turned from line BC to line BD in Figure 5, despite that an additional more than 20,000 sizeable man-made slopes have been formed as a result of urban development in Hong Kong. Since 1977, the outcome of the retrofitting effort under the LPM Programme is progressive risk reduction along Line BE (Fig. 5). From a global QRA, the calculated overall landslide risk in year 2000 is 50% of that in 1977 (Cheung & Shiu 2000), i.e. Point X in Figure 5. It was also found that by year 2010, the retrofitting works should have brought the overall risk level to within 25% of that in 1977 (Cheng 2011), i.e. Point E.

(Line BE) that accounts only for the effect of slope retrofitting works. Over the past 20 years, the actual annual landslide fatalities in Hong Kong have been consistently less than the theoretical risk level by at least 50%. The overall risk trend suggests that the contribution of the non-works initiatives to reduction of landslide risk in Hong Kong could be fairly significant. As an illustration, in the past 20 years, the number of Landslip Warnings issued, landslide incidents reported, buildings and people temporarily evacuated, and sections of road closed as a result of the landslide emergency responses of the GEO and the community are shown in Table 2.

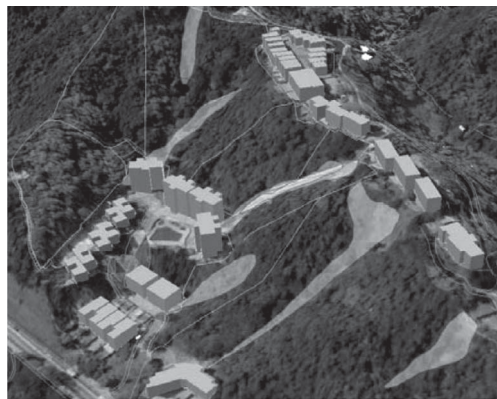
Site-specific QRA, on the other hand, facilitates a rational consideration of risk tolerability and evaluation of risk mitigation strategy at a particular locality. This is where state-of-the-art quantified risk management is usefully applied. For example, a natural terrain landslide hazard study has been carried out at Sha Tin Heights, Hong Kong (Fig. 6) following six landslides in 1997, three of which developed into debris flows that affected residential buildings. QRA was used to evaluate the acceptability of risk levels (Fig. 7) and the cost effectiveness of risk mitigation strategies. Risk mitigation works were completed in 2004.

Figure 6. Residential buildings affected by landslide hazards at Sha Tin Heights (after Wong & Ho 2005).

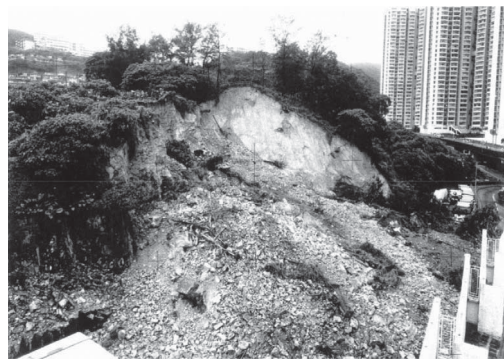
Figure 8. Failure of cut slope at Fei Tsui Road on 13 August 1995.

- i. The 13 August 1995 landslide at Fei Tsui Road (GEO & Knill 1996) involved a large-scale failure ($14,000 \text{ m}^3$) of a 27 m high engineered cut slope that had no structural support (Fig. 8).

A total of 370 mm rainfall was recorded at the site within 24 hours before the landslide, and the 31-day rainfall of 1303 mm exceeded the highest calendar monthly rainfall ever recorded by the rain gauge at the Hong Kong Observatory since records began in 1884. The landslide consisted of a translational failure with the detached ground mass sliding on a surface dipping gently out of the slope. Large failures of this type are unusual in Hong Kong. The post-failure investigation established that the basal slip surface of the landslide developed along a laterally extensive ($>50 \text{ m}$) weak layer of kaolinite-rich altered tuff, which was about 15 m below the crest of the cut slope and dipping out of the slope at about 10° to 25° . The failure caused one fatality.

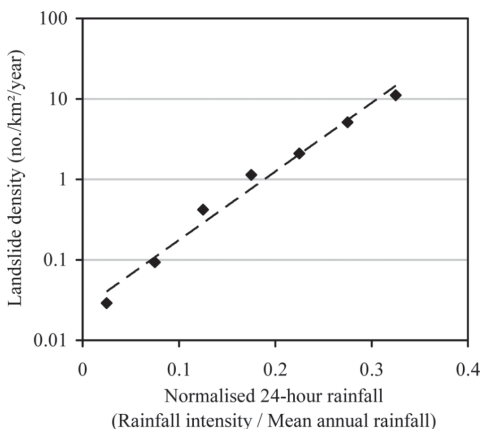
Figure 10. Correlation between rainfall and natural terrain landslide density.

Natural terrain in Hong Kong also exhibits instability that resembles this category of landslide problem, in that natural terrain tends to respond vigorously to severe rainfall. Ko (2005) established from detailed rainfall and natural terrain landslide correlations that the density of natural terrain landslides increases exponentially with rainfall intensity (Fig. 10). Under moderate to heavy rainfall conditions, there are generally few failures on natural terrain in Hong Kong. However, when rain becomes severe, e.g. when 20% or more of the average annual rainfall is recorded within 24 hours, widespread natural terrain landslides tend to occur. For instance, in the June 2008 rainstorm, Lantau Island was subjected to a maximum of 623 mm rainfall in 24 hours, with a statistical return period of about 200 years. The 4-hour rainfall of 384 mm in the rainstorm was most severe, which measured over 1000-year return period. More than 2400 natural terrain landslides occurred during the

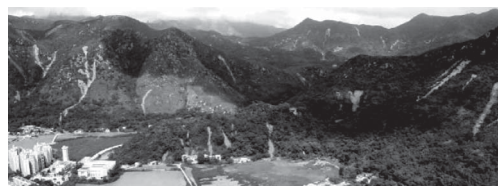
Figure 11. Natural terrain landslides at Tung Chung, Lantau Island during the June 2008 rainstorm.

rainstorm (Fig. 11). Furthermore, it was evident that the scale of the natural terrain landslides and the mobility of the landslide debris also increased drastically under such extreme rainfall (Wong 2009b).
