風雨同渡五十載

Weathering the Elements Together

回溯過去半世紀香港斜坡安全的發展 居安亦思危

A look back on the development of slope safety in Hong Kong over half a century in preparation for the challenges ahead

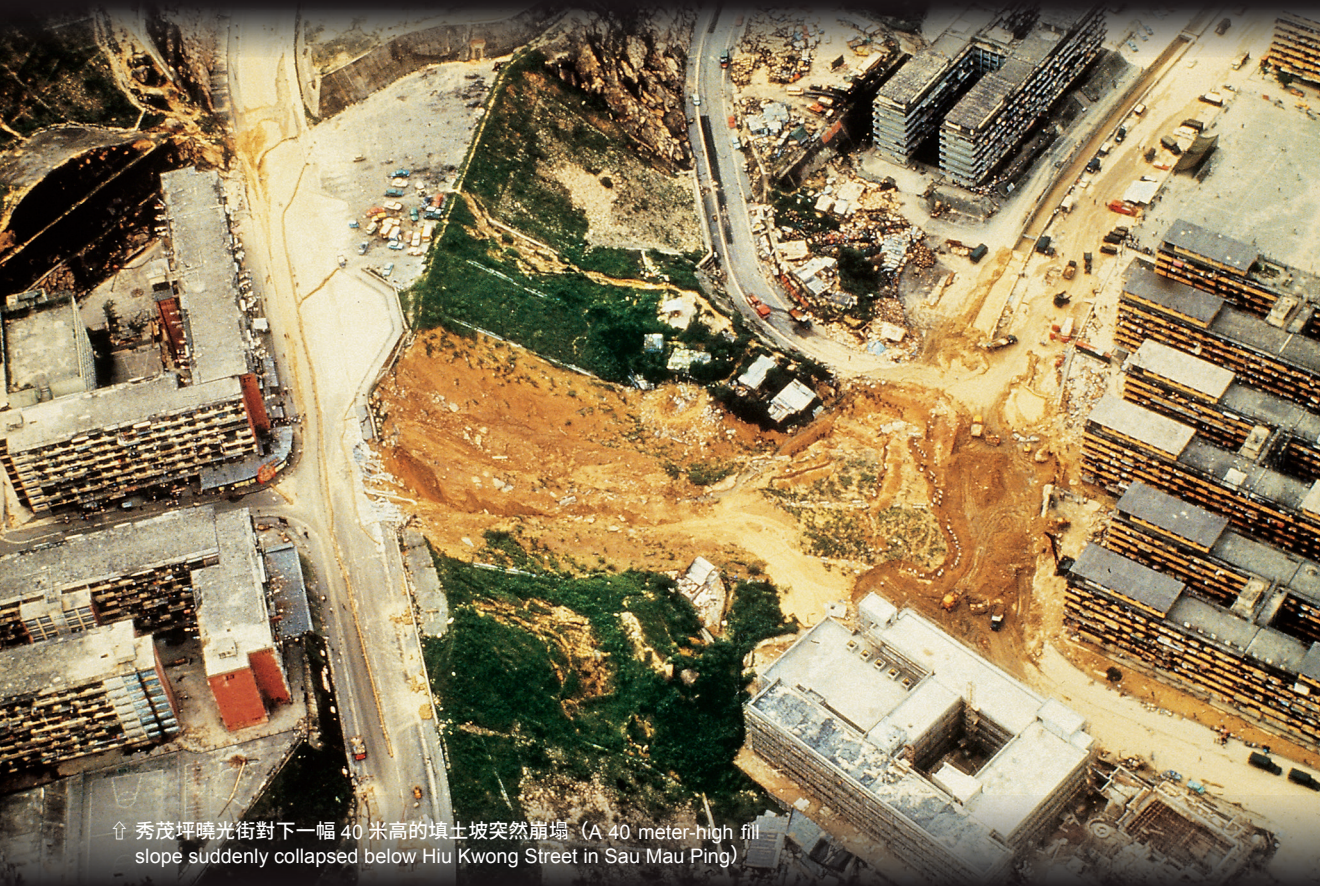
↑ 秀茂坪曉光街對下一幅 40 米高的填土坡突然崩塌 (A 40 meter-high fill slope suddenly collapsed below Hiu Kwong Street in Sau Mau Ping)

1972年6月16日，大雨開始下過不停。三天之內，天文台錄得共653毫米的雨量，每日雨量超過200毫米，是有紀錄以來6月份連續三日最高降雨量，差不多是全年平均雨量的三成。就在6月18日的中午時分，秀茂坪曉光街對下一幅40米高的填土坡突然崩塌，大量泥土一湧而下，數秒之間淹蓋了臨時安置區內的78間木屋，多達71人死亡。

土力工程處處長張偉文博士闡述「六一八」事件的成因：「秀茂坪塌下的山坡在60年代其實是一個山谷，後來在附近找來泥土填成山坡。當時沒有岩土工程設計概念，斜坡工程的施工準則和監督亦沒有像現時般嚴謹，估計當時填泥非常鬆散。連場大雨之下，液化了的泥土就好像地氈一樣滑下。而寶珊道對上是一幅天然山坡，山坡倒下的時候就好像滾雪球一樣，最後有約2萬立方米的泥石沖了下來。我們的調查找出了三大成因：首先是山坡的土質容易讓水滲透，其次是

Dr. Raymond Cheung, Head of the GEO, explained how the 6.18 Landslide Disaster happened. “The collapsed slope at Sau Mau Ping was a valley in the 1960s and became a fill slope afterwards. As people didn’t have much idea about geotechnical design and the requirements for slope works were not as stringent as they are nowadays, we can assume that the soil was very loose at that time. After continuous downpours, the soil became liquified and slid down like a carpet. As for Po Shan Road, it involved a natural hillside. When it collapsed, it gathered momentum and the situation snowballed. As much as 20,000 cubic meters of mud was washed down. According to the investigation

after the incident, there were three causes. First of all, the soil was highly permeable. Secondly, the unusual continuous downpours gave rise to a surge in the groundwater level. Lastly, a construction site nearby was conducting deep excavation works and the lack of adequate support caused the soil to collapse.”

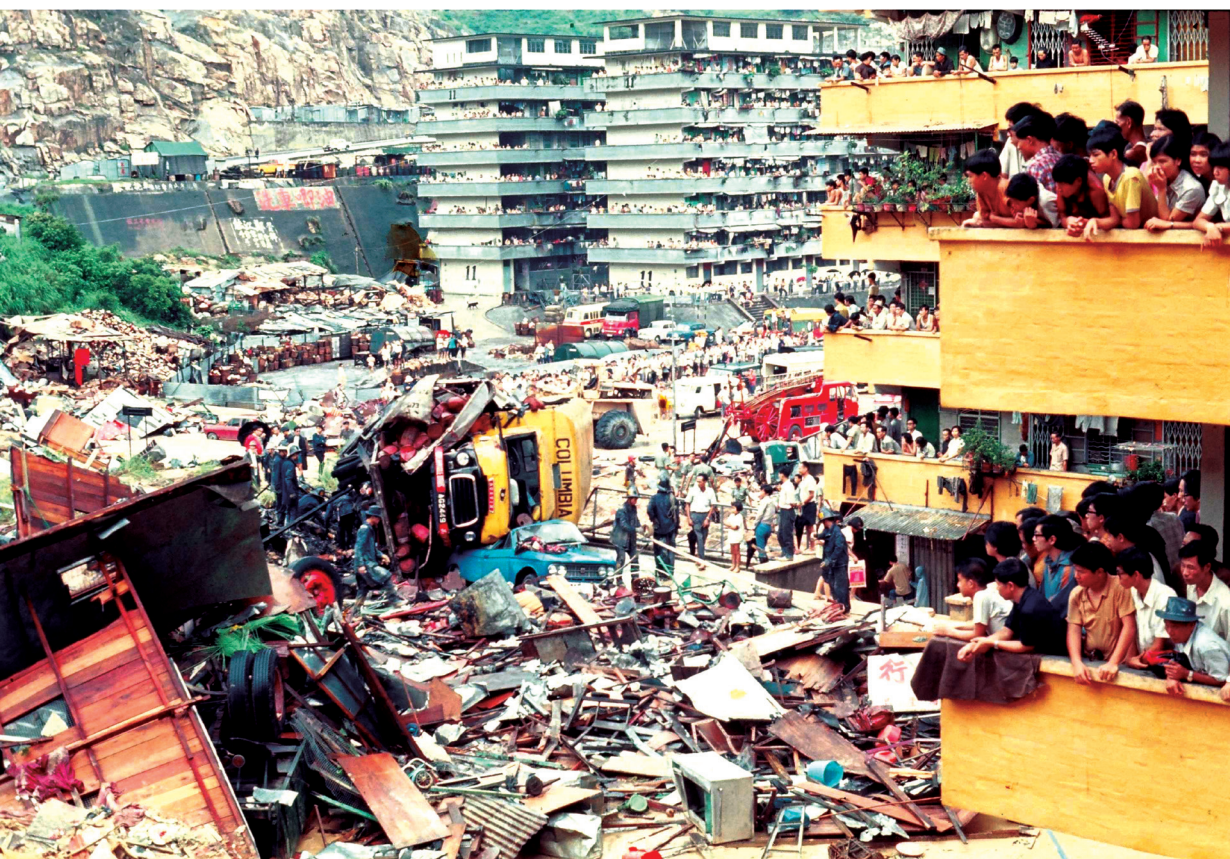
↑ 秀茂坪山泥傾瀉的災區 (The landslide disaster area of Sau Mau Ping)

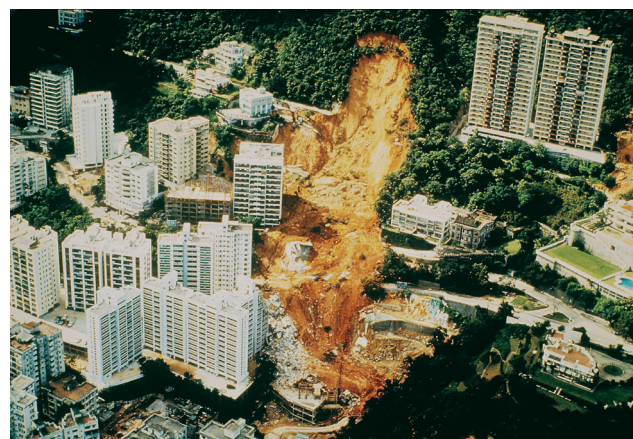
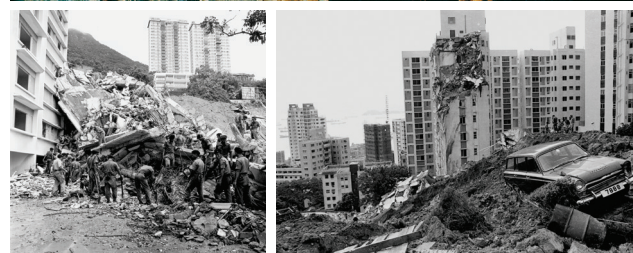
↑ 寶珊道山泥傾瀉的情景 (The aftermath of the landslide at Po Shan Road)

禍不單行，當晚接近九時，港島半山寶珊道附近一幅天然山坡突然崩塌。泥石帶着巨大動能捲走旭龢道11號一幢六層高的建築

物，並繼續沖向12層高的旭龢大廈，將它徹底摧毀。倒塌的旭龢大廈撞上旁邊一幢尚未入伙的建築物，將它最高的四層削去。山泥傾瀉持續不足十秒，67人被奪去性命。

The troubles did not end there. Shortly before 9 p.m. on the same day, a natural hillside above Po Shan Road in the Mid-Levels of Hong Kong Island tumbled down. The landslide debris gathered momentum as it washed down, striking a six-storey building at No. 11 Kotewall Road and the 12-storey Kotewall Court, causing both to collapse completely. The collapsing Kotewall Court struck another unoccupied building next to it and shaved off the top four storeys. The landslide, lasting less than 10 seconds, took 67 lives.

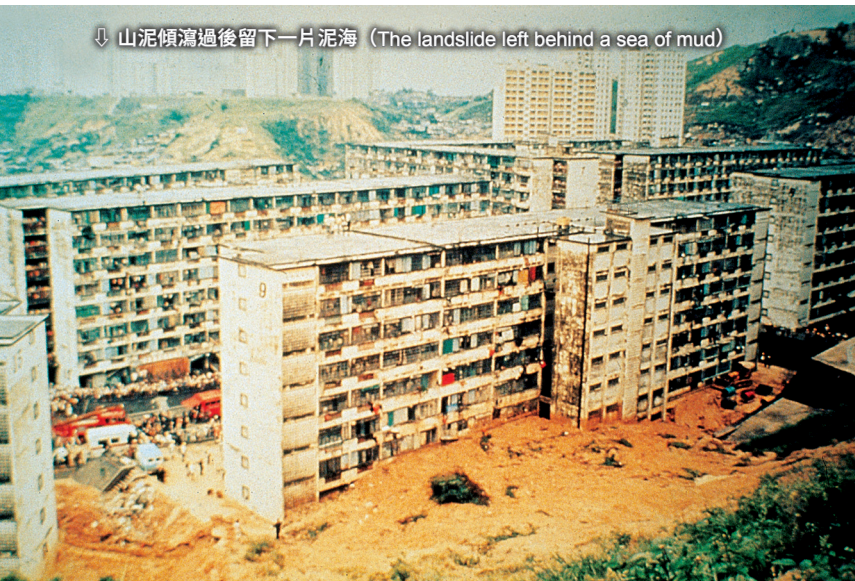
↓ 山泥傾瀉過後留下一片泥海 (The landslide left behind a sea of mud)

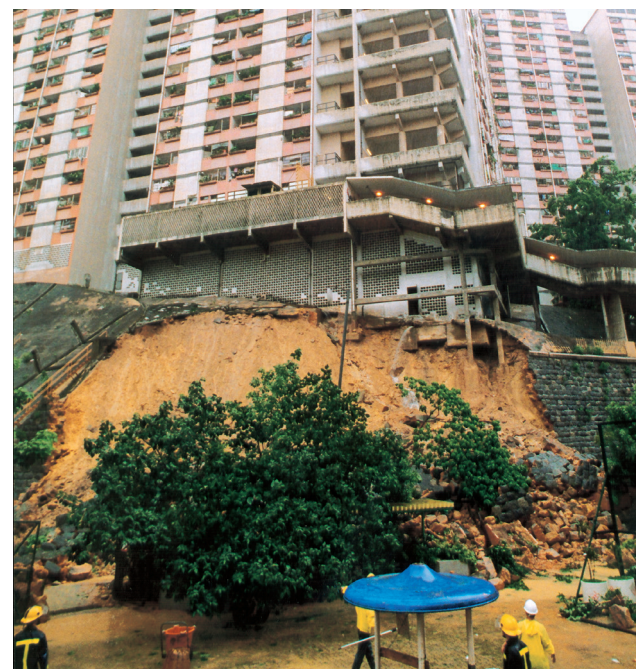
↑ 觀龍樓 D 座對下砌石牆及斜坡塌下，部分地基外露。(The masonry wall and a slope below Block D of the Kwun Lung Lau building collapsed, exposing part of the foundation.)

1994 年 7 月 23 日，天文台發出山泥傾瀉警告，大雨持續 48 小時未有休止。堅尼地城觀龍樓 D 座對下的部分砌石牆及斜坡突然塌下，導致 5 名途人遇難。當時率先到達現場的消防車，剛巧由曾經參與「六一八」事件救援工作的胡強擔任主管。他憶述拯救的難度：「現場漆黑一片，我們只聽到泥石下傷者求救的聲音。其中一位生還者不斷請求我們先救她的女兒，但因為位置的關係，我們得先移開山泥救出那位母親，然後再徒手挖掘半小時左右，才可以把她的女兒救出。」

On July 23, 1994, the Hong Kong Observatory issued a landslip warning amid almost 48 hours of torrential rain. At the Kwun Lung Lau building in Kennedy Town, part of the masonry wall and a slope below Block D suddenly collapsed, killing five people. The first fire engine on the scene happened to be under the charge of Wu Keung, who had participated in the rescue operation of the 6.18 Landslide Disaster. He recalled how difficult it was to rescue the survivors, “The site was in complete darkness and we could only hear survivors crying for help under the debris. One of them kept asking us to help her daughter first. However, we had to save her first as she was more accessible. We manually removed the debris to get her out and kept digging further with our hands for another 30 minutes or so before we could reach her daughter.”

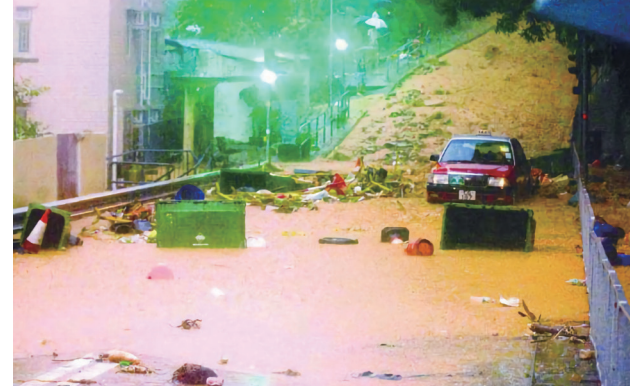
↑ 泥石流湧至荃灣老圍。(The debris flow rushed into Lo Wai, Tsuen Wan District)

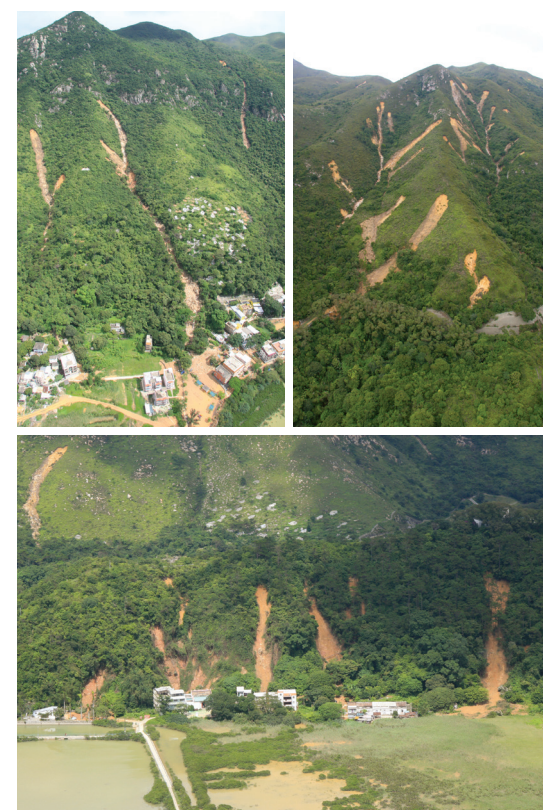
↑ 西大嶼山引發了多宗天然山坡山泥傾瀉。(At the western part of Lantau Island alone there were numerous incidents of natural terrain landslides)

On June 7, 2008, a 4-hour rolling rainfall of 384 mm was recorded at Lantau Island, triggering more than 2,400 natural terrain landslides in the area. One landslide blocked a 200-meter section of the North Lantau Highway with soil debris and muddy water, causing the closure of this artery that connected the city to the Hong Kong International Airport for as long as 16 hours. In the same morning, 13 landslides were reported in the Tai O area, with debris volume ranging from 25 to 2,000 cubic meters, blocking the roads to Tai O. The

2008 年 6 月 7 日，大嶼山 4 小時內錄得的最高雨量達 384 毫米，單在大嶼山就引發了 2,400 多宗天然山坡山泥傾瀉。連接市區與機場的北大嶼山公路有 200 米路段因天然山坡山泥傾瀉而被泥石及洪水淹蓋，截斷了通往機場的重要運輸通道長達 16 小時。同日早上，大澳共有 13 宗山泥傾瀉報告，塌下的山泥體積由 25 立方米至 2,000 立方米不等，堵塞了大澳通往外間的道路，加上流動及固網電訊設備均出現故障、食水供應中斷，數以千計居民的生活大受影響。

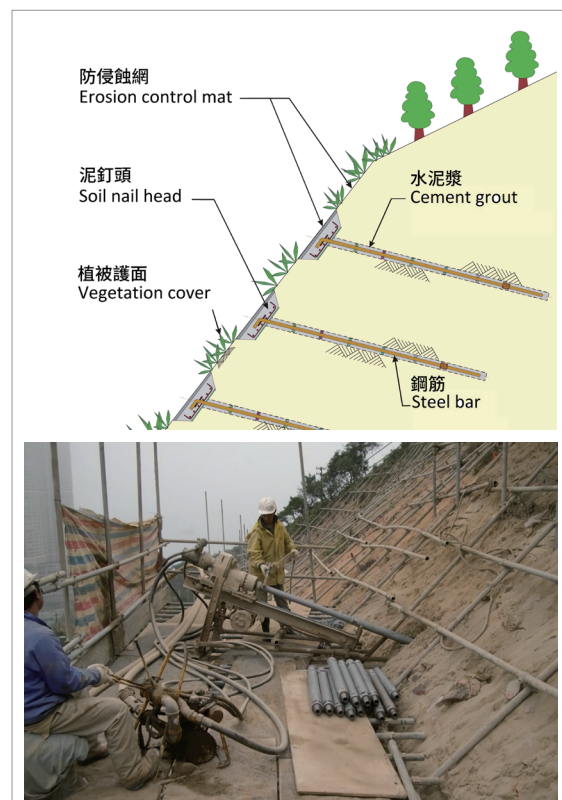
↑ 泥釘工作原理(上)及建造泥釘現場環境。(How soil nails work (upper) and how they are constructed on site)

觀龍樓事件後翌年，政府決定增撥資源，落實「五年加速防止山泥傾瀉計劃」。此外，土力工程處亦成立由國際岩土專家組成的斜坡安全技術檢討委員會，審視及檢討土力工程處在斜坡安全的工作及成效。處方亦對山泥傾瀉的發生進行系統性研究，從而提出改善斜坡設計及建造的建議。此外，土力工程處由九十年代開始使用泥釘加固斜坡，使斜坡安全的情況進一步改善。

In the year after the Kwun Lung Lau incident, the government launched the 5-year Accelerated Landslip Preventive Measures Project to allocate more resources to tackle the risk of landslides. The GEO also set up the Slope Safety Technical Review Board (SSTRB) comprising renowned geotechnical experts from across the globe to examine and review GEO's work and effectiveness in slope safety management. The GEO also conducted systematic studies of landslides to come up with recommendations for improving slope design and construction practice. Apart from this, the GEO started applying soil nails to reinforce slopes in the 1990s, thus further enhancing slope safety in Hong Kong.

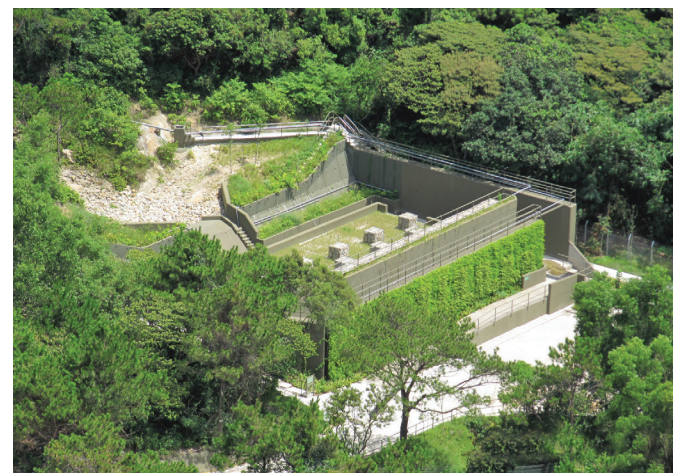
↑ 泥石壩 (Rigid barrier)

為了全面地處理好天然山坡和人造斜坡的山泥傾瀉風險，土力工程處於 2010 年開展「長遠防治山泥傾瀉計劃」。由於天然山坡的覆蓋範圍比人造斜坡大得多，在天然山坡進行大規模的斜坡鞏固工程，勞民傷財之餘，對自然生態亦有嚴重影響。如果採取風險緩減措施，例如透過山坡下的泥石壩和柔性防護網阻擋塌下的泥石湧入民居或道路而造成傷亡，除了成本較低之外，還可以避免

To manage the landslide risks of both natural terrain and man-made slopes in a more holistic manner, the GEO launched the LPMitP in 2010. As natural hillsides cover a much larger area than man-made slopes, it would have been both costly and environmentally damaging to stabilize natural hillsides on an extensive scale. Using risk mitigation measures such as rigid barriers or flexible barriers to prevent debris from reaching houses or roads and resulting in casualties not only comes at a lower cost, but also avoids undue impact to the environment.

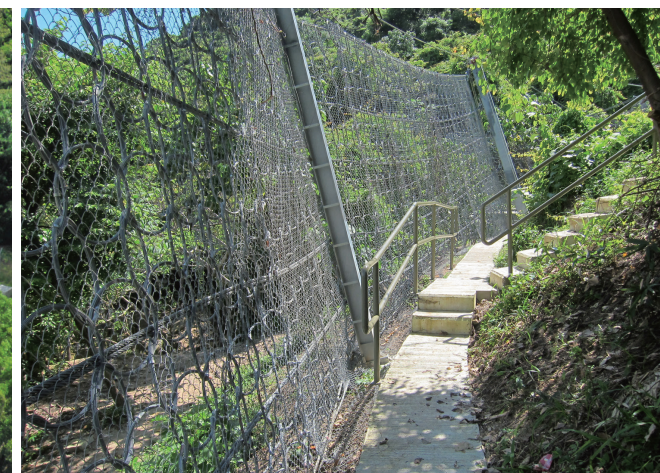
↑ 柔性防護網 (Flexible barrier)

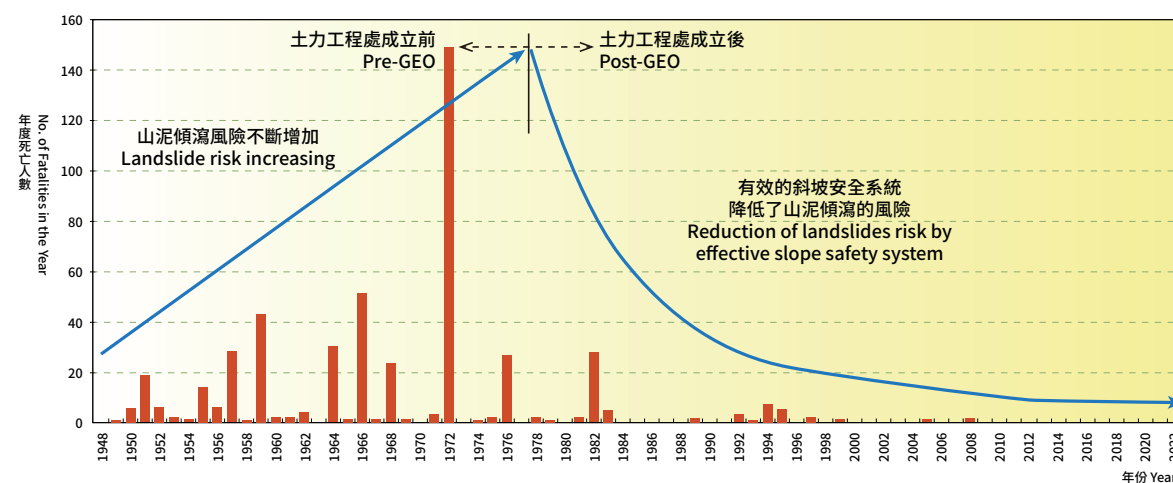
↑ 山泥傾瀉導致的死亡人數 (Number of fatalities caused by landslides)

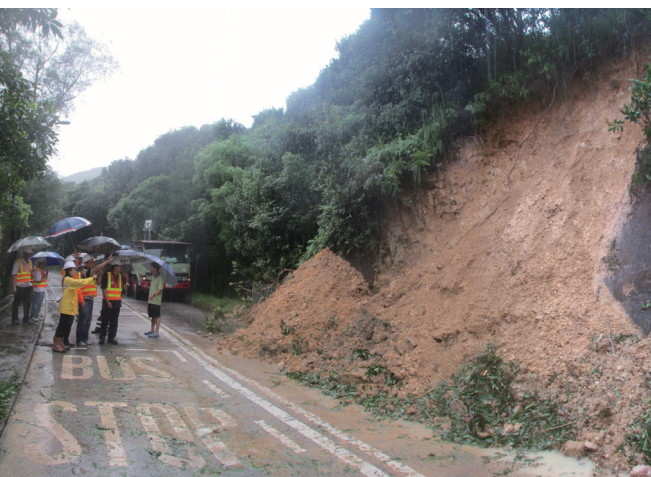
↑ 土力工程師在山泥傾瀉現場視察 (Geotechnical engineers inspect a landslide site)

當天文台發出山泥傾瀉警告或八號或以上熱帶氣旋警告信號時，土力工程處的緊急控制中心便會啟動，由一共十三隊以土力工程師及技術主任所組成的專責隊伍輪班當值。接獲山泥傾瀉報告後，他們會無懼風雨到現場視察，協助各政府部門

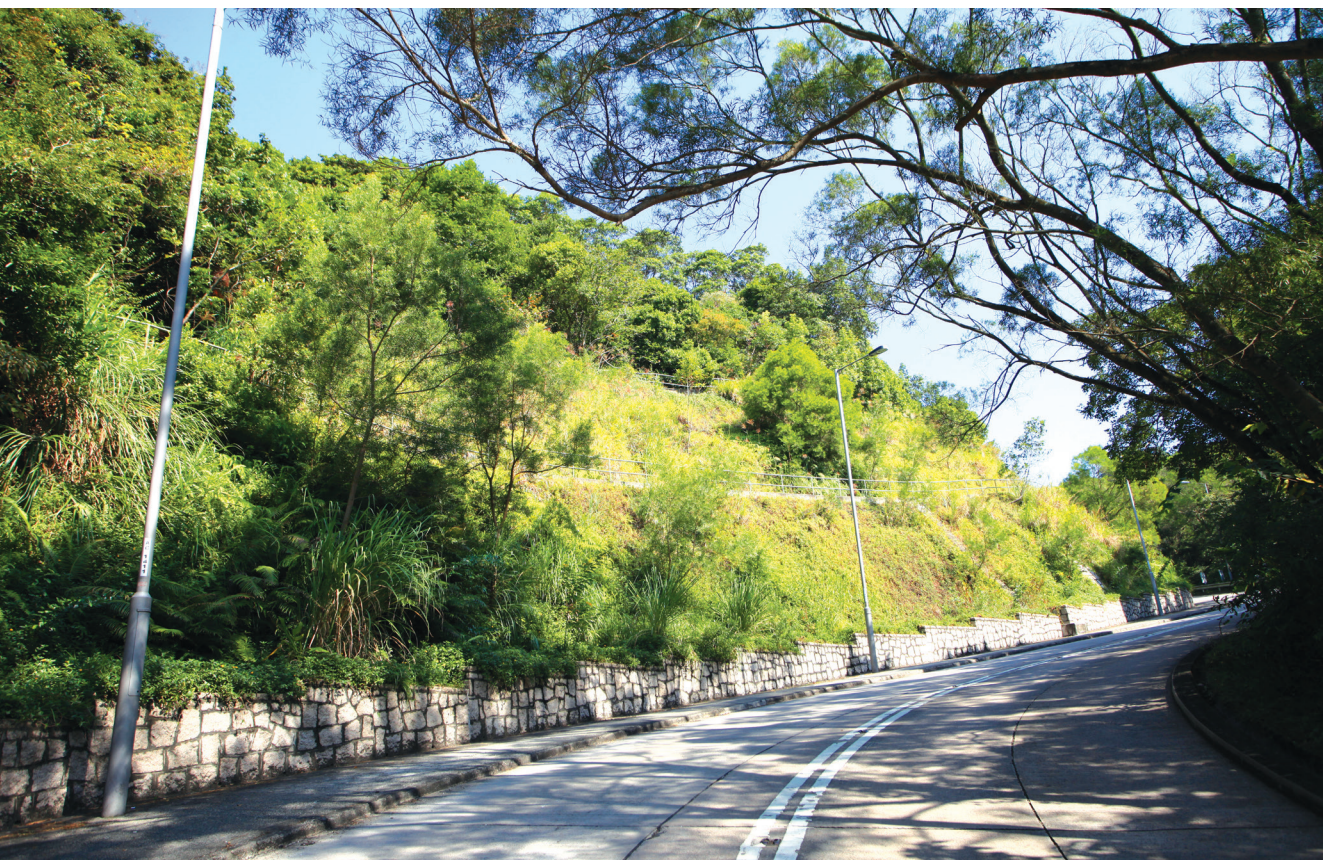
↓ 在斜坡鞏固工程中加入綠化元素 (Greening measures in slope upgrading works.)

除應對極端天氣帶來的挑戰，土力工程處更致力在鞏固斜坡的工作中加入綠化及生態保育等元素，使斜坡與周邊環境融為一體，並建立一個能維持生物多樣化的生態環境。土力工程處副處長（防止山泥傾瀉）許海航表示：「我們會盡量保留原有植物並採用原生物種重鋪人造斜坡植被或修葺山泥傾瀉殘痕。若發現工程範圍或其附近存在稀有動植物品種，我們會對其加以保護，並在有需要時進行生態調查。」

Besides combating the challenges of extreme weather, the GEO also adopts greening and conservation measures in slope upgrading works so that the slopes blend in with the surrounding environment and foster biodiversity. Thomas Hui, Deputy Head of the GEO (Landslip Preventive Measures) said, "We'll try our best to keep the original plants and use native species for restoring vegetation covers on man-made slopes or landslide scars wherever practicable. If we find rare animal and plant species within or near the project area, we'll exercise special care to conserve them and conduct an ecological survey if needed."

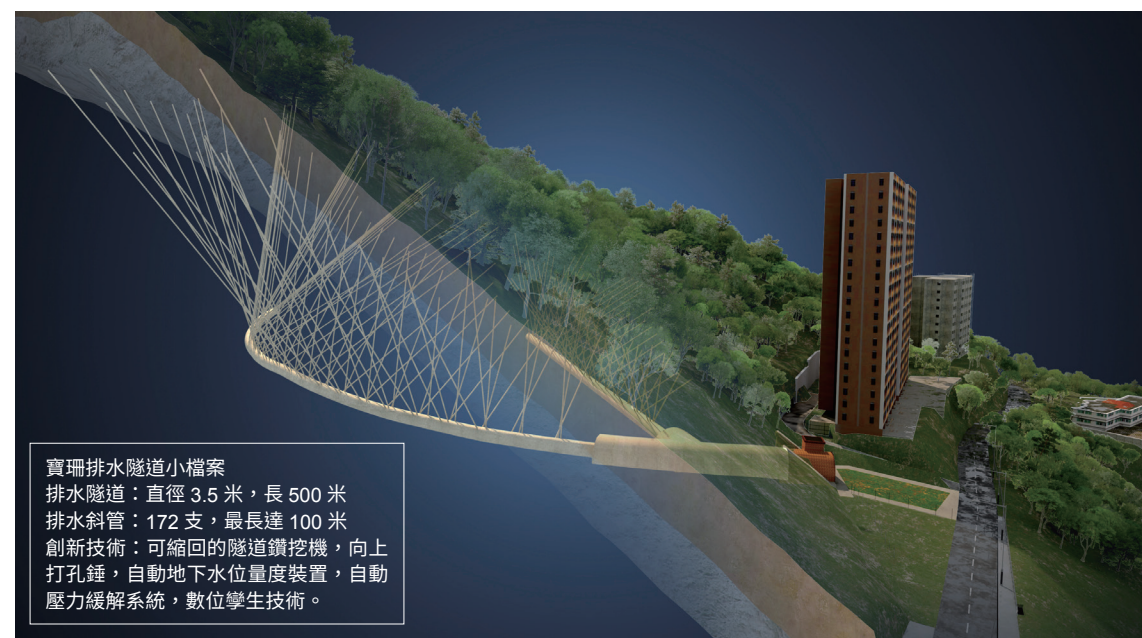
寶珊排水隧道小檔案
排水隧道：直徑 3.5 米，長 500 米
排水斜管：172 支，最長達 100 米
創新技術：可縮回的隧道鑽挖機，向上打孔錘，自動地下水位量度裝置，自動壓力緩解系統，數位孿生技術。

↑ 寶珊排水隧道的原理 (How the Po Shan Drainage Tunnel works)

為了令 1972 年寶珊道的大規模山泥傾瀉不再重演，土力工程處設計及建造了寶珊排水隧道，以創新的地下水位調控系统控制該地段的地下水位。當排水斜管壓力計的數據超過預設值，系統中的虛擬「雙胞胎」會即時向工程人員通報，令他們可以迅速調節水位，減少發生大型山泥傾瀉風險。

To prevent large scale landslides like the 6.18 Landslide Disaster at Po Shan Road from happening again, the GEO designed and built the Po Shan Drainage Tunnel, which uses an innovative groundwater regulation

system to control the groundwater level in the area. When the readings from the manometers of the sub-vertical drains exceed a preset threshold, the virtual “digital twins” of the Drainage Tunnel in the system will immediately identify the location(s) and notify the GEO's engineers so that they can take prompt actions to regulate the groundwater level to reduce the risk of major landslides.

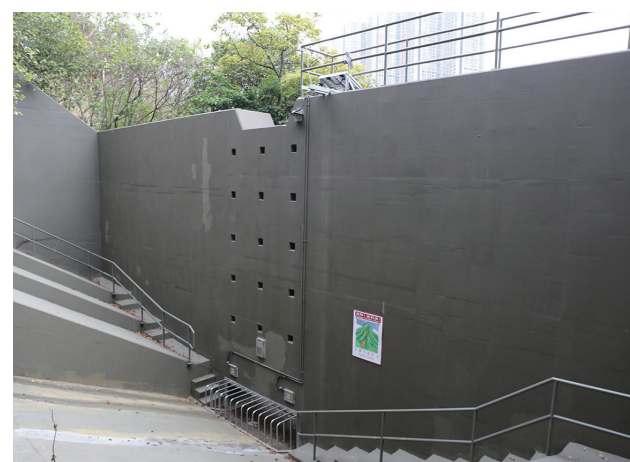
↑ 楊暉副處長（上）講解智能泥石壩如何運作（下）(Jenny Yeung, Deputy Head of the GEO [upper], explains how the Smart Barrier [lower] works.)

The Smart Barrier System comprises IoT (Internet of things) devices installed on debris-resisting barriers. Jenny Yeung, Deputy Head of the GEO (Planning and Standards), explained how it works. She said, “Many barriers are located at natural stream courses or hillsides, where accumulation of landslide debris behind the barriers may easily go unnoticed. We therefore developed the Smart Barrier System. When landslide debris hits the impact switches, the system will immediately send alert signals to the monitoring officers

壩後方的泥石難以被察覺。有見及此，土力工程處研發「智能泥石壩」系統，當感應器被泥石撞擊時，系統會即時向監察人員發出警報，並持續將數據和影像傳送給他們，以便適時安排跟進行動。監察人員亦可控制系統以收集更多實時數據和影像，令部門能更快地應對緊急的山泥傾瀉事故。」

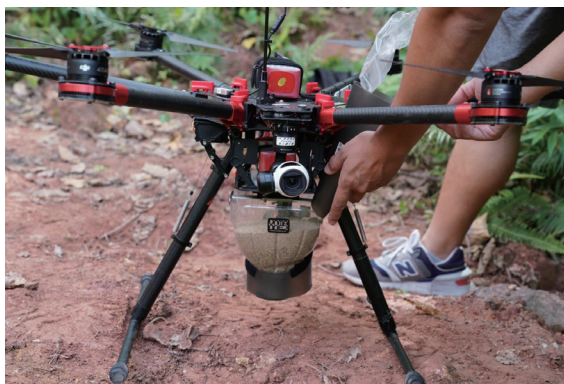
↑ 無人機裝有自行開發的播種器，配合香港的情況。(The drone is equipped with a seeder developed specifically for Hong Kong's environment.)

To avoid losing time-critical data, the GEO uses drones to quickly reach landslide sites for inspection and to collect data for three-dimensional modelling. In addition, the Office started to try broadcasting seeding by drones in 2019 to revegetate landslide scars at remote pilot sites, with a view to speeding up the restoration of vegetation on natural hillsides.

以免重要資料隨時間消失。此外，他們由2019年開始試驗以無人機在偏遠山坡的山泥傾瀉殘痕上播種，希望加快植物生長，令天然山坡得以盡快回復天然原貌。

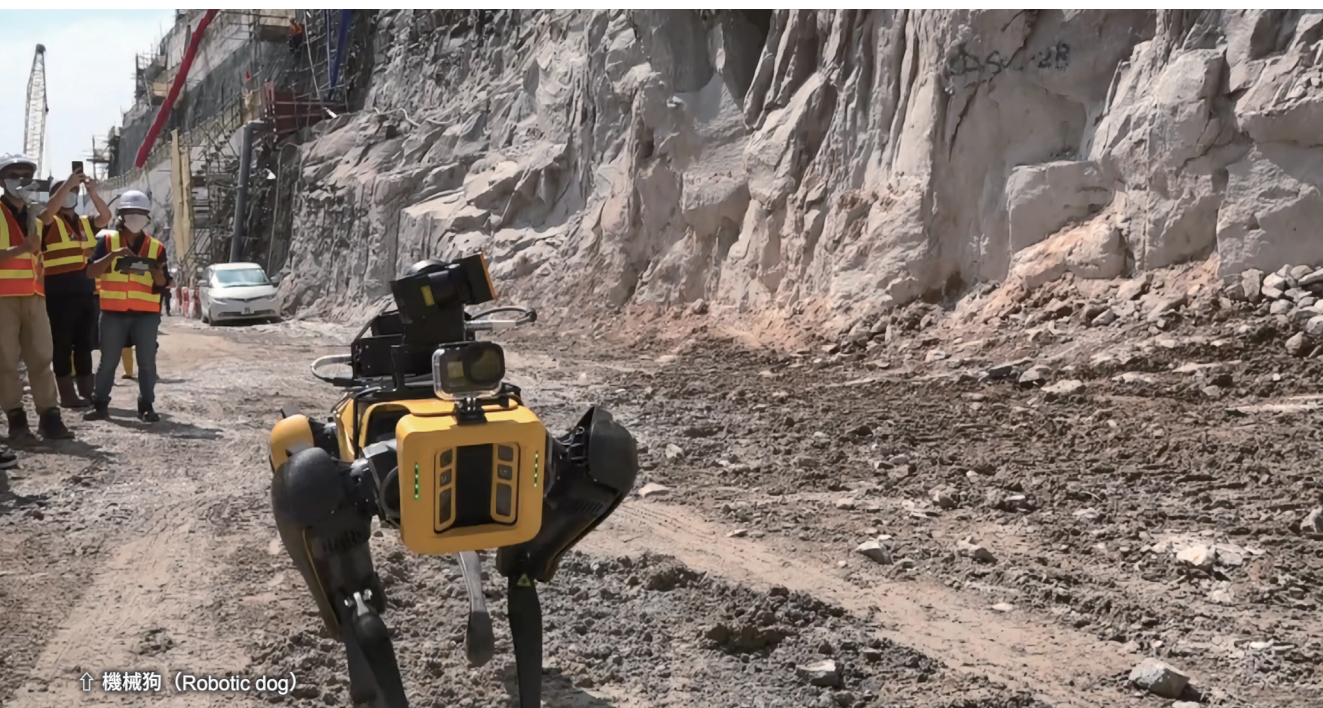
↑ 機械狗 (Robotic dog)

土力工程處於2020年8月從外地引入兩隻機械狗，並與本地科創公司合作，訓練機械狗在山泥傾瀉現場收集數據，並利用測量儀器取得數據製成三維地形數碼模型。工程人員可以遠程控制機械狗進行視察，並將現場影像即時回傳至緊急控制中心。

to train the robotic dogs so that they can collect important information from landslide sites for 3D digital landscape modelling. Engineers can remotely steer the robotic dogs to survey the site and transmit real-time images to the Emergency Control Centre.
