# The Significance of Primary Volcanic Fabrics and Clay Distribution in Landslides in Hong Kong

P. A. Kirk, S. D. G. Campbell & C. J. N. Fletcher

*Geotechnical Engineering Office, Civil Engineering Department, Hong Kong*

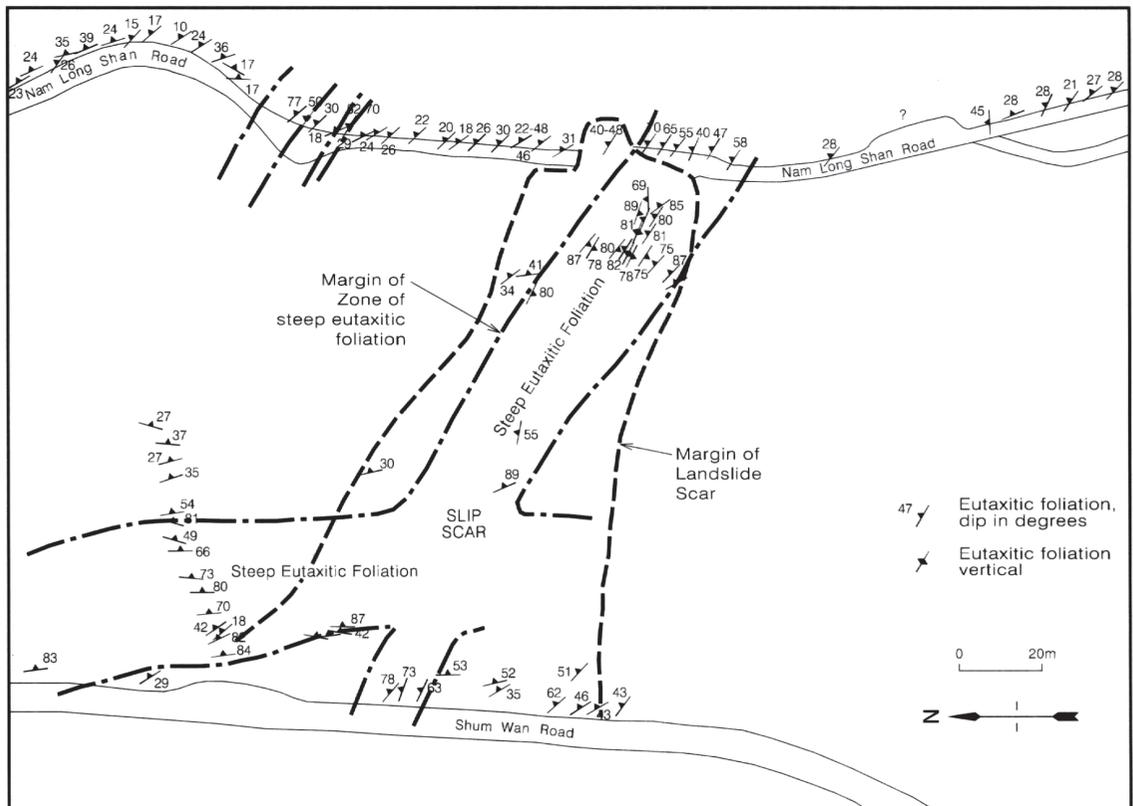
foliation is commonly very steeply inclined (70-90°) or locally overturned (80-90°), and strikes similar to, but slightly more NNW than the WNW-trending landslide scar (Figures 10 and 11). Outside the scar, the foliation is more shallowly inclined (15-40°). The northern margin of the zone of steep foliation coincides with an increase in the size of the fiamme and reduction in the material weathering grade. In the lower part of

Figure 10. Map showing variation of eutaxitic foliation around the Shum Wan Road landslide

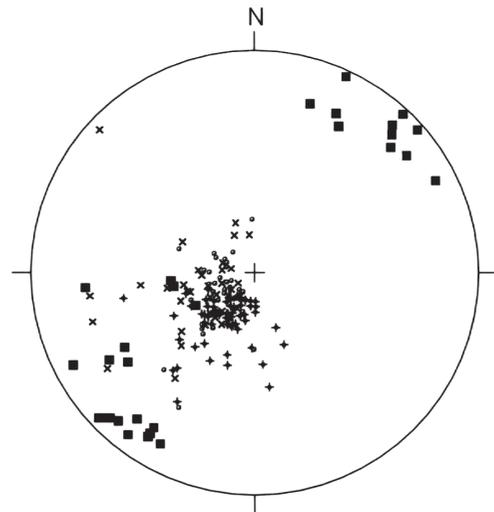
Figure 11. Stereoplot (equal-area, lower hemispheric) of poles to eutaxitic foliation at Shum Wan Road landslide site, and to its north and south along Nam Long Shan Road.
