Engineering Geological Aspects of Landslides

S. Hencher

Halcrow China Limited, Hong Kong

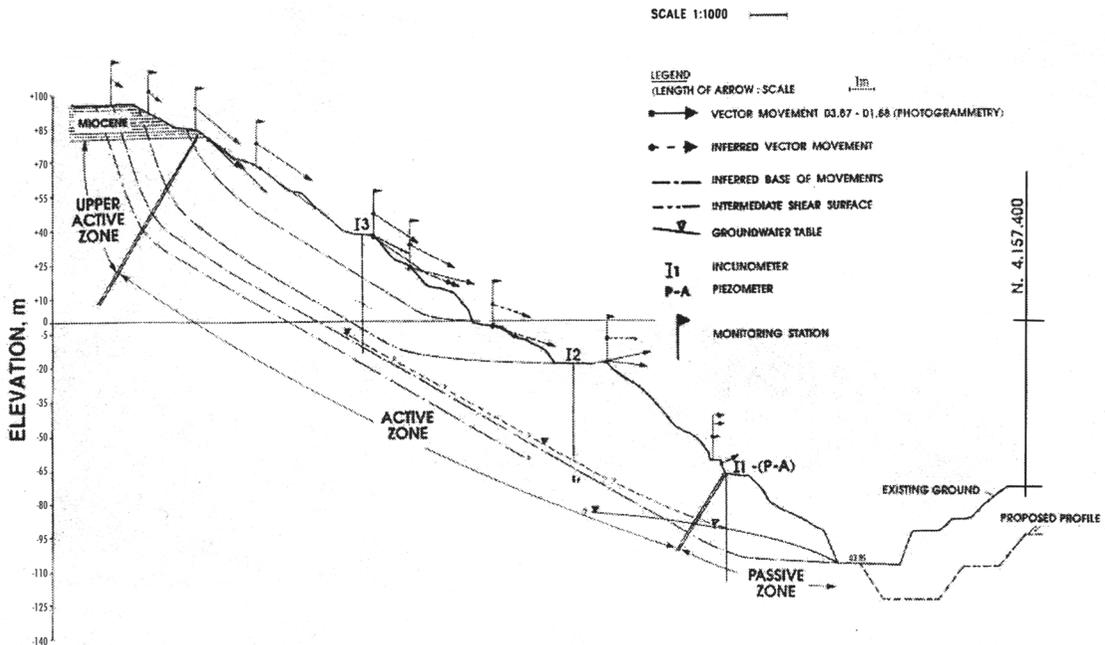
Figure 5. Section through failing slope (Hencher et al, 1995)

Another example of this type of failure is that at Aznalcollar open pit mine in Spain (Hencher et al, 1995) (Figures 4 & 5). One section of the slope was continually on the move (several mm per day), speeding up following heavy rainfall, whilst another, apparently similar section remained apparently stable. The latter slope was of most concern because it was feared that a sudden, brittle type of failure might occur and careful monitoring had to be set up to try to get some advanced warning of imminent failure. The rock mass is predominantly fairly closely fractured slate with steeply dipping cleavage (much steeper than the failing slope which has an overall angle of only about 33 degrees).

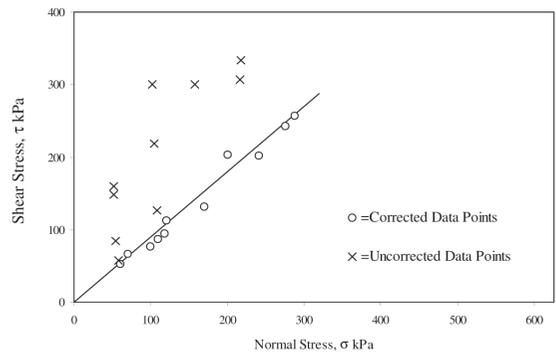
Figure 14a. Measured peak strengths and data “corrected” for dilation

To illustrate the importance of weathering to shear strength, data are presented in Figure 14, collected following a failure on Tuen Mun Highway (Hencher & Martin, 1984). The data are analysed in detail in GCO (1983c). Block samples were collected from below the failure scar and tested in direct shear and triaxially. Triaxial test results are omitted from Figure 14 for clarity but generally provided further support to the discussion below. The samples tested were all within the range highly to completely decomposed (on the basis of field index tests) but the raw shear test data exhibited considerable scatter in terms of peak strength (Figure 14a). Once one takes account of the dry density of the samples, however, a clear pattern emerges. Those with highest density have the highest peak strength (Figure 14a) as might have been anticipated (Wong, 1982). It was also apparent that the densest samples also showed the greatest amount of dilatancy during shear. An attempt was therefore made to “correct” the data for dilatancy in the same way

as for rock joints (Rowe, 1962; Hencher & Richards, 1982, 1989). The corrected data in Figure 14a from all samples provided a well-defined “basic friction angle” which is close to the dilation-corrected strength of rock joints through granite (whatever the weathering grade) (Hencher & Richards, 1982). Clearly the amount of extra strength available due to dilation was dependent upon dry density (reflecting degree of weathering) but also stress level. At high enough stress levels, dilatancy would be inhibited whatever the density of the sample (Figure 14b). It is interesting that these data indicate that the strength above basic can be interpreted as stress dependent rather than cohesional. This does not mean that true cohesion does not exist in weathered rocks (say grade IV) which, no doubt, it does.

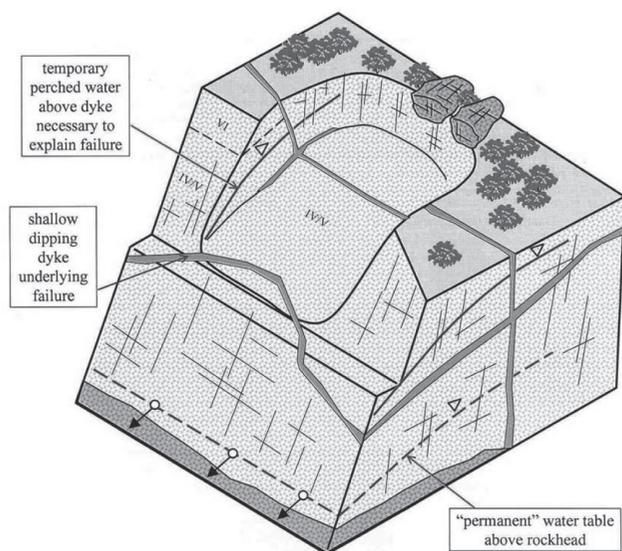
Figure 16b. Block model of geology of landslide area (modified from Hencher & Martin, 1984)

& Hencher (1984) give examples. Au (1986) reviewed several cases. Figure 16 shows a failure that occurred on Tuen Mun Highway in 1982 together with a block model interpretation of geological conditions that, it was believed, led to the development of perched water.
