# Environmental Factors in Triggering Slope Failures

S. W. C. Au & R. Y. C. Suen

*Geotechnical Engineering Office, Civil Engineering Department, Hong Kong*

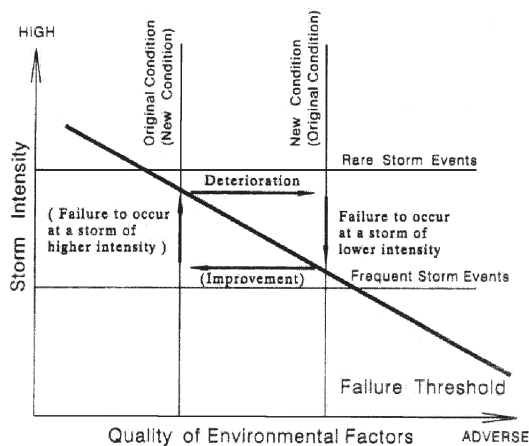
Figure 2. Relationship between storm intensity and environmental factors in triggering failure

For a given slope where its uphill environmental factors give rise to a point for concentration of water, flooding or channelling of flow will occur (Au & Suen, 1991). As the environmental factors become more unfavourable, failure can be more readily triggered by lower rainstorm intensities and vice versa (see Figure 2). Many of the environmental factors are in fact created by or associated with human activities. Some of these factors may not come into effect until after a critical rainfall intensity has been reached, and thus the hazard which they pose may not be obvious beforehand. To give just a rough idea of their variety in the Hong Kong urban environment, some examples commonly encountered are cited:

High concentrations of surface runoff are the cause of many slope failures in Hong Kong. Environmental factors causing high surface water concentrations should be removed or improved (see Figure 2).
