The 23 July 1994 Landslide at Kwun Lung Lau, Hong Kong

H. N. Wong & K. K. S. Ho

Geotechnical Engineering Office, Civil Engineering Department, Hong Kong

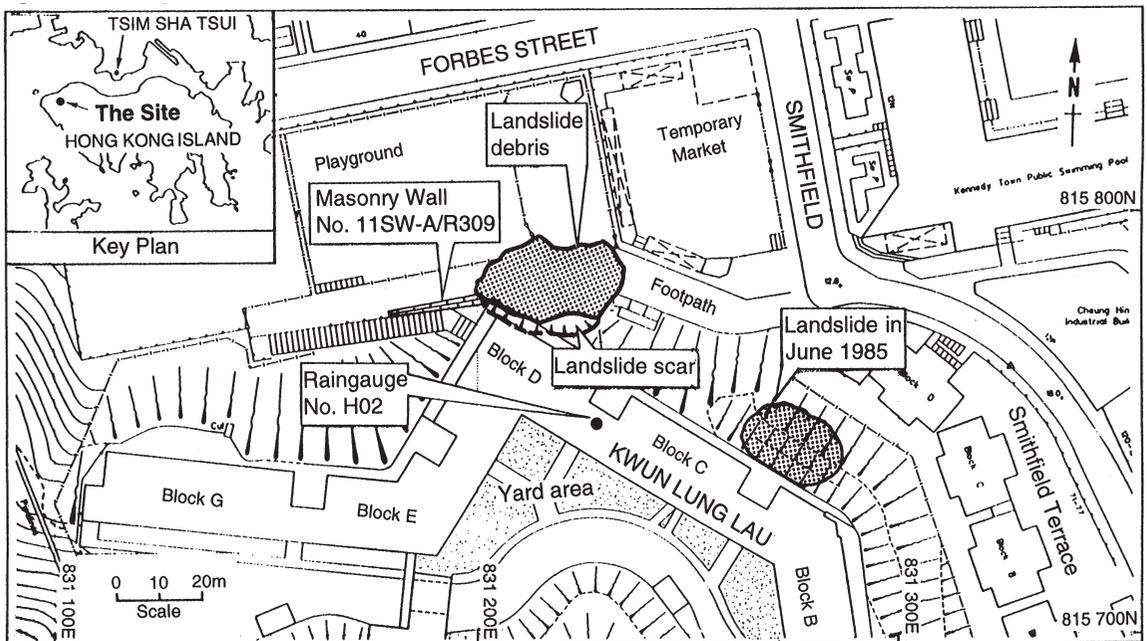
Figure 3. Site location plan. Base map from survey sheet 11-SW-6D dated 29 September 1992. Scale 1 : 1000

The location of the landslide at Kwun Lung Lau is shown in Figure 3. The ground that failed comprised a portion of the masonry wall and slope below Block D (Figure 4). In front of the masonry wall is a 7-10 m wide footpath that provides a pedestrian access to Kwun Lung Lau. There is a playground and a football pitch adjacent to the footpath.

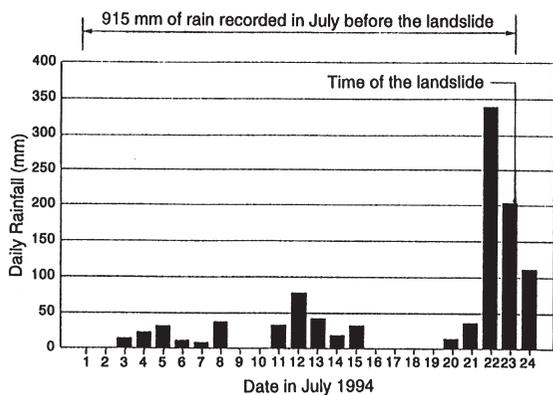
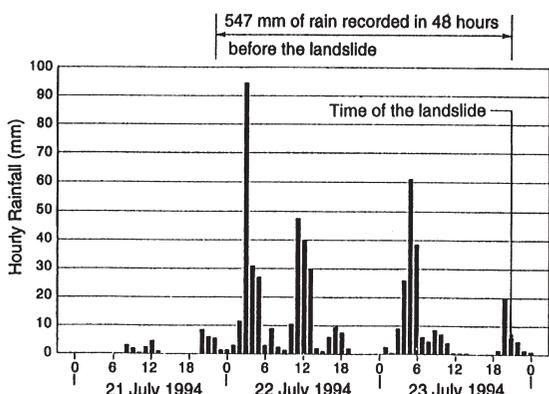
Figure 9. Rainfall records of GEO rain gauge H02

at Kwun Lung Lau. The daily rainfalls recorded by the rain gauge in July 1994, together with the hourly rainfalls from 21 to 23 July 1994, are shown in Figure 9. In the month of July 1994, a total of 915 mm of rain had been recorded by the rain gauge up to the time of the landslide on 23 July 1994. This amount had already exceeded the highest rainfall ever registered in any July at the Royal Observatory's station in Tsim Sha Tsui (Figure 3) since records began in 1884.

The maximum hourly rainfall was 101 mm, which occurred between 2:05 and 3:05 a.m. on 22 July 1994, about 42 h prior to the landslide. Only 29 mm of rain was recorded by the rain gauge between 11:00 a.m. on 23 July 1994 and the time of the landslide, i.e., approximately 95% of the 48 h rainfall fell more than 10 h before the landslide. The Kwun Lung Lau landslide was therefore a "delayed" failure, in that it occurred several hours after cessation of the intense rain.

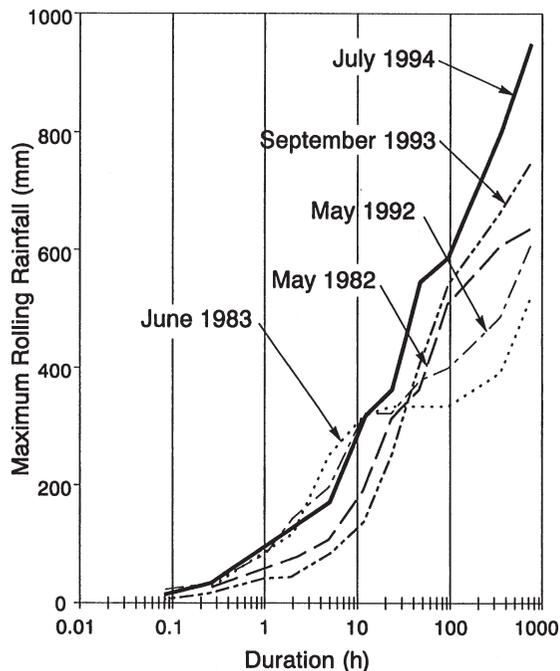
Figure 10. Maximum rolling rainfalls at rain gauge H02 for major rainstorms

It is noteworthy that the July 1994 rainstorm contained the heaviest long-duration rainfall (i.e., 2 days or more) recorded at Kwun Lung Lau since the installation of rain gauge H02 in September 1978 (Figure 10). The long-duration rainfall intensities were significantly higher than those of the previous rainstorms experienced at Kwun Lung Lau since September 1978. For example, the 48 h rainfall before the landslide exceeded the previous maximum,

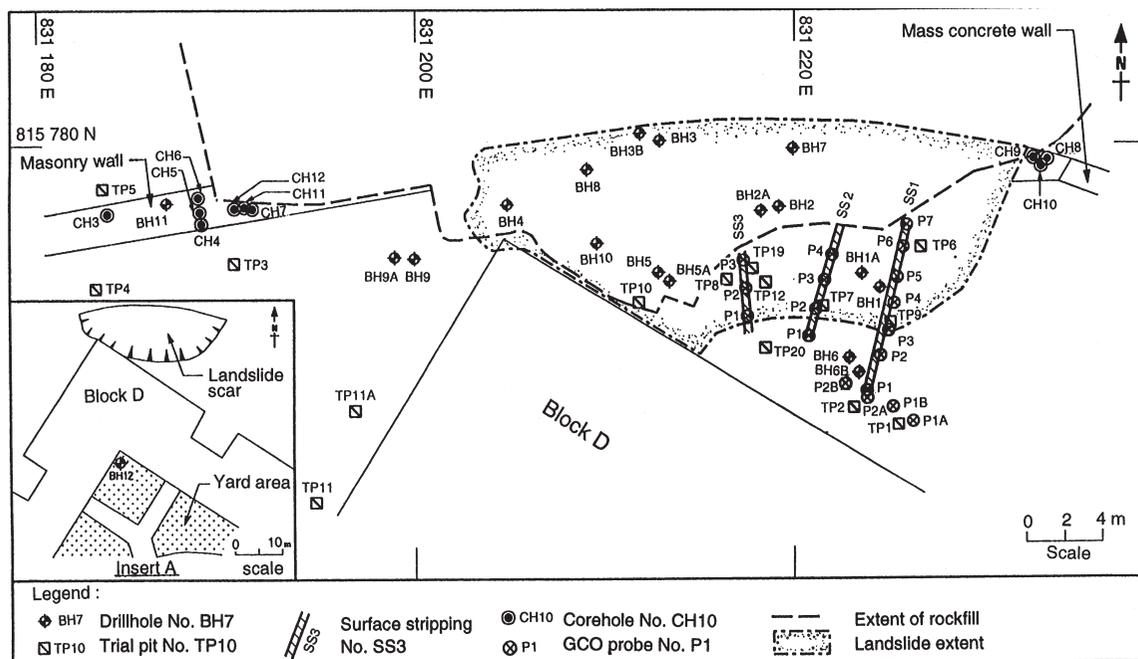
Figure 11. Location plan of the ground investigation work

The ground investigation, carried out in accordance with the standard of practice presented by the Geotechnical Control Office (GCO 1987), comprised 18 drill holes, 15 trial pits, three surface strippings, and 10 coreholes through the unfailed part of the masonry wall (Figure 11). Disturbed and undisturbed soil and rock samples were retrieved for visual inspection and laboratory testing. Field tests, including standard penetration tests (SPT), falling-head permeability tests, sand replacement tests, GCO-probing tests, and index tests were carried out to determine the in situ properties of the soil. In addition, 24 pits were dug underneath Block D and in the yard area to the south of the block for inspection of the building substructure and drainage systems and observations of water seepages.

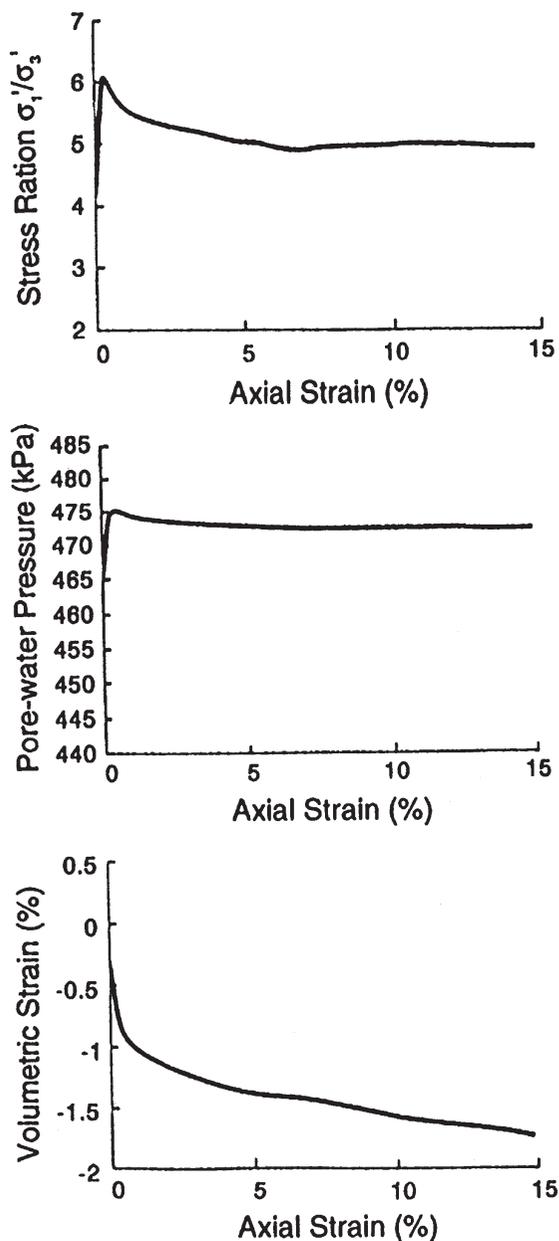
Figure 12. Typical behaviour of CDV in a stress-path triaxial test. σ_1' and σ_3' , major and minor principal effective stress, respectively

The results indicate that the stress-strain relationship obtained from the imposed stress path (Figure 12), which better simulates the process of gradual increase in pore-water pressure in a slope, exhibits stiffer and more brittle behaviour than that obtained from conventional triaxial compression tests. The soil strengths given by the special tests are generally higher than that determined in conventional triaxial compression tests, whereas the postpeak strengths are comparable.

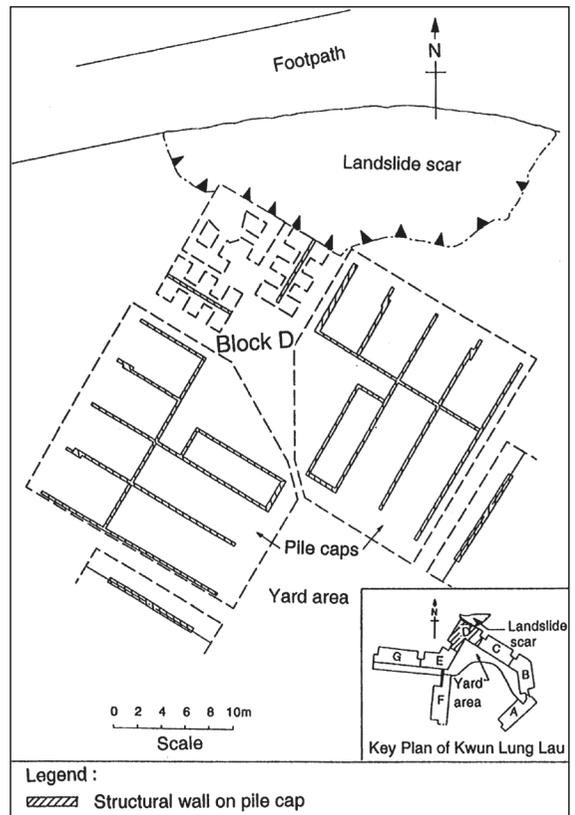
Figure 14. Layout of pile caps under Block D

The layout of the pile caps and structural walls of the substructure of Block D is shown in Figure 14. Block D is underlain by two large pile caps founded on weathered volcanic tuff, with fill placed within the gap between the caps. The fill extends to the landslide site and the yard area to the south of Block D, as shown in Figure 15.
