土木工程拓展署  
土力工程處  
Geotechnical Engineering Office  
Civil Engineering and  
Development Department

# 香港的山泥傾瀉 LANDSLIDES IN HONG KONG

# 引言 Introduction

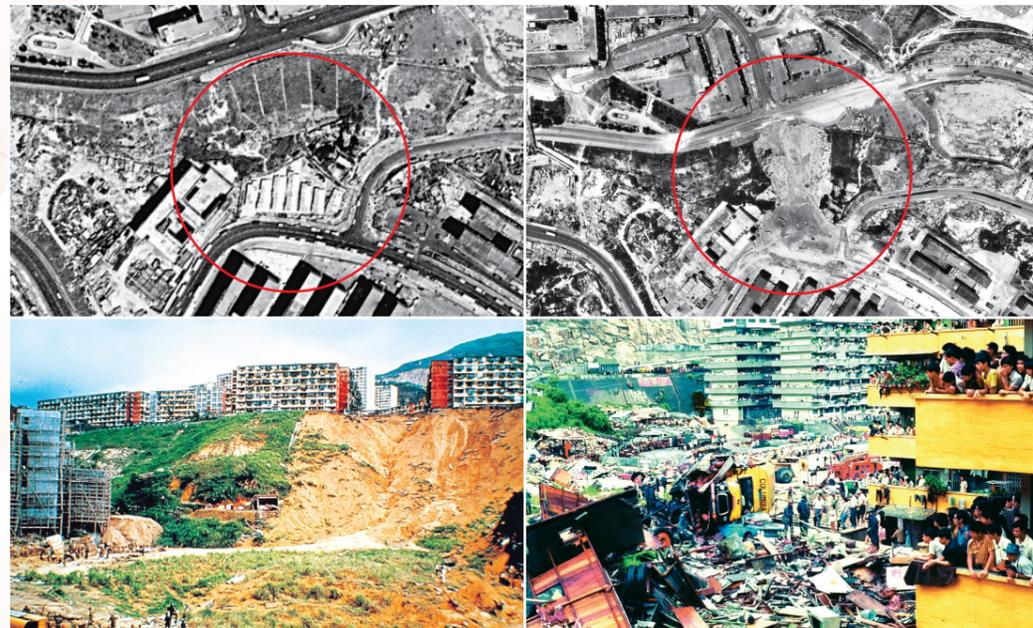
圖4. 1972年秀茂坪山泥傾瀉。  
Figure 4. 1972 landslide in Sau Mau Ping.

1972及1976年發生了兩次暴雨災害，政府因此於1977年成立了土力工程處作為一個制訂斜坡政策的中心部門。香港歷史上最嚴重的山泥傾瀉發生於1972年6月18日。下午1時後不久，位於秀茂坪安置區發生山泥傾瀉(圖4)，一幅40米高的路堤邊坡倒塌，隨之而來的泥石摧毀了位於斜坡下面的臨時安置區，導致71人死亡及60人受傷。數小時後，香港島半山區寶珊道一處私人住宅區附近的山坡又發生另一重大山泥傾瀉，一座12層高的私人住宅大廈被急速傾瀉的山泥沖毀(圖5)，導致67人死亡及20人受傷。此山泥傾瀉成因的詳情，請參閱附錄A。

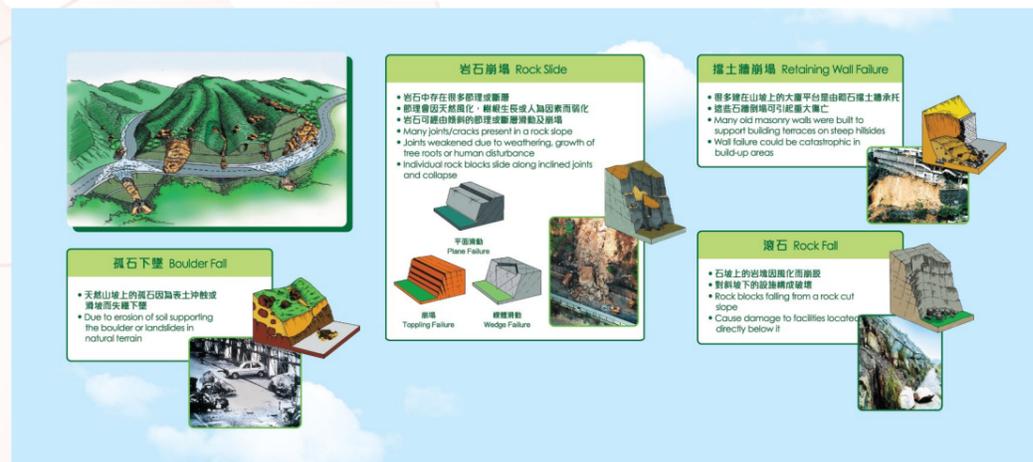
圖31. 常見的山泥傾瀉模式(非土坡)。  
Figure 31. Common failure mechanism of landslides (non-soil slopes).

香港普遍的斜坡災害於表2按不同的斜坡種類、斜坡物質性質及快速崩塌形式而分類。圖2展示不同種類的斜坡，而圖31及32則說明崩塌形式。香港大部份崩塌發生於舊的削土坡。但亦有發生於舊的填土坡及擋土牆。近來，天然地形的山泥傾瀉有

The common types of slope hazards in Hong Kong are summarized in Table 2 with respect to the different slope types, nature of slope-forming material and mechanisms of fast-moving failures. Figure 2 explains the different types of slope and Figures 31 and 32 illustrate the failure mechanisms. In Hong Kong, most of the failures occur on old cut slopes. However old fill slopes and retaining

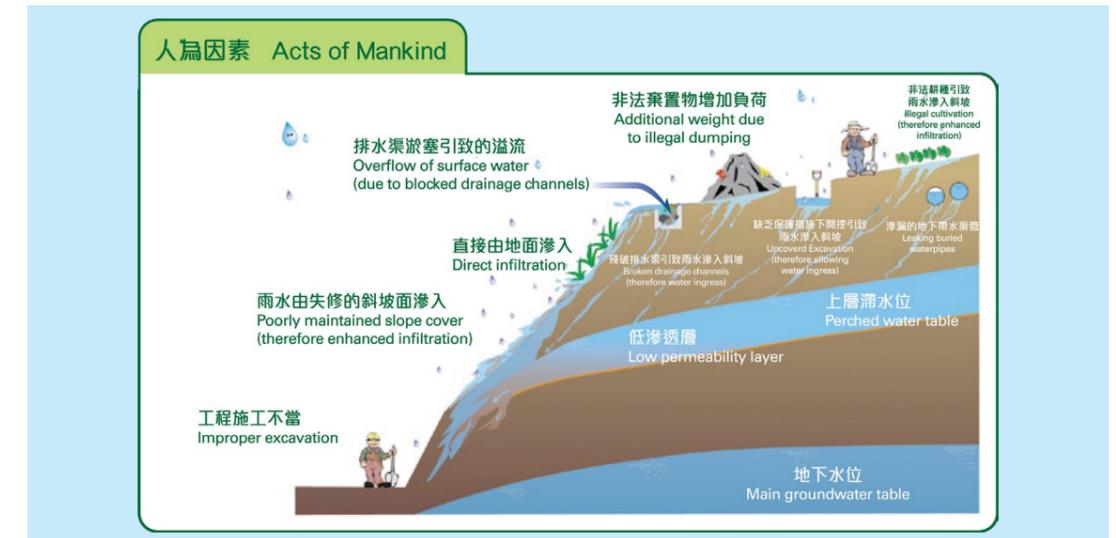
圖35. 導致山泥傾瀉的一些常見人為因素。  
Figure 35. Some common human causes of landslides.

Broadly speaking, there are two main causes of landslides: Acts of Nature and Acts of Mankind. Figure 34 shows some common natural causes of landslides in a simplified way while Figure 35 explains some common human causes.

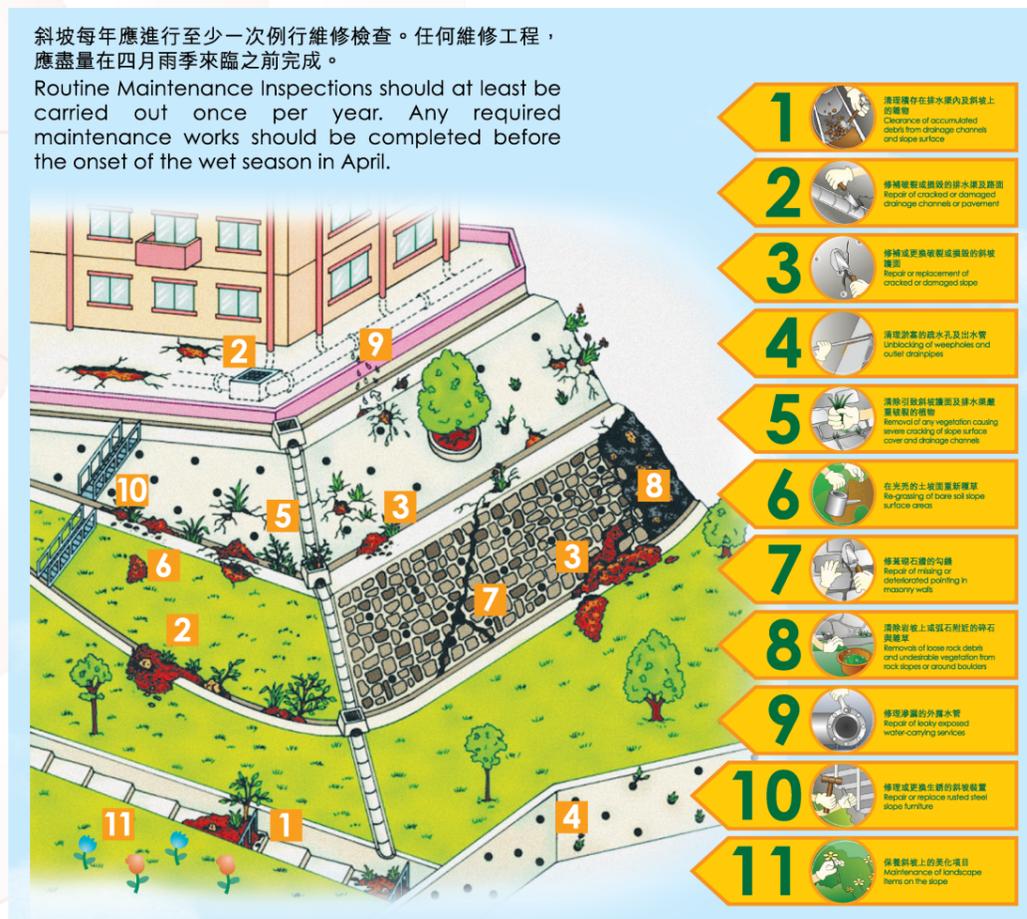
圖36. 定期維修斜坡能有效減低山泥傾瀉風險。  
Figure 36. Regular slope maintenance can effectively reduce landslide risk.

Table 4 shows some key measures in more concrete terms. Examples of engineering works to prevent or mitigate the landslides problems are shown in Figures 36 - 38.
